REPAIR AND RENOVATION OF THE HISTORIC CHURCH IN RUDA ŚLĄSKA AFTER MANY FAILURES CAUSED BY MINING EXPLOITATION

Abstract

3. DESCRIPTION OF THE CHURCH BUILDING

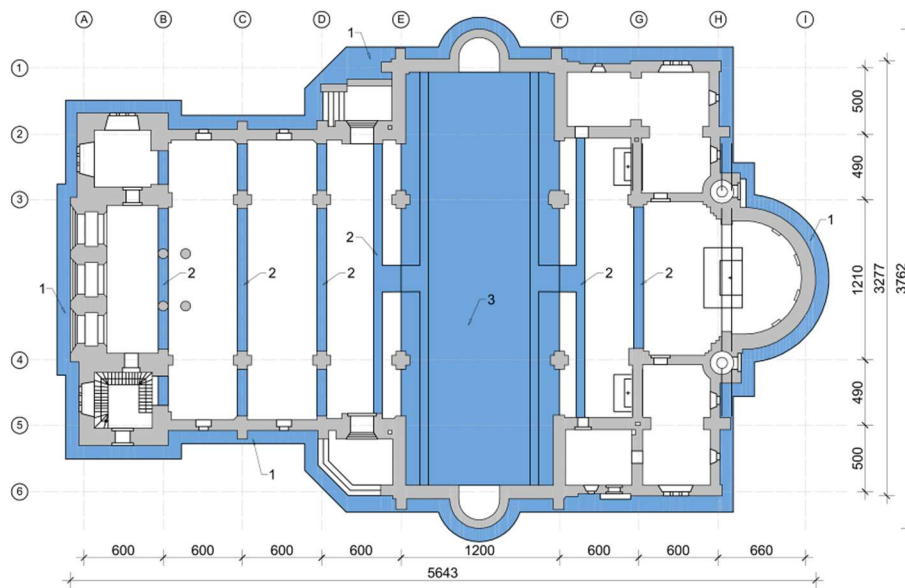
The church building was not originally protected against the effects of mining exploitation. First minor damages to the building were noticed in 1936, and the serious damage was found in the late 1970s which resulted in installing benchmarks for the survey inspection. The damaged walls and vaults were repaired on 23 June 1980. The repair works included rebricking of external walls and lintels of arch windows, and injection of cracks on the vaults with epoxy resin. In 1986÷1987, the reinforced concrete apron of 1.0 x 1.0 m cross-section was performed at the elevation of -2.20 m below ground level (Fig. 3). The concrete apron was reinforced with 20 rebars of 32 mm in diameter (18G2 class) in the

Fig. 3. Strengthening of the church horizontal foundation in the years 1986-1987:
1 – reinforced concrete apron, 2 – reinforced concrete tie rods, 3 – reinforced concrete slab over tie rods

longitudinal direction, and transversely with 16 rebars of 32 mm in diameter (18G2 class). Inside the church, the apron was connected with transverse tie rods placed on the axis of the posts. Over the tie rods in the transept area, the reinforced concrete slab (diaphragm) was performed.

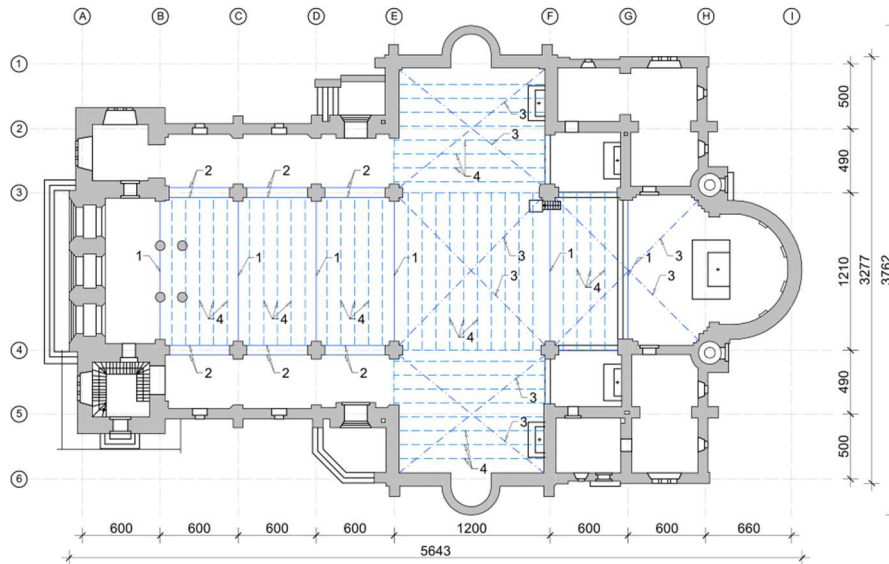
The post heads were horizontally stiffened (level of +8.6 m) above the floor level. This stiffening using longitudinal and transverse tie rods/flying shores was a part of the works performed in the years 1986÷1987. These flying shores were made of two C-shaped beams 2xUPN240. Additionally, the vaults of the main nave were stiffened at the level of post heads in aisles, the vestry and chapel rooms using rigid two-branch tendons and the system of longitudinal and transverse slender tie rods. Also the vaults of the transept and the nave were protected with slender cross tie rods made of steel. Above this protection, steel cords were stretched to fix the safety net (Fig. 4). Photographs illustrating strengthening works are presented in Fig. 5.

Fig. 4. Horizontal strengthening of the church at the level of +8.6 m in the years 1986-1987: 1 – tie rods 2x UPN240, 2 – tie rods 2xUPN100, 3 – slender steel tie rods $\phi 32$, 4 – cords to stretch the net protecting people inside the church

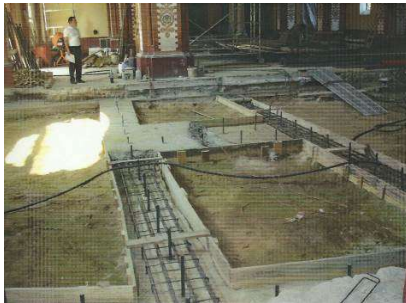
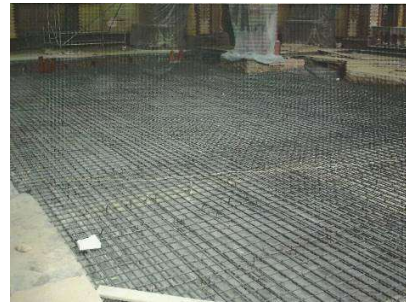
Fig. 5. Strengthening performed in the years 1986-1987: internal tie rods (left) and reinforcement of reinforced concrete slab (right)

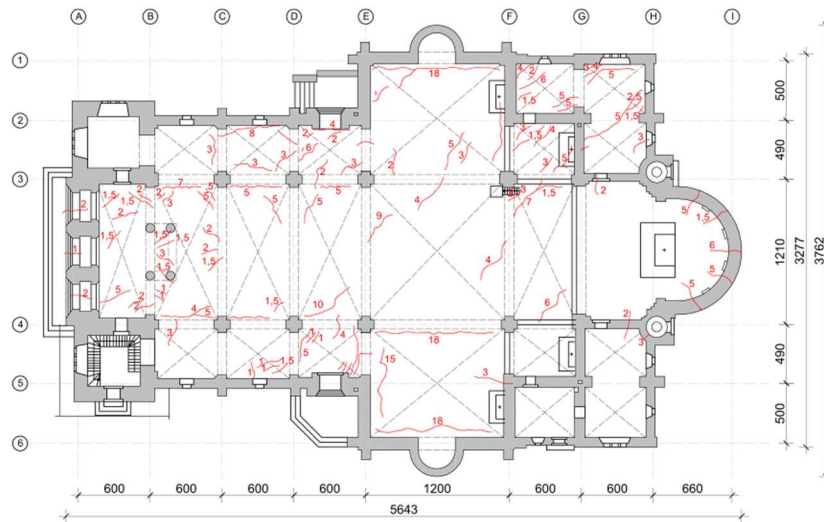
The repair works for new cracks and fractures developed in the walls and vaults of the church began in 2002. Their width was up to 18 mm. However, no cracks were observed in the towers. After injecting the cracks with epoxy resin, the church was plastered and painted wall decorations were restored. New damages were formed directly after finishing the works. At first, cracks were observed in the arches of the main wall. They were so big (with the width up to 20 mm – Fig. 6 and 7) that they posed a risk of falling out of the masonry units. Thus, it was recommended to wedge the arches and ribs of the vaults (Fig. 8 and 9) and to support them locally with arch centerings adjusted to their geometry.

Fig. 6. Cracks found in 2003

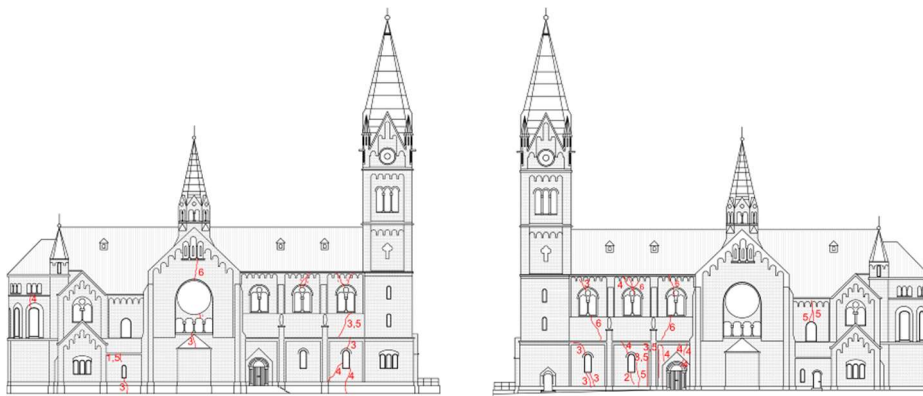
Fig. 7. Cracks of the elevation found in 2003

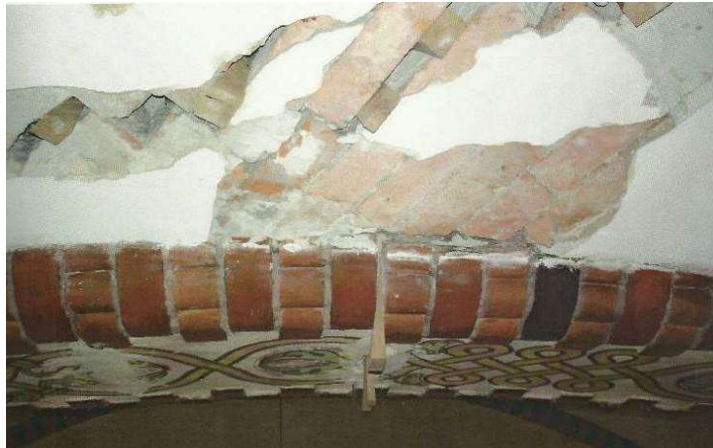
Fig. 8. Damage to the arch and wood wedges driven in the place of cracking (2003)

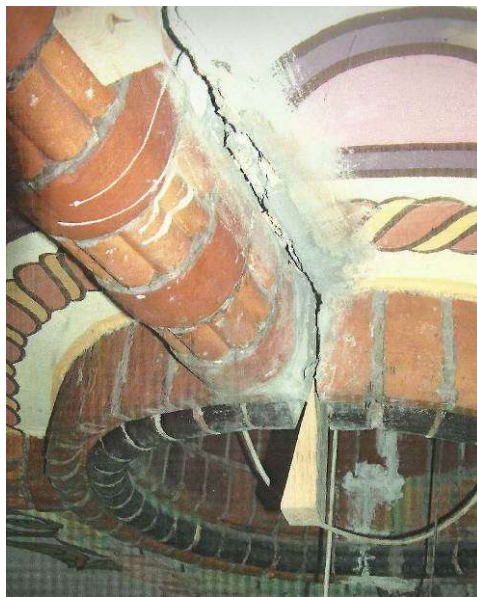
Fig. 9. Damaged area near the vault ribs and wood wedges driven in the place of cracking (2003)

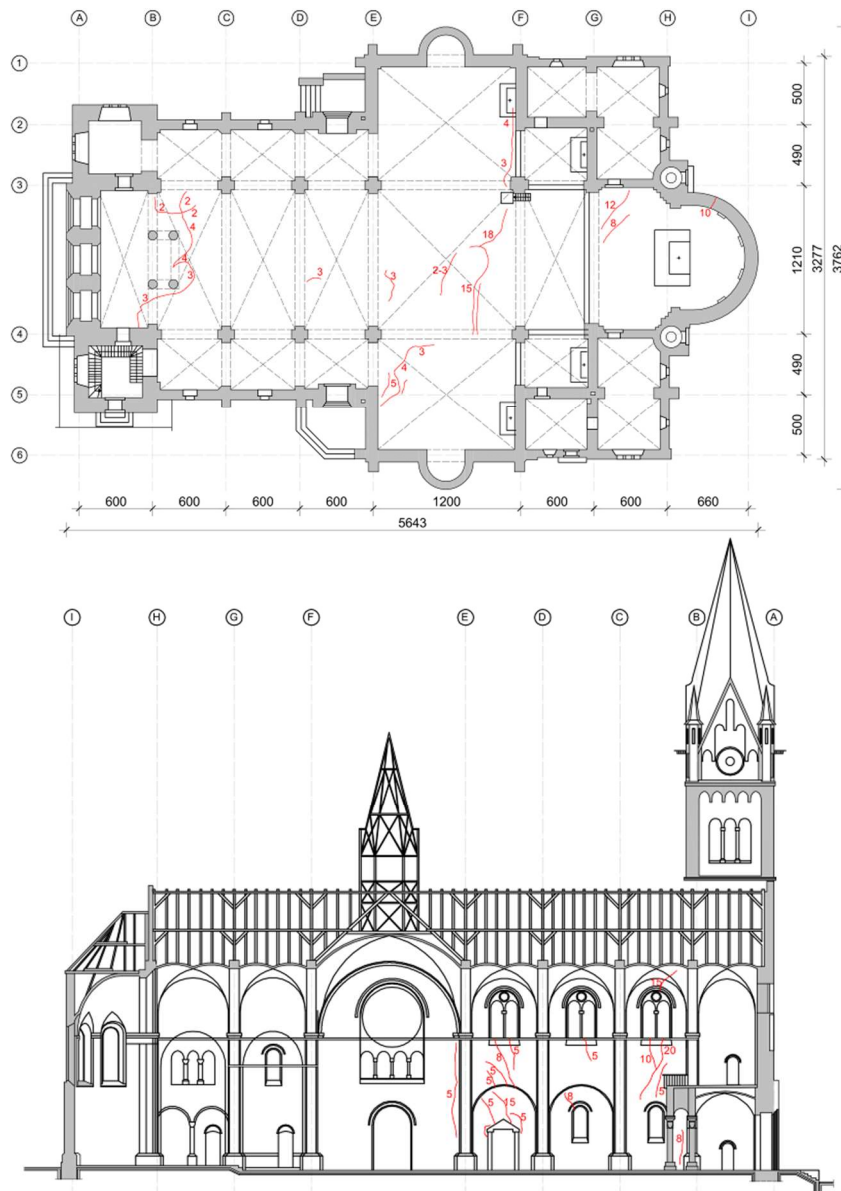
A sudden increase in the width of existing, but repaired cracks and the formation of new ones were observed since 2005 (Fig. 10-12). Non-continuous deformations occurred as pockets on the stone paved area around the church (the pit with the deflection of 12 cm).

Fig. 10. Cracks found in 2005 (view and cross section)

The church floor repaired by injection and overlaying was considerably cracked (the width up to 20 mm). New cracks (some with displacement) were formed in the walls and the vaults. Cracks on the stone elevation of the towers, loss and cracking of grouts were observed for the first time.

Another repair works of the church were conducted in the years 2005-2006. The vaults and walls were again injected. Additionally, a protective coating of the vault was applied from the top using the PCC technology. Floors, plaster and painted wall decorations were repaired.

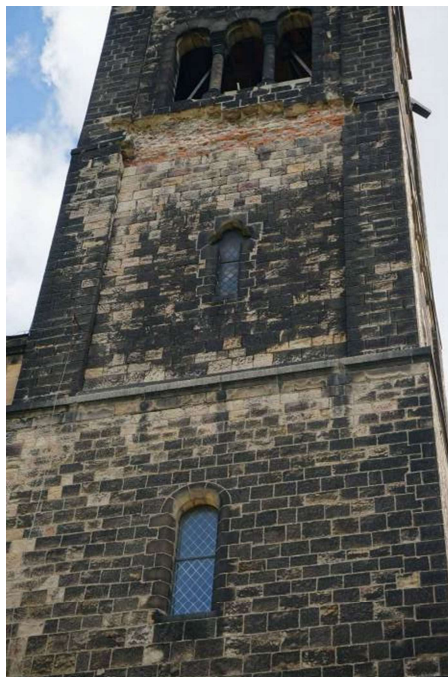
At night-time 2/3.07.2016, a part of the wall of ca. 12 m² was loosened in the west elevation of the south tower at the height of ca. 30 m above the ground level, in the place of damage observed in 2005 (Fig. 11 and 12) and fell down destroying an information board and the paving stones. The tower wall in this place is composed of two layers, the internal layer is made of bricks and the external layer made of stone (sandstone). Both layers are overlapped and bonded with lime mortar. Five stone blocks with the arch ornament were loosened. Each block was 63 cm high, ca. 92÷93 cm wide and differed in their thickness. Their thickness varied from 10 to 20 cm. Also stone blocks of the cornice, one whole layer of stone blocks above the cornice, and parts of two other layers were loosened. Debonding of single masonry units in the buttresses of both towers was also found. The loose masonry units fell down at the west side of the tower. They destroyed the noticeboard and caused the deflection of 7 cm in the stone paved-area.

Fig. 11. View of damaged west elevation of the south tower

- Damage repair in the failure zone. The repair works consisted of rebrickwork of the wall facing and the parts of the remaining wall. They aimed at keeping as many original masonry units as possible. Unfortunately, the stone blocks with the arch ornament broke into pieces. Thus, they had to be copied. The new stone elements were selected regarding the colour, the size, and the strength. The applied mortar was the system mortar for the historic buildings, similar to the original one.

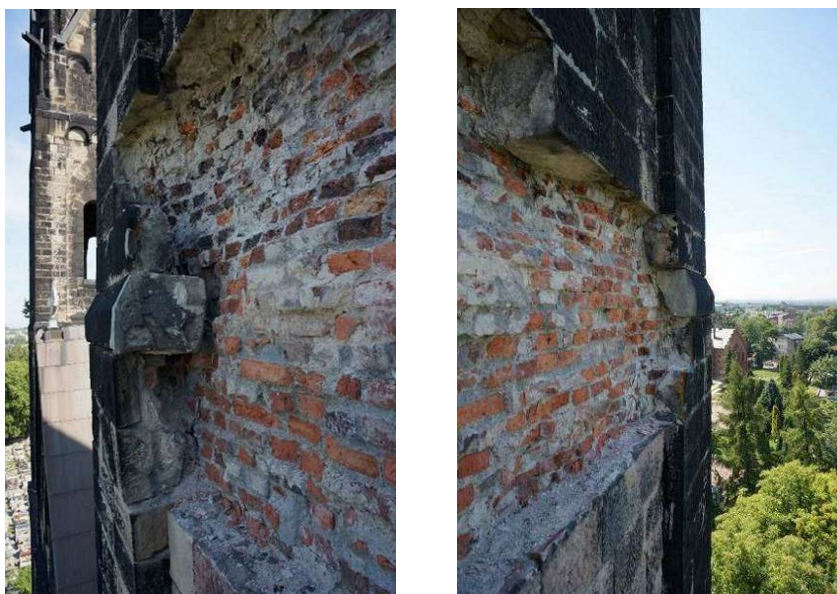
Fig. 12. Damage detail of the west elevation of the south tower

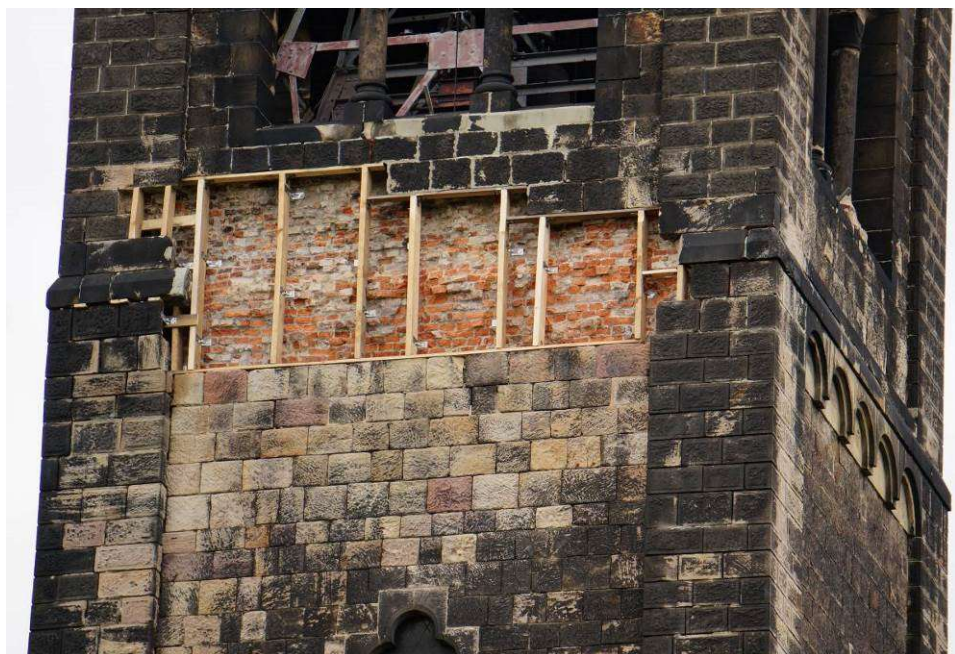
Fig. 13. Temporary protection of the debonding zone

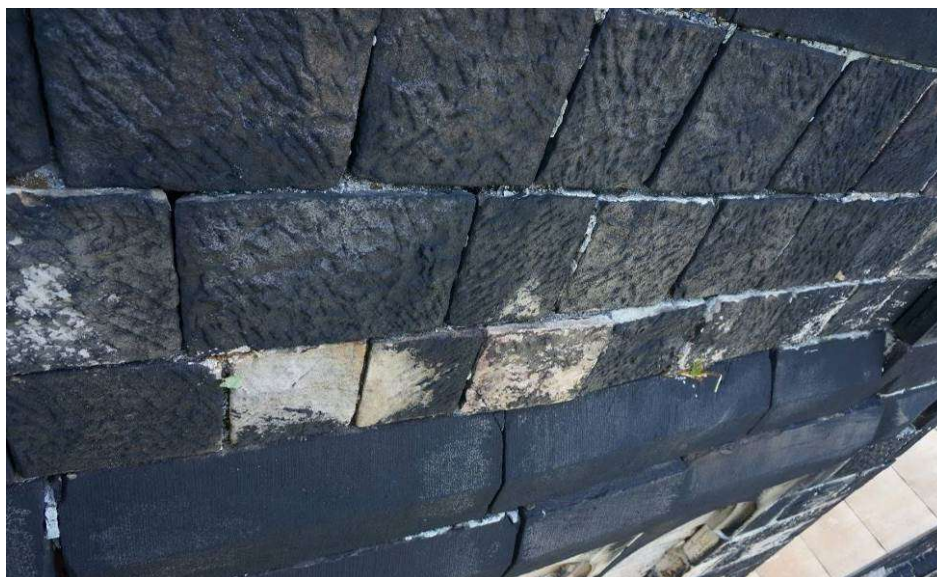
Insect nests were found in both towers, in the spandrel area, in the wall crevices. Bees nested were in the south tower, and wasps nested in the north tower. After the damage to the front wall, the fire service removed the loose masonry units and mortar from the debonding zone on 3 July, 2016. The area around both towers was fenced. The loose masonry units were removed, and temporary centering of the wall facing was performed where debonding was noticed (Fig. 13). The inspection of the second tower indicated significant debonding of the wall facing and high probability of the occurrence of the similar situation (Fig. 14).

Fig. 14. North tower. Loss in joints, cracks in stone works, bumps in masonry units and the cornice

- Crack repairs in the tower masonry. The cracks were stitched with stainless steel anchors placed in bed joints. Mineral injections were applied to the cracks.

- Masonry anchorage. All stone blocks with the arch ornament were anchored to the brick masonry using stainless steel anchors based on chemical anchors. Two anchors were used per one unit. Additionally, selected elements of the cornice and walls were anchored. Over 400 anchors were used in each tower.

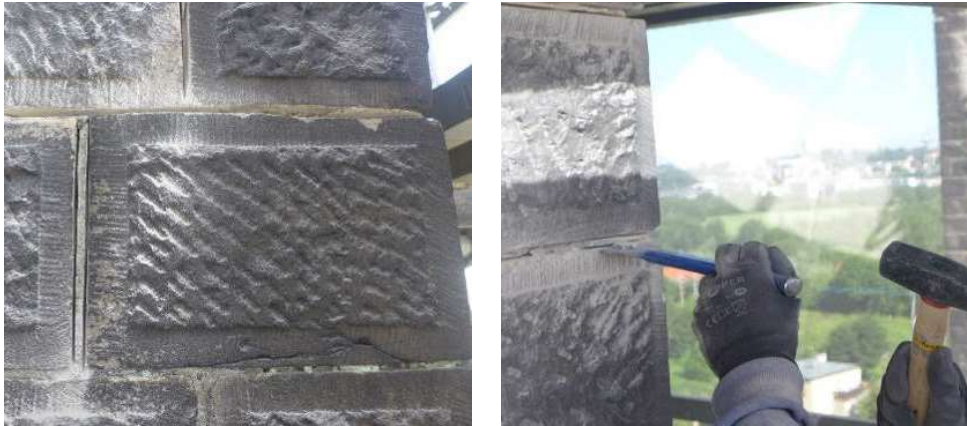
Fig. 15. Removal of secondary pointing

- Removal of secondary pointing with cement mortar.
- Cleaning of the wall face. The wall was cleaned using the mixed method, that is, manual and blast cleaning.

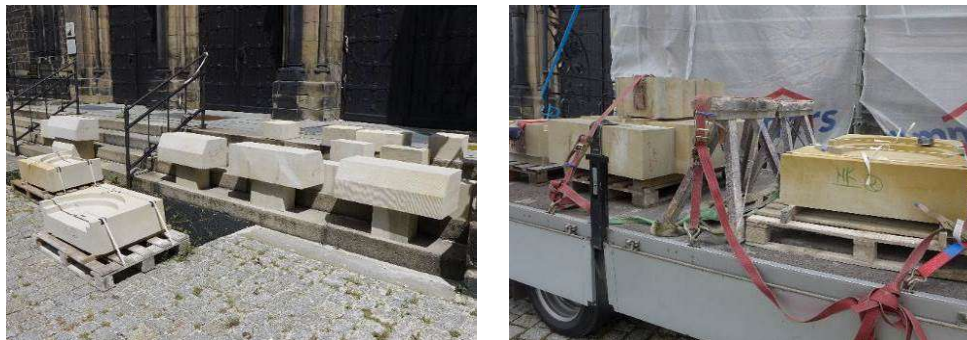
Fig. 16. New masonry units

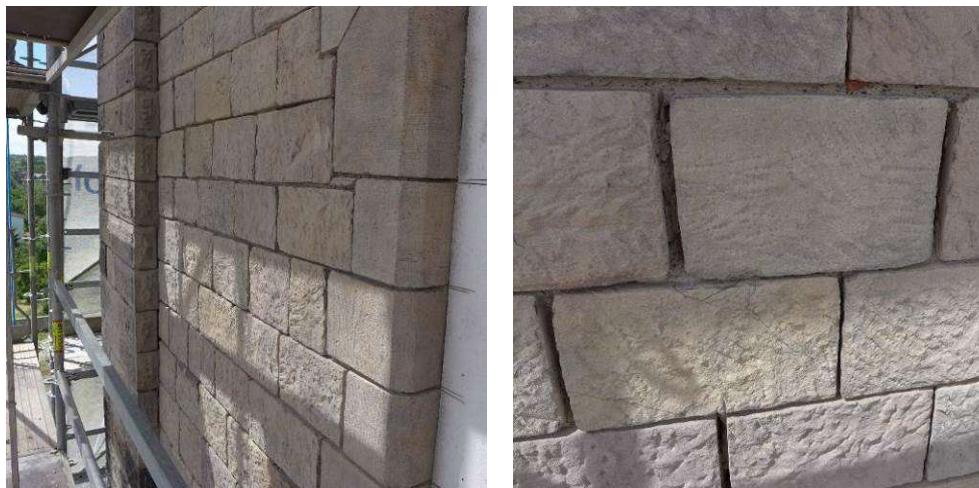
Fig. 17. Cleaned elevation and removed secondary pointing

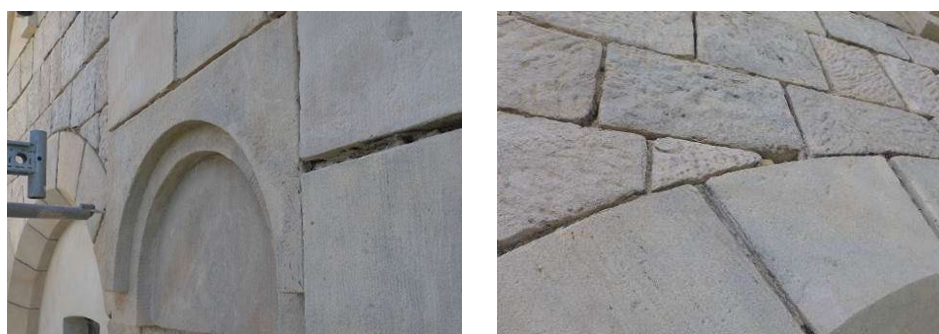
Fig. 18. Cleaned elevation and removed secondary pointing

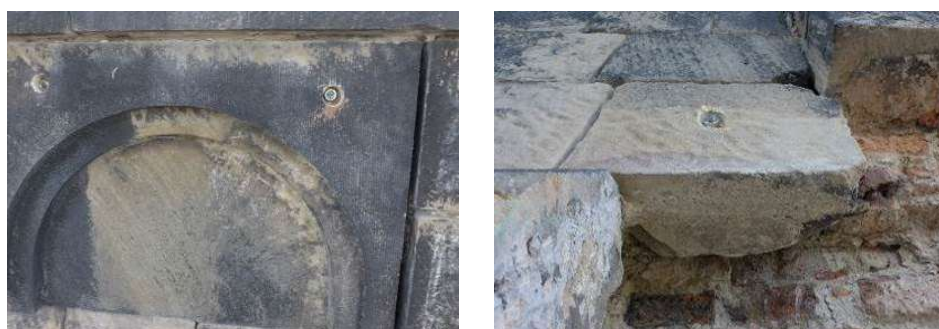
Fig. 19. Anchorage of loose elements

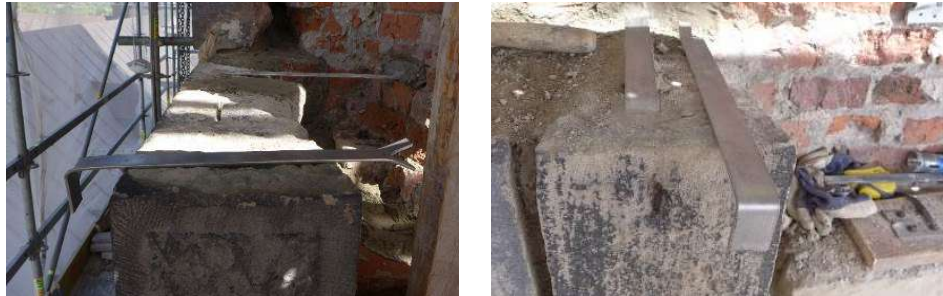
Fig. 20. Anchors for bed joints

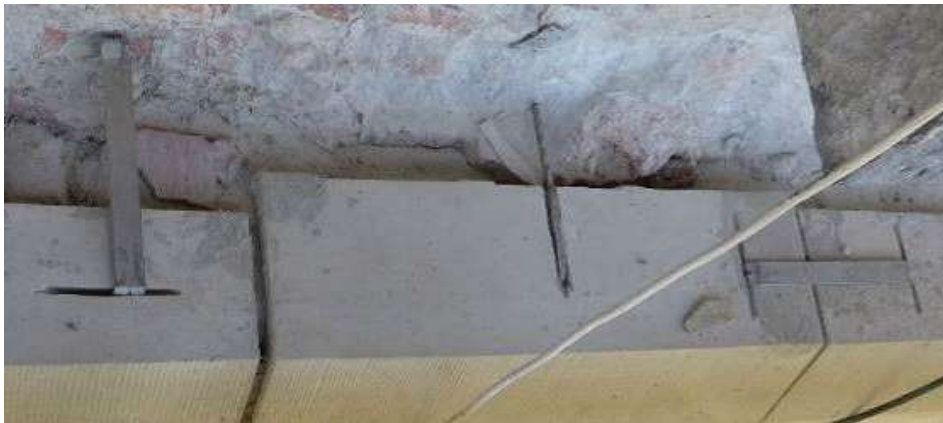
Fig. 21. Anchorage of new cornice elements in the failure zone

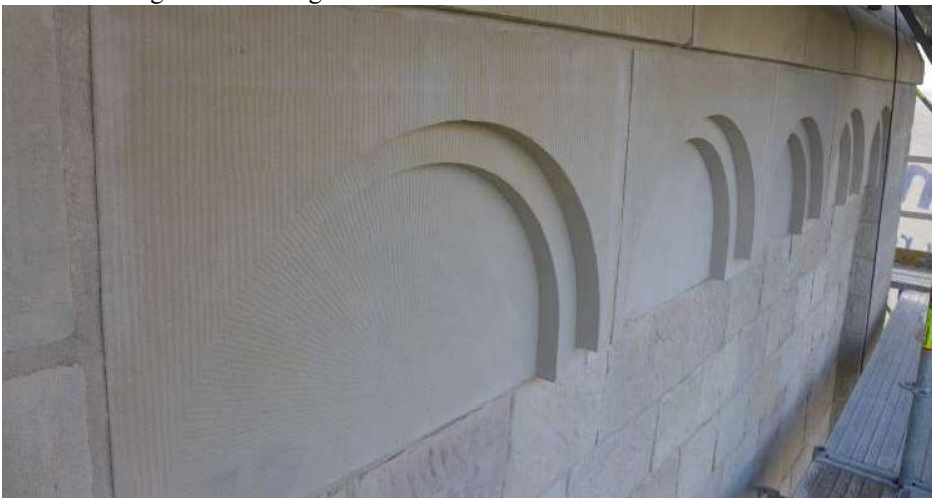
Fig. 22. Restored failure zone in the south tower
