## **DIAGNOSTICS AND REPAIRS OF DAMAGE OF THE LEANING TOWER IN ZABKOWICE SLASKIE**

Tomasz ABEL<sup>1</sup>

Wroclaw University of Science and Technology

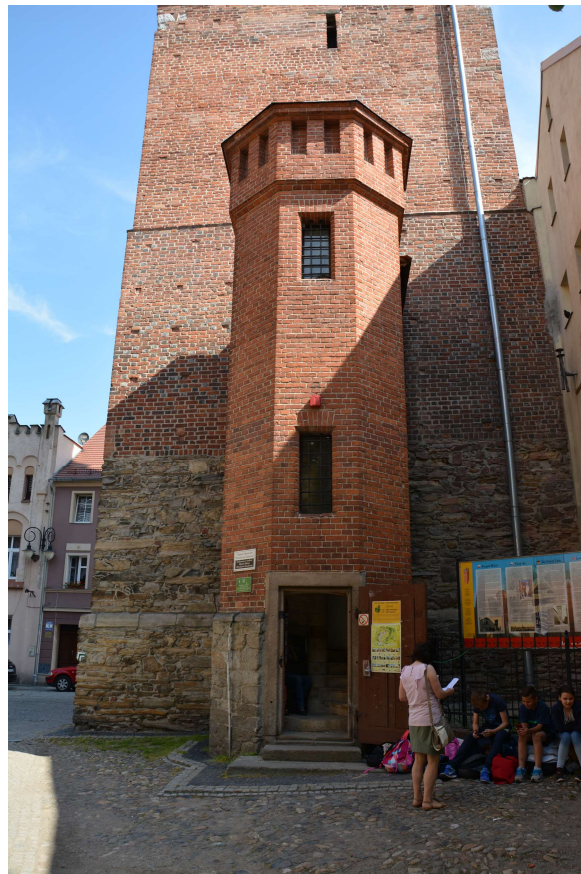
As a result of expert works, the occurrence of cracks and scratches was found at the connection of the tower with the outbuilding, which is a housing for the fan-shaped stairs leading to the first usable level of the Leaning Tower (see Fig. 2).

Fig. 2. View of a part of the tower and outbuilding

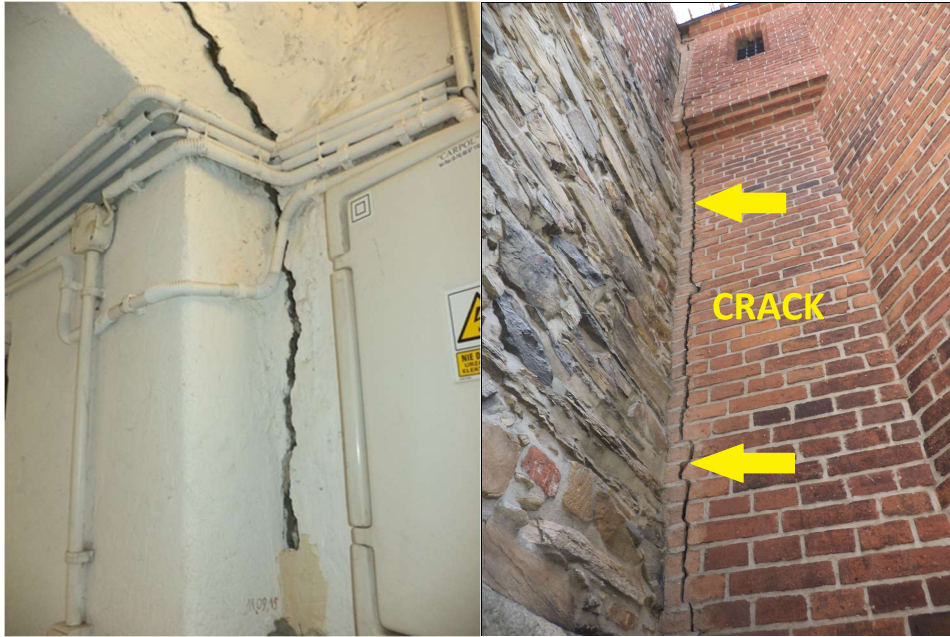
The cracks and scratches of the structural elements – at the connections of the walls of the outbuilding with the south-west wall of the tower - are continuous cracks that occur along the entire length of the elements and which propagate through the elements into their interior, as shown in the photo documentation below (Fig. 3).

Fig. 3. Crack at the connection of the tower and the outbuilding – the view from inside and outside

The probable change in the moisture content of the soils located just under the tower's outbuilding caused a change in their volume, which resulted in the phenomenon of subsidence and the formation of cracks at the interface between the two elements (Fig. 4).

The analysis of the occurring phenomena and the determination of the geotechnical conditions for the foundations of the object show the complexity of the causes of the damage. Damage to the tower's structure is a result of the following factors:

- unstable cohesive soils in the level of the foundations of the outbuilding,
- changes in the groundwater level,
- two different levels of foundations of individual parts of the facility.

## 6.3. Repairs of scratches and cracks

In order to locally reinforce and recreate the continuity of the construction elements, stitching reinforcement was installed from the inside. Ribbed bars with

a diameter of 6 – 10 mm were used. The bars were fixed in grooves that were cut in the joints perpendicular to the crack. After embedding the bars, the joints were filled with polymer cement concrete (PCC) mortar that had a compressive strength of no less than 25 MPa [10, 11].

The existing cracks were filled with a low-viscosity cement suspension. Injection using this type of material guarantees that the repaired crack will be durable and that good strength parameters will be ensured.

Strongly cracked wall fragments above the windows (fragments of lintels) in the passage between the staircase and the tower (see Fig. 3), which had cracks with a large width (over 10 mm), were rebricked. The purpose of the rebricking was to recreate the original connection between the bricks, while at the same time to ensure the joining of the parts of the wall separated by the cracks.

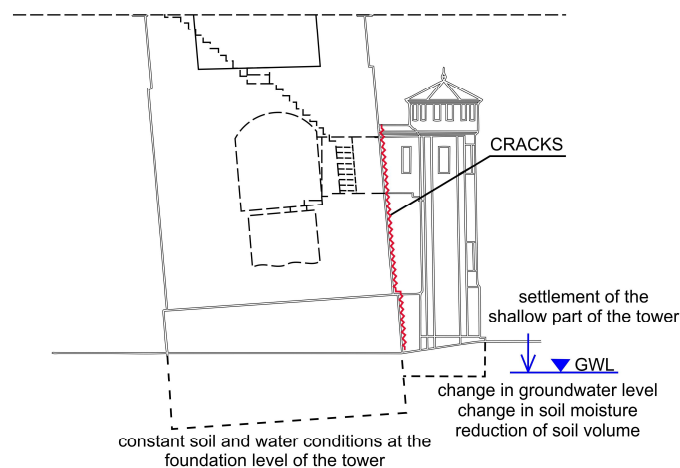
Fig. 4. Schematic diagram of the emerging phenomena

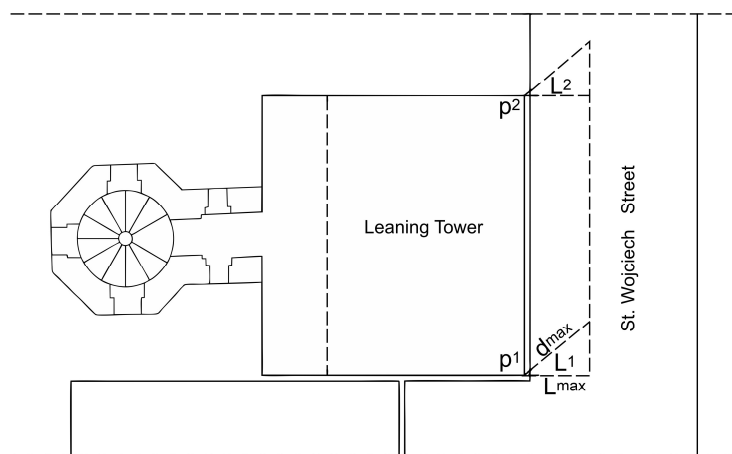
Fig. 5. A situational sketch showing the measured values

As can be seen from the conducted measurements and conclusions contained in the geodetic surveys, the maximum deflection of the tower did not change in the period from 2013 to 2015. The authors of the geodetic study recommended periodic tests of displacements and deformations, as well as the object's settlement. Such tests, thanks to the monitoring of changes in the location of control points, ensure the safety of using the facility and enable timely preventive measures to be implemented in order to prevent failures and construction disasters.

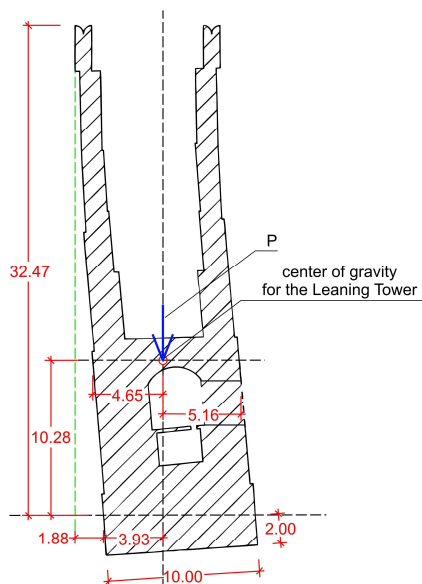
By projecting force  $P$  onto the foundation's base, it is possible to determine the arm of its action, which in this case is equal to approximately 1.30 m. The core of the tower's foundation -  $B = (10,0\text{m})^6$  - is equal to 1.66 m. Therefore, the force remains inside the core, which is shown in Figure 6.

Fig. 6. Location of the centre of gravity and the stabilizing force (P)

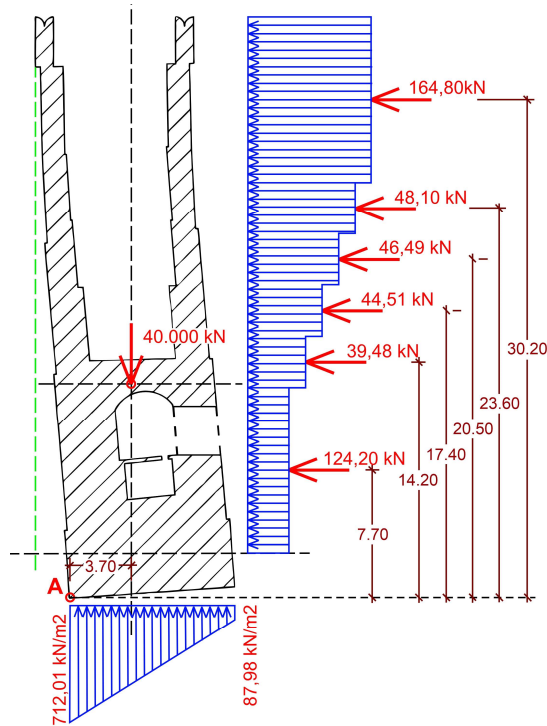
The general verification of the tower's stability with regards to rotation was performed in relation to the most unfavourable point in the structure (point A in Fig. 7) using formula:

Fig. 7. Summary of the forces acting on the object

- the centre of gravity of the object, and also force P, are located in the foundation's core, which positively affects the stability of the object,
- at the level of the foundations, the arm of the resultant holding force is relatively small (approximately 1.3 m), and therefore the phenomenon of the "overturning moment" does not arise,
- the analysis of the maximum horizontal force that results from the wind load, which is considered as the basic component of the "overturning loads", as well as the verification of the condition for rotation show that the moments that can cause overturning are approximately 12 times lower than the moments that maintain the stability of the tower,
- there is no risk of the tower losing stability.

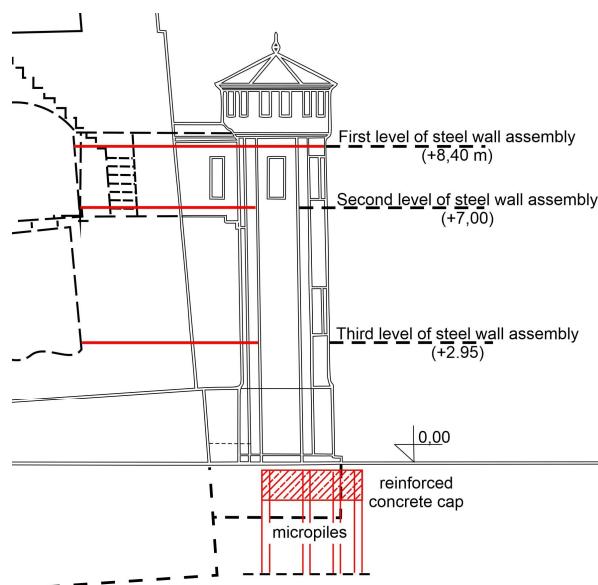
Fig. 8. Method of strengthening the object - steel ties and micropiles

In order to protect the structure of the outbuilding (staircase) against progressive horizontal displacements (a secondary phenomenon resulting from the settlement of the object), steel ties made of  $\phi 30$ mm bars were installed on three levels (see Fig. 8), namely:

- level I - main ties were installed "through" the structure of the building above the stairs outside the communication zone - at the level of about 8.40 m above ground level (above the windows of the corridor that connects the staircase with the tower),
- level II - additional ties were installed at the level of 7.00 m above ground level (under the corridor windows) - the ties ended on the wall of the

staircase;, the recesses were cut out in the wall for mounting the retaining sheets,

- level III - additional ties were installed at the bottom of the tower's "starvation" dungeon.

The micropiles were designed with the use of cement mortar injection, which causes the enlargement of the pile's diameter in the area of the load-bearing soils. They were made of perforated steel thick-walled pipes with an outer diameter of 180 mm and a wall thickness of 10 mm (reinforcement pipe). The pipes reached the offset level of the existing stone foundation (the offset level is approx. at 0.2 m below ground level). The axis of each pile was 35 cm from the edge of the walls of the outbuilding.

In order to obtain a complete joining of the existing foundation with its concrete envelope, which transfers the load to the micropiles, anchors made of steel bars chemically attached to the existing foundation and connected with the reinforcement of the concrete envelope were made.
