TECHNICAL ASPECTS OF RENOVATION OF THE 16TH-CENTURY ROOF TRUSS

Beata NOWOGOŃSKA¹

University of Zielona Góra, Zielona Góra, Poland

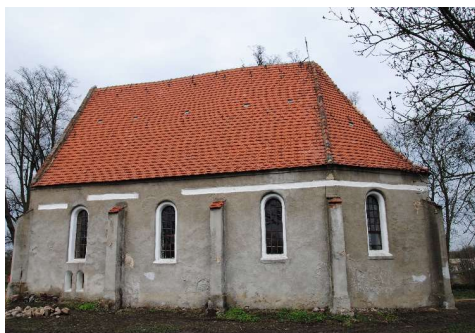
Photo 1. South view. Visible deflection of the ridge, roof slope deformation

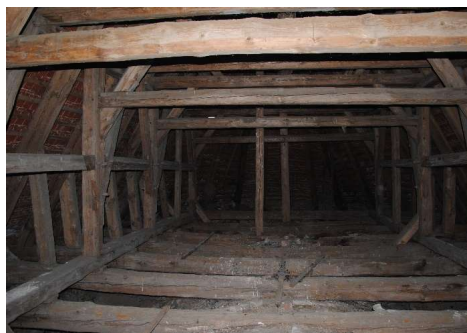
Photo 2. Truss structure with two supporting walls reinforced with dead bolts.

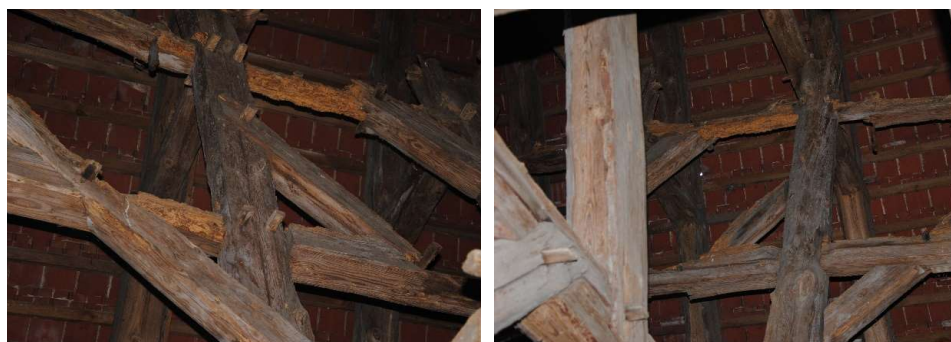
An assessment of the technical condition of the church roof truss was carried out. As a result of the research, it was found that the degree of wear of many elements is within 70% - 80%, and the supporting-dead bolt wall supporting the upper tab is worn 100%. It was found that some of the carpentry joints were split and displaced, numerous traces of secondary reinforcements and repairs are visible.

Photo 3, 4. Corroded supporting-dead bolt wall elements

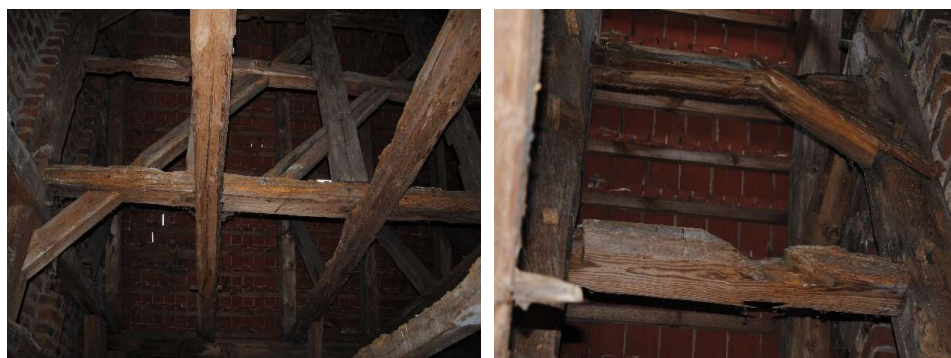
Photo 5. Bent collar beams and dead bolts

Photo 6. Split connections of support and transom wall elements

Measurements of deviations and displacements of the church roof truss structure were made. Deviations from the vertical columns of SL1 - SL7, SP1-SP7, S1, S2A, S3 were measured. Deviations from the vertical of the columns are in the range of 2.0 - 20cm. In addition, the rafter deflections are 20 cm in places, the deflections of the collar beams and dead bolts reach 25 cm.

Strengthening of damaged upper and lower purlins, collar beams, and dead bolts has been designed by using double-sided C30 wood seasonings with cross-sections supplementing the amount of hewn wood 6cm x 19cm (or 20cm). The beams will be joined together using M16 threaded rods, class 5.8. Between the purlin (beam, transom) on the non-corrosive section and the reinforcements, in the place of the bolted connection, double-sided stud plates should be used [5]. Corroded truss nodes in the support zone should be replaced. Before starting the work, it will be necessary to apply the concentration transferring the load from the reinforced truss to the outer wall of the church. The bracing will be in the form of struts located in the plane of the roof slope.

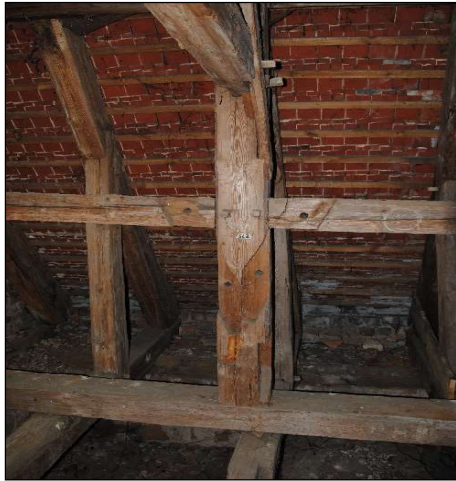
Photo 7. Places after removed struts.

Fill in the missing swords with 17 x 20cm wooden elements, and the missing S2B pole in the truss W6.1. A combination of elements for the overlay with narrowing was designed, adapting it to the existing cut-outs in the support and purlins [5]. Seasoned C30 grade wood, protected against biological corrosion and fire, by means of vacuum-pressure deep impregnation or hot-cold baths will be used for all newly introduced wooden elements.

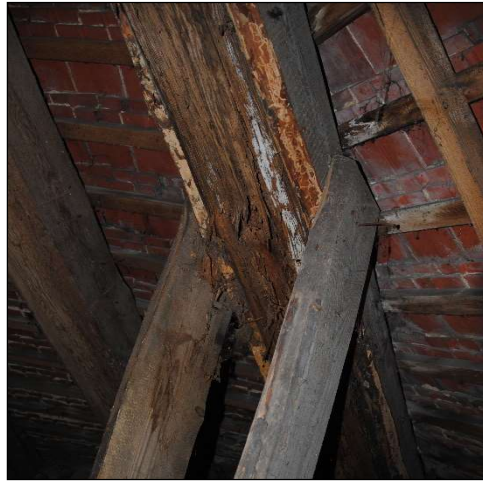
Photo 8. Corroded rafter secondary reinforced with counter battens

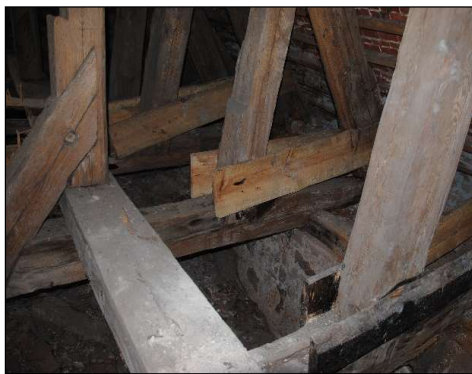
In the W2 and W3 trusses there are no braces, in the W4 and W5 trusses there are no single braces. In the W2a, W3, W3a, W4, W4a (L) trusses, the corroded ends of the truss beams are reinforced with wooden prints, the washers used between the lower purlin PD and the truss beam are used.

Photo 9. Corroded truss beam ends are reinforced with counter battens from boards

Then proceed to strengthen the corroded truss beams. Truss beams will be reinforced with additional beams located on the sides of the damaged element. The beams will be interconnected with M16 threaded rods, class 5.8, and between the girder beam on the non-corrosive section and the reinforcements in the place of the bolted connection, double-sided stud plates will be used [5].

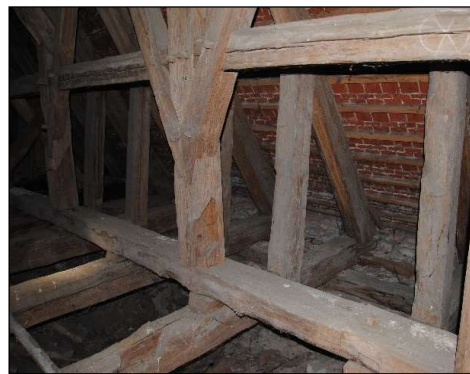
Photo 10. Wedges between the lower purlin and truss beams

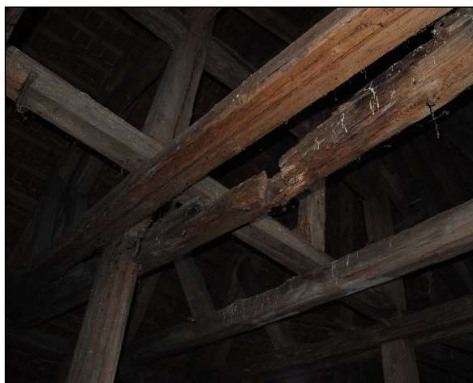
Photo 11. Place after the removed pole, biological corrosion of the collar beam

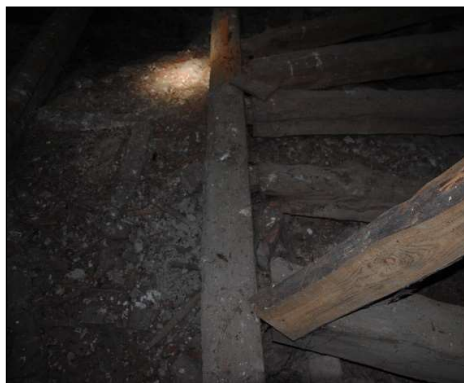
Photo 12. Split connections of truss beams above the presbytery
