BIODETERIORATION DUE TO IMPROPER EXPLOITATION OF EXTERNAL FACADES

Marlena PIONTEK¹, Hanna LECHÓW
University of Zielona Góra, Poland

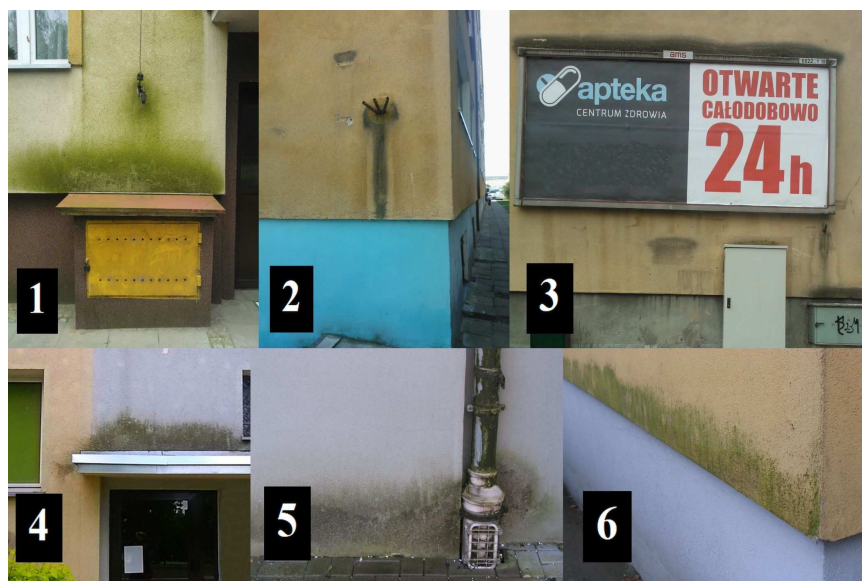
Fig. 1. View (1-6) on places in northern facades with visible discoloration and deposits

The phenomenon is caused by moisture which persists with higher intensity than in other parts of the facade and is the main factor contributing to the formation of biological corrosion [3, 4, 6, 8-11]. Over time, it can lead to the formation of biodeterioration (biological corrosion). With the increase of water content within the material, its coefficient of thermal conductivity grows as well, thus

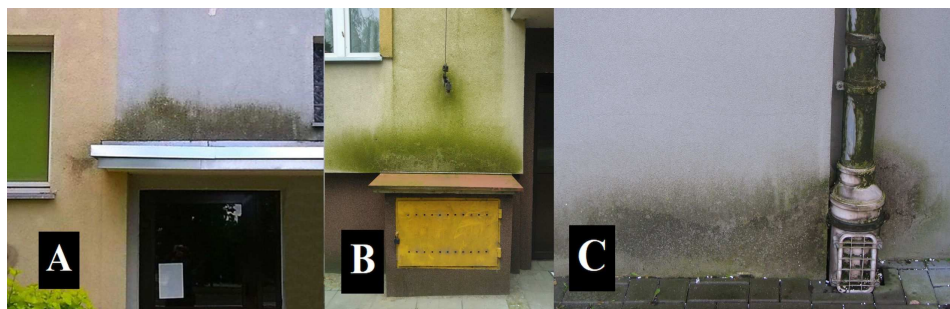
Samples for microbiological analysis were collected from 3 selected locations in the northern facades of buildings in Zielona Góra (Figure 2) on which barriers were placed and visible discoloration and deposits have formed. All objects underwent thermomodernization. Warming was made according to ETICS (from the English name: External Thermal Insulation Composite System) - or in other words: seamless insulation system. The section of a two-layer wall of buildings, that is, the connection of the wall with the thermal insulation material includes about 9 components: 1. hollow bricks, 2. optional substrate priming, 3. adhesive for fixing panels, 4. thermal insulation made of Styrofoam, 5. additional fixing - connectors for Styrofoam, 6. adhesive for the reinforced layer, 7. reinforcing mesh, 8. plaster base, 9. thin-coat plaster. Nearby the selected elevations one can find greenery, shrubs, and trees, which increase the emission of biological agents on the surface.

Fig. 2. View of the sampling areas on the northern facades of buildings in Zielona Góra: A- multifamily building developed at Podgórna Street, B - multifamily building developed at Batorego Street, C- facade of the buildings of the Environment Engineering Institute of the University of Zielona Góra.

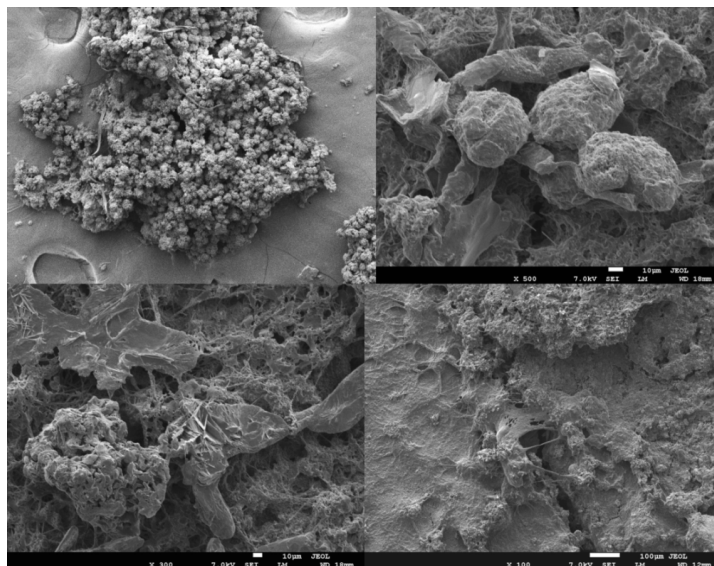
SEM photos showed (Fig. 3) the presence of biological agents in deposits found on the facades. Their presence results in the emergence of unsightly deposits and formation of degradation processes. Photos made with the use of the nanometer technology revealed the complex structure of the deposits.

Fig.3. Exemplary SEM photos of the biological material collected from northern elevations of buildings with deposits
