ANALYSIS OF CHANGES TO STEEL FOOTBRIDGE GEOMETRY WITHIN 25 YEARS IN SERVICE

Jacek SZTUBECKI¹, Adam BUJARKIEWICZ¹, Justyna SOBCZAK-PIĄSTKA¹, Tomasz JANIĄK¹, Jarosław GAJEWSKI¹
University of Technology and Life Sciences in Bydgoszcz, Bydgoszcz, Poland

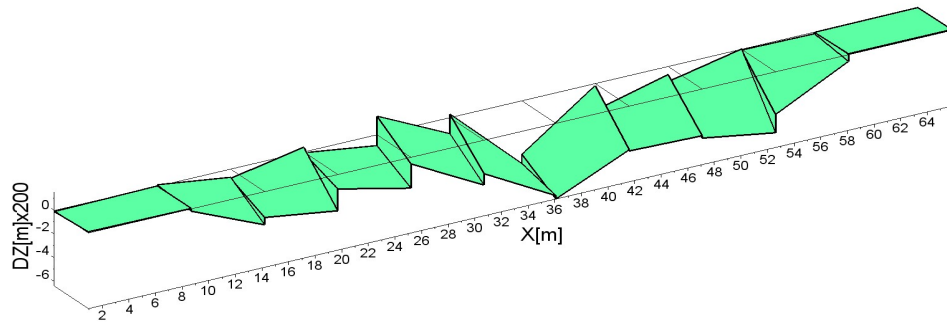
Fig. 2. Graphical representation of differences between the measured ordinates and the theoretical ordinates for measurement 2

Values of ordinate differences for measurement 2 showed that there are divergences relative to the geometry assumed to be theoretical. Therefore, bridge geometry was corrected after this measurement, and a third, control measurement was performed after the correction. Analysis of ordinate differences for measurement 3 shows significant improvement in bridge geometry after its correction. It is notable that the correction of geometry in points with significant divergence from the theoretical geometry negatively affected neighbouring points. However, values of these differences are visibly lower from those from before the correction.

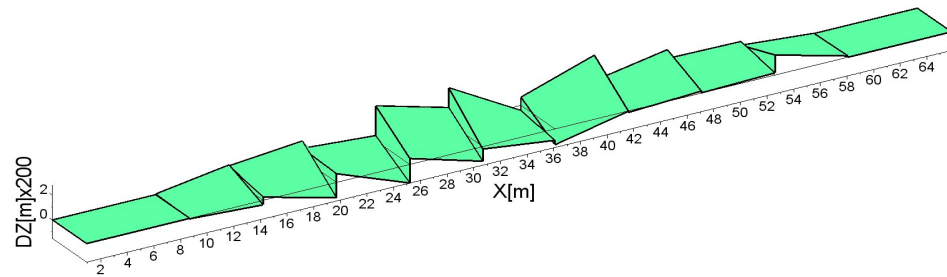
Fig. 3. Graphical representation of differences between the measured ordinates and the theoretical ordinates for measurement 3

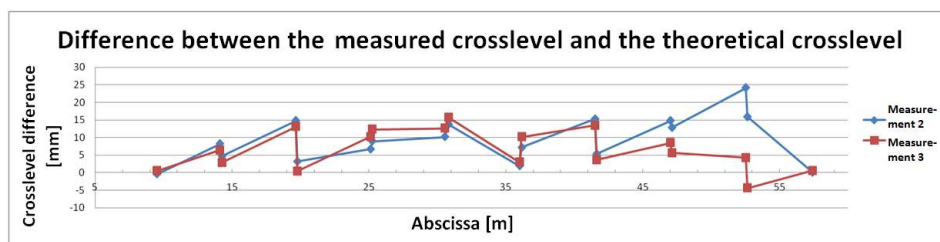
Fig. 6. Difference between the measured crosslevel and the theoretical crosslevel for measurements 2 and 3

Comparison of crosslevels resulting from measurement 2 (before the adjustment) and measurement 3 (after the adjustment) indicates that their change is significant only in the last three segments of the footbridge, at the abutment from the Jagiellońska street side (shown in Figure 6). Changes in crosslevel values along the remaining part of the main span were minor, with similar inclination tendencies being retained.

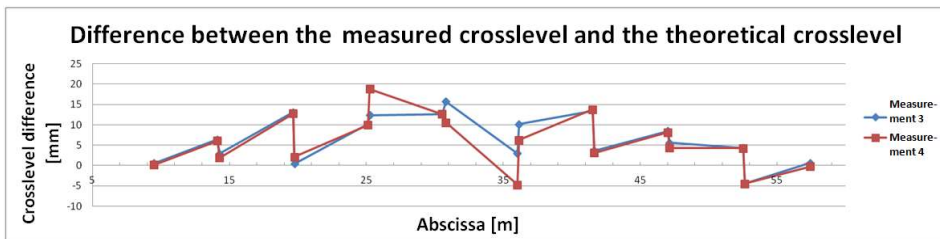
Fig. 7. Difference between the measured crosslevel and the theoretical crosslevel for measurements 3 and 4

On the other hand, the charts for crosslevels shown in Figure 7 show that, in the course of the last 23 years (from the adjustment of 1994 to the next measurements in 2017), significant crosslevel changes occurred only in the three middle segments of the footbridge, whereas other segments actually retained their transverse inclination. Of particular significance is the change in crosslevel on the border of segment 3 and 4 (abscissa of ca. 25 m). This might be evidence of loosened connection between these segments or even of its being damaged.

- ◆ Over the last 23 years in service, a significant change in crosslevels in the area of the middle three segments of the footbridge happened, *inter alia*. It can be assumed that, following the adjustment performed in 1994, cable stays on the right side of the footbridge were weighed down and the ones on the left side – relieved. Consequently, forces leading to inclination of the deck towards the left side began to act upon the deck structure. The twisting of segment 4 (within the range of abscissae of ca. 25 m to ca. 30 m) and huge change of the crosslevel on the boundary between segment 3 and 4 concluded from Figure 7 may be evidence of weakened segment 4 structure and weakening or even damaging of the connection between segments 3 and 4.

- ◆ Second adjustment of the pull of footbridge cable stays is recommended. While doing this, an approach to the design of this adjustment other than the one used in the years 1992-94 has to be implemented. The predicted effect of the adjustment should be achievement of correct geometry of the footbridge gradeline (as opposed to both of its edges) and equalisation of forces in cable stays. Such an adjustment will restore static operation of the footbridge as initially assumed in the design.
- ◆ A technical inspection of the footbridge should be conducted, and special regard should be paid to the structure of segment 4 and the connection between segment 3 and 4.
