## **RECONSTRUCTION OF WAR DAMAGED BUILDINGS - A PROBLEM THAT STILL STANDS. THE CASE OF THE NATIONAL ECONOMY BANK IN WARSAW RESTORED DURING THE SECOND WORLD WAR**

Sławomir ŁOTYSZ<sup>1</sup>

Polish Academy of Sciences, Warszawa, Poland

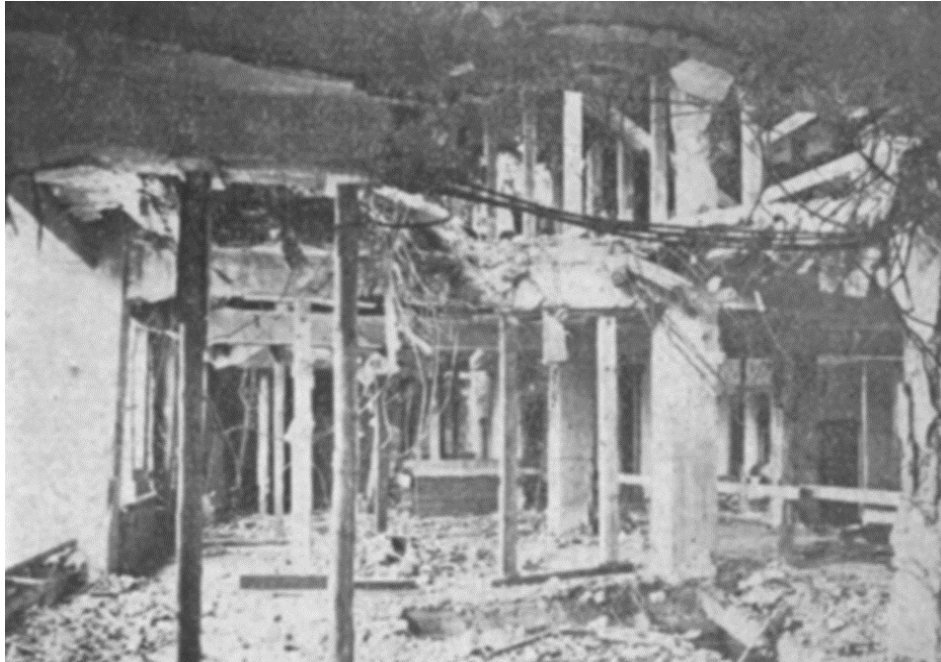
During the inspections of the premises, a reinforced concrete structure constituting 55% of the roof area was found to have been completely destroyed by artillery fire and aerial bombardment. Damage to beams, columns and slabs in

about 10% of the area were so great, that their repair turned out to be uneconomical. In the remaining part, in spite of the scratches and cracks, the structural elements were suitable for repair.

Fig. 4. Damage caused by the German bombing in September 1939. An entire span and part of the floor is missing [4]

It was also observed that the bomb damage had a specific character. The bombs first pierced the roofing slabs, travelling down through the floors and then exploding. At the points of detonation and in their immediate vicinity, the structure was completely collapsed, while elements located radially around the epicentre of the blast were damaged to a lesser extent. As a result of the blast, within the horizontal plane between the floor and ceiling of the level on which the explosions occurred, supporting columns were displaced, resulting in horizontal cracking at their bases and in their heads. The exploding bombs also caused vertical forces between the floors. These lifted the ceiling slabs, bending the main floor beams upwards and cracking them along their bottoms, which had been reinforced for normal operation under compression conditions. Flooring slabs that were lifted with the blast waves were detached from the beams and after the self-collapse of the main floor structure, the beams often remained raised up, their surfaces bulging out. Just how powerful the destructive forces affecting the

construction were, could be seen in the reinforced concrete bars exposed in the beams bent by the blast waves.

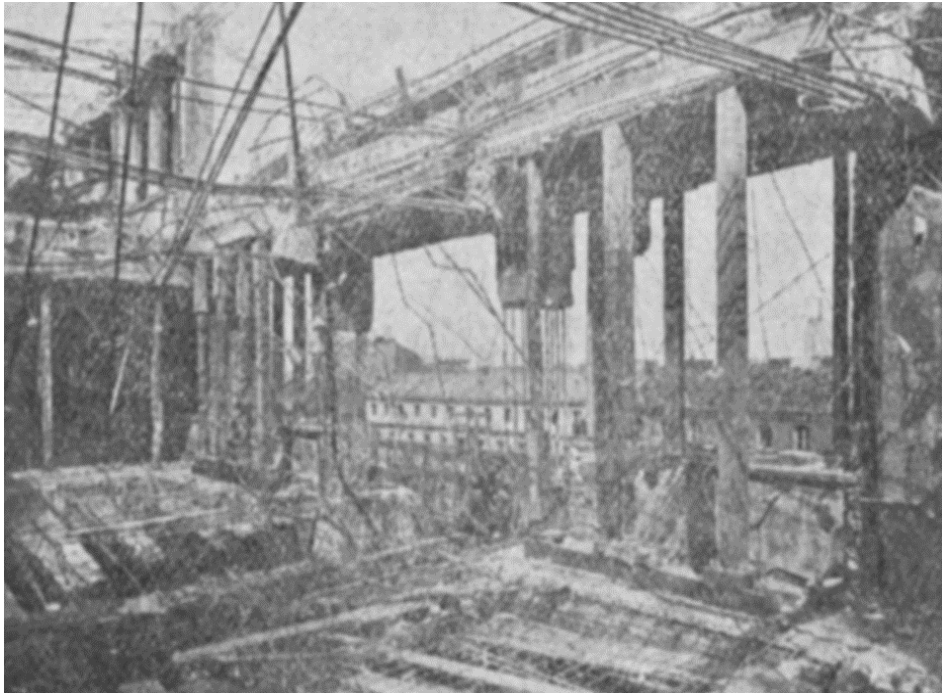
Fig. 5. Damage caused by the German bombing in September 1939. The damaged pillars being removed from the fifth floor [4]

Usually, the bombs would explode on the top two floors, and the stresses carried by the frame structure nodes to the lower floors were not that significant. As a result, the number of elements that needed to be exchanged or repaired decreased on subsequent floors, and the ground floor did not require any work.

Damaged reinforced concrete elements were removed by hand, using chisels and hammers. Broken rods, anchored at both ends in the old concrete, and those that were excessively elongated were first cut out, then extended by adding new inserts. Each insert overlapped the remaining rod by a length of approx. 40 diameters of replaced rod. Where two or more steel rods had to be repaired in beams and columns, the engineers tried to avoid doing this in one place, instead cutting out the damaged elements at different lengths. When merging old and new rods, which always means weakening an element's durability, the engineers always tried to choose a spot as close to the point where the lowest bending force was calculated as possible.

Some rods were not cut out of the damaged parts, and after hammering-off the existing concrete they were only straightened in place, boarded and concreted anew. In general, only 10% of the reinforcement needed to be made of new steel. In their reports, the engineers leading the works emphasised that the increase in labour costs associated with the preparation of old rods for re-use was significantly lower than the cost of buying the right amount of reinforced steel new.

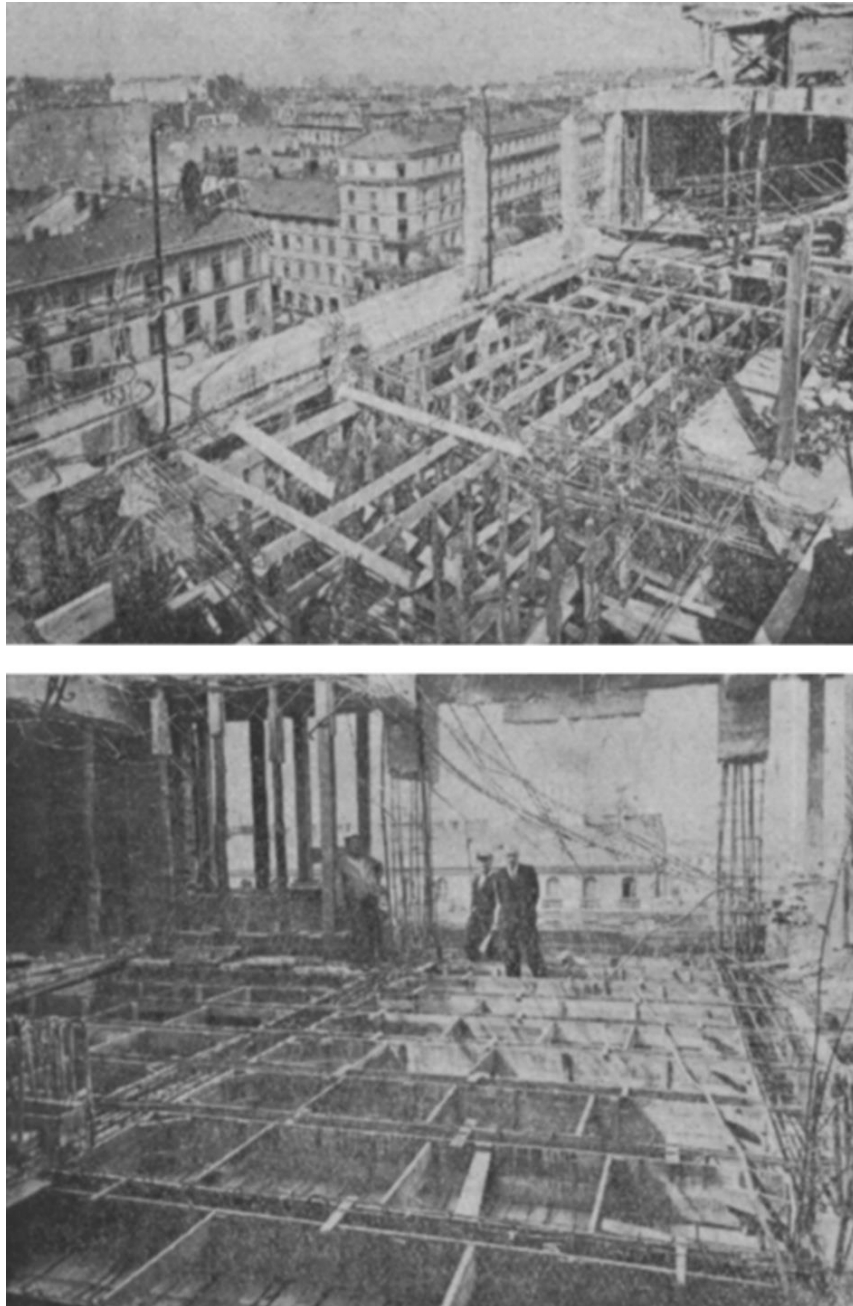
Fig. 6. Top: the roofing, which suffered the most during the bombing, has been entirely replaced. Bottom: the restoration of a less damaged slab on a lower floor [4]

*parts were limited to pumping cement grouting under pressure into the cracks, followed by finishing with cement mortar ” [4].*

This method was used in the repair of main floor beams throughout the building and of the least damaged parts of the roof on the Nowy Świat street side. Cement grout was pumped under pressure with few or several atmospheres of pressure by means of a specially-constructed apparatus using compressed air from a cylinder. Cracks to be filled were sealed on the outside with plaster, and then a hole was drilled into them, in which the pipe feeding the grout was inserted. In the case of the largest cracks, the mixture pumped in over several tens of centimetres.
