## EXECUTIVE DISADVANTAGES IN THE LAYERED WALL OF THE FACADE

Elżbieta GROCHOWSKA<sup>1</sup>, Antoni MATYSIAK<sup>2</sup>  
University of Zielona Gora, Zielona Góra, Poland

### Abstract

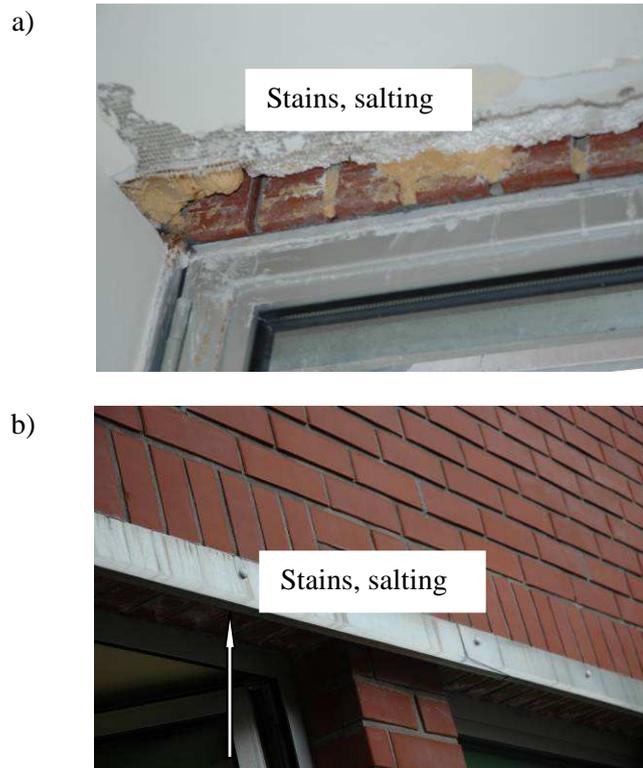
In accordance with the will of the architect (and with a design) windows were made in the construction of metal and mounted (in some walls) in the plane of the face of the external walls. Stains, resulting in the building on one of the windows, were shown in Figure 1 a.

Fig. 1. Setting of window in the three-layer wall; a) view the installed windows from the inside b) the method of attaching aluminium canopies above the windows

Between the window frame and bricks of the protective wall there is no gap comfortable for the setting of windows and then performing the required sealing. This solution is shown in Fig. 1a. It follows that the window frame was a lintel for wall part made above the window. Between flat (smooth) metal and rough, porous brick is no tightness, water penetrates easily. Such a phenomenon

has occurred in many places in the building. In addition, the wall of the facade one did not filled tightly, with a suitable mortar, the space between the clinker bricks, which is also the cause of the leakage.

Proper execution of the designed three-layer wall with windows, arranged in the face of the exterior wall, requires special attention. The user of the object decided on their own to protect the building against leaks and, above the windows, made canopies, of sheet metal, shown in Fig. 1 b. Canopies did not provide adequate protection against the penetration of water, leaks still occurred.

The cause of leakage of water into the interior of the building was leakiness of the protective wall, especially in places of contact between windows and wall. The reasons for leakage of the protective wall are associated with difficulty to correctly perform the wall in accordance with the architectural design. The construction project lacked the details and technology of performing such a

In this situation, this kind of solution (sealing with expansion tape) is no longer possible. The solution to this problem involves financial outlay. The sealing can now be done only on the inside of the building so as not to destroy the existing clinker facade and the vision of the architect, regarding the appearance of the building. This can be done as follows: around window frames one should create drills of respective depth (less than the thickness of the brick) and seal with proper preparations which are resistant to humidity, aging, and are flexible.

In order for building elements not to undergo further destruction, due to penetration of rainwater into the building, it should be, on the inside of the building around window frames, performed the appropriate sealing.

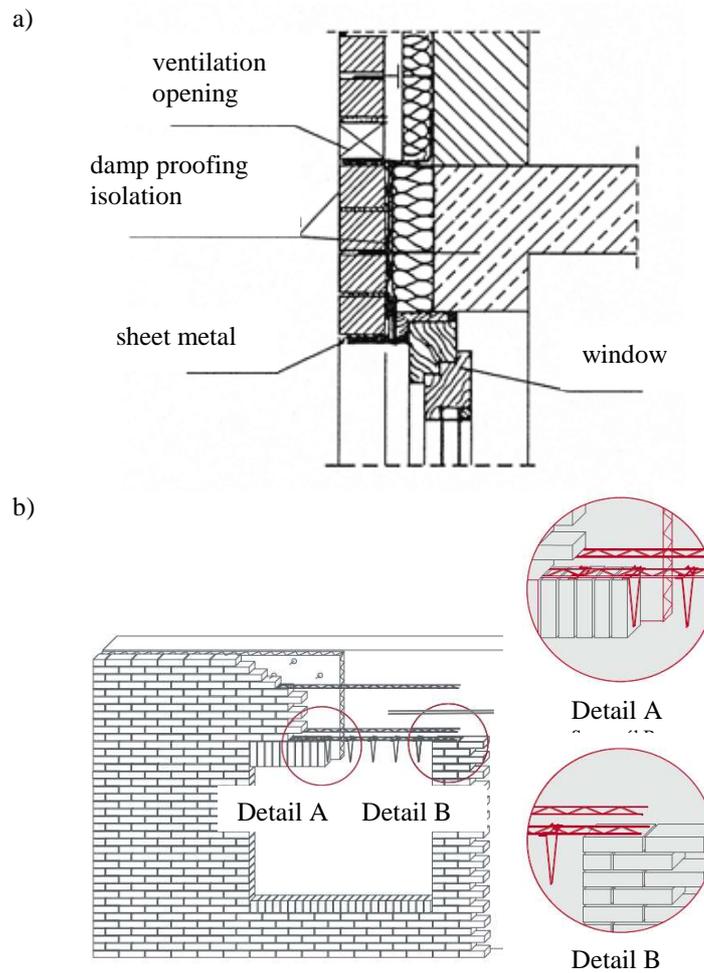
Fig. 2. a) Example of the gap sealing between the aluminium window and doorjamb in three-layer wall by [2]; b) the sample brick lintel in the three-layer wall by [3]

Correct performance of the lintel, embedding windows and sealing gaps (which should be left) between the window and the doorjamb without nib is shown in Fig. 2.
