RENOVATION AND RECONSTRUCTION OF A NEOCLASSICAL BUILDING ON THE EXAMPLE OF A PUBLIC CITY LIBRARY IN NOWA SÓL

Abstract

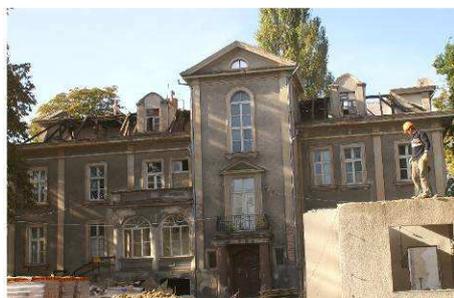
While carrying out the inspection of the roof trusses, lengthwise splitting of approximately 40% of the rafters and posts was confirmed, with 20% in the case of roof purlins and collar ties. Another conclusion was that the cross-sections of purlins spaced 3.5-4.5 m apart are insufficient despite the presence of angle braces. The remaining construction elements, such as the foundation, load-bearing and partition walls, and stairs did not require additional strengthening or replacement.

Fig. 2. Building during the taking apart of roof trusses. Source: MBP archives.

- replacing a portion of the ceilings over the basement, ground floor and upstairs,
- the replacement of roof trusses modeled on the existing structure,
- creating two dormer windows in the roof, on the side facing Bankowa Street,
- constructing an elevator and stair platform lift for the disabled inside the building, and a ramp on the outside near the entrance,
- reconstruction of the outside entrance to the basement and removal of outside stairs,
- destroying some of the of inside door openings and creating new ones, along with installing new door elements,
- constructing additional ventilation chimneys,
- lowering the basements floors to a level of -2.80 along with insulating the floor,
- finishing the inside walls, ceilings and floors,
- renovating the wooden elements of the stairwell,
- patching outside plasters, carrying out insulation with bitumen, and paintwork on the facade.

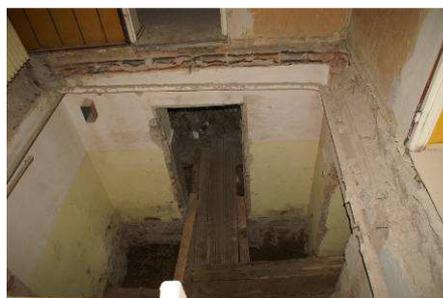
Fig. 3. Removing a part of the old ceiling. Source: MBP archives.

The existing floors were changed to ones of reinforced concrete, 12 cm in thickness, using C12/15 (B15) concrete reinforced with bars Ø8 of A-I steel, spaced 15 cm apart, welded to the middle of the beams, supported by IPE 200 and 180 steel beams for floors characterized by smaller spans.

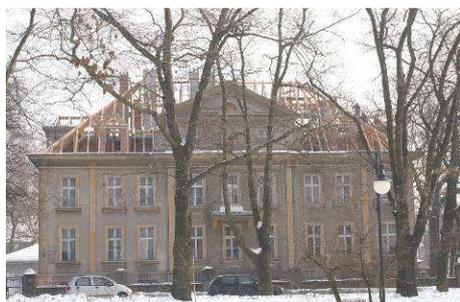
Fig. 4. Replacing the roof truss system
Source: MBP Archives.

A new roof truss construction was made based on the original, additionally creating two dormer windows on the side of Bankowa Street. Class K-27 wood was used. The cross-sections of the truss elements have been provided in Table 3.

No.	Type of element	Cross Section [cm]
1	Ridge beam	12x18
2	Valley rafter	12x18
3	Rafter	10x16
4	Post	12x12
5	Posts	10x10
6	Purlin	12x18
7	Collar ties	8x16
8	Angle braces	8x12
9	Tie beams	12x12

The roof is covered with two layers of plain type pantile, laid in the "lacing" pattern.

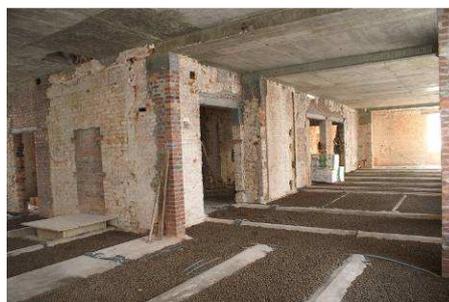
Fig. 5. Construction works on floors.
Source: MBP Archives.

Beams were made of I 200 steel sections, set on concrete pads made of C12/15 concrete measuring 40 x 25 cm, additionally stiffened using webs due to twisting.

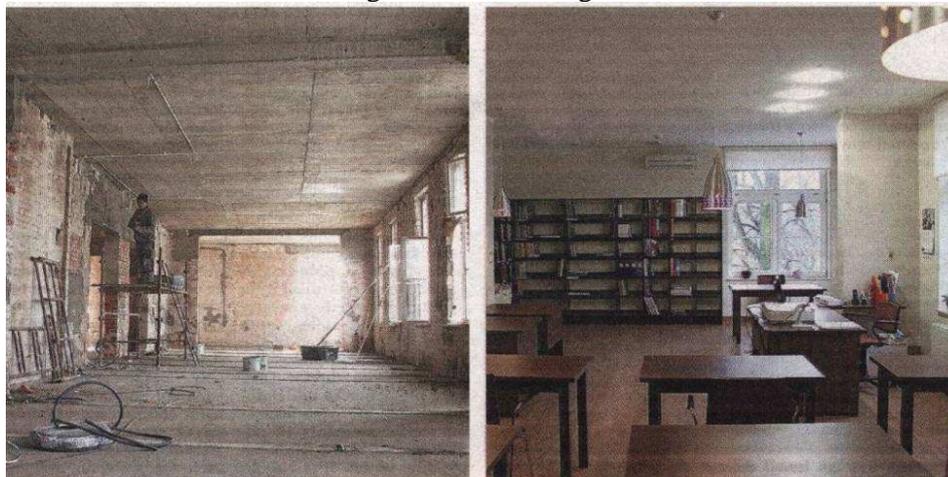
Fig. 6. Reading room at the beginning of construction works (on left) and upon completion (on right). Source: Gazeta Lubuska (Lubuska Newspaper) No. 28, 2011

In addition to renovation works, many demolition works also took place, as the taking apart of interior partitions in order to obtain a bigger surface area, or the outside staircase, which had been added on in the 80's. Some of the inside door openings were walled up and new ones created in order to adapt the building to its new function. All of the wooden doors and windows were replaced. Some windows, as for example the windows in the stairwell, were renovated [4]. A series of moisture and water protection as well as thermal and acoustic insulations were carried out in the walls and floors of the basement. Due to the historical nature of the building, it did not undergo thermorenovation.
