## RENOVATION OF SHAFT MINING BUILDING NO. 2 IN KŁODAWA SALT MINE

### Abstract

## 2. DESCRIPTION OF SHAFT TOP BUILDING NO. 2

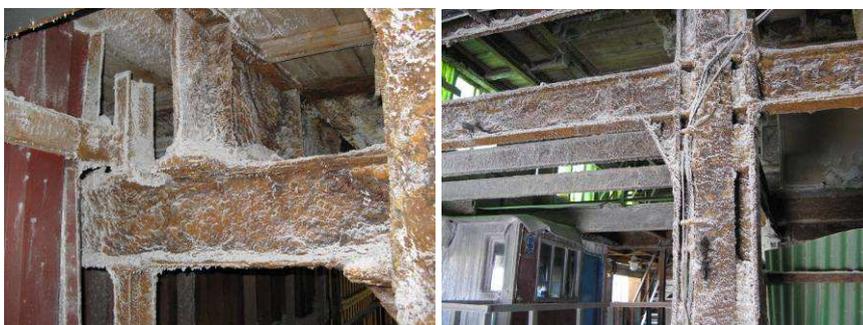
An assessment of the technical state of the building was made along with necessary photographic documentation. The level of damage caused by the corrosion of the steel construction was measured, with particular attention paid to the main load-bearing construction of the floors and columns in areas of increased loads. The state of the construction has been shown in Fig. 3.

Fig. 3. View of the technical state of load-carrying beams and main beams of the frame

A percentage scale indicating the degree in which the thickness of the walls of profiles are reduced in relation to their initial thickness was used to assess the degree of corrosion. This facilitated the introduction of the actual characteristics of the cross-section into a computer program at a later stage of the analysis. Measurements of the depth of corrosion in the cross-sections of columns, secondary beams, primary beams, girders and joists were taken. It was established that the depth of corrosion varies in the different steel profiles. Some of the steel construction is in good shape (elements repaired in 2002), whereas some at immediate risk of failure and requiring replacement. On the basis of the above inspection as well as statistical calculations indicating the

Ceiling and load-carrying beams in the area of the sieves at the level of +8.00 m, between axes 1 and 3 were severely damaged by corrosion and practically impossible to repair. Moreover, they were covered by a thick layer of salt. Immediate replacement of these beams was recommended, as they posed an actual threat to damaging the operating machinery.

The main beams at the various floor levels as well as their connections with columns were strengthened by enclosure in a box using 15 mm (upper and lower strips) and 10 mm (both sides of the web) sheet metal. For this purpose, the wood construction of the ceiling was successively taken apart and upon reinforcing the construction areas, renovation work carried out. In areas where it was not possible to apply the designed methods of reinforcement, additional profiles were welded beneath the existing ones. The connections of columns with beams were strengthened using 15 mm sheet metal and, what is very important, the continuity of strength being carried over from the beams to columns ensured.

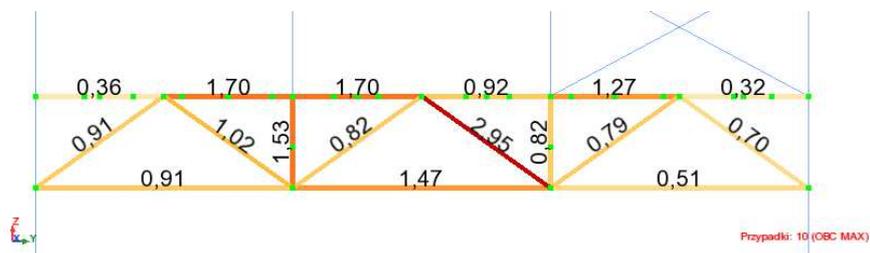
In order to demonstrate the durability analysis procedure and accepting necessary reinforcement on its basis, sample calculations of the load-bearing lattice in axis 3 below the level of +5.30 m have been presented in this chapter. This is a very important element of the construction, as it carries the loads of many higher floors. The calculations were carried out in the Autodesk Robot Structural Analysis program. The spatial model has been presented in Fig. 2. Figure 4 presents the level at which the lattice bars are used, accounting for 30% weakening due to corrosion (state determined on the basis of studies). A coefficient of 1 indicates 100% use. As indicated, the stress-strain state of most profiles in the central zone of the girder significantly exceeds the permissible limits. It should be recognized that a beam with a use of 2.95 was improperly selected at the initial design stage of the construction or that the technological load increased over the time the building was in service. Fig. 5 shows the stress-strain state of the elements of the lattice accounting for strengthening. Examples of how the profiles can be strengthened have been presented in pt. 5.

Fig. 4. Stress-strain state of lattice in axis 3 with profiles weakened by corrosion

The lattice under the level of +5.30 m in axis 3, due to the high stress-strain state of the bars and progression of corrosion, was strengthened by fitting cross braces and additional angle sections adding a minimum of 50% to the cross-section of strengthened bars. The connection of the lattice beam to the existing studs was additionally strengthened by constructing a table under the lower strip. Attention was given to maintaining the continuity of the added angle brackets in the upper and lower strips of the lattice girder. The angle brackets were connected outside the joints on full butt welds.

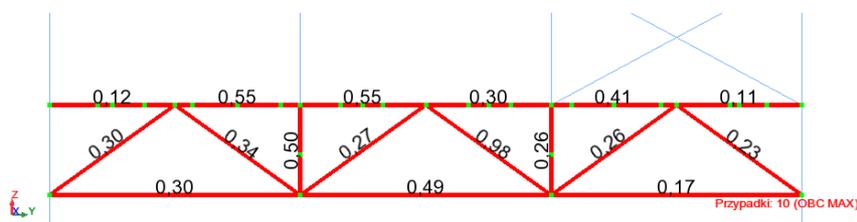
Fig. 5. Stress-strain state of lattice in axis "3" following strengthening

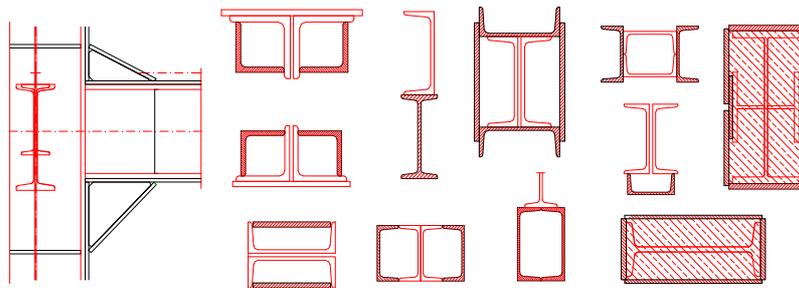
Fig. 6. Examples of ways in which the various load-bearing elements can be repaired

Strengthening the outside columns of the high part between axes 1 and 5 involved enclosure in a box using 15 mm sheet metal. The sheet metal was welded to the existing ledges of profiles which created enclosed areas which are precisely filled with cement mortar of the 15 brand and tightly sealed in order to cut off oxygen supply and prevent their further inner corrosion.

The load carrying beams of the silo at the level of +8.00 m and 13.80 m, between axes 2 and 4, which support the salt chute weighing approximately 20 tons (when full), required reinforcement by enclosure in a box using 15 mm (upper and lower strip) and 10 mm (both sides of the web) sheet metal. In areas where it was not possible to apply the designed method of reinforcement, it was recommended that additional profiles be welded beneath the existing ones.

Schematic means of reinforcing the profiles have been presented in Fig. 6.
