**IDENTIFICATION OF ALTERNATIONS IN THE STRUCTURE  
OF HISTORICAL MASONRY WALLS USING THE GPR METHOD  
ACCOMPANIED WITH ARCHITECTURAL SURVEY IN THE FORMER  
PIAST GYMNASIUM IN BRZEG**

Piotr FRĄCKIEWICZ<sup>1</sup>, Krzysztof RASZCZUK, Jerzy JASIEŃKO

Department of Building Structures, Wrocław University of Science and Technology, Wrocław, Poland

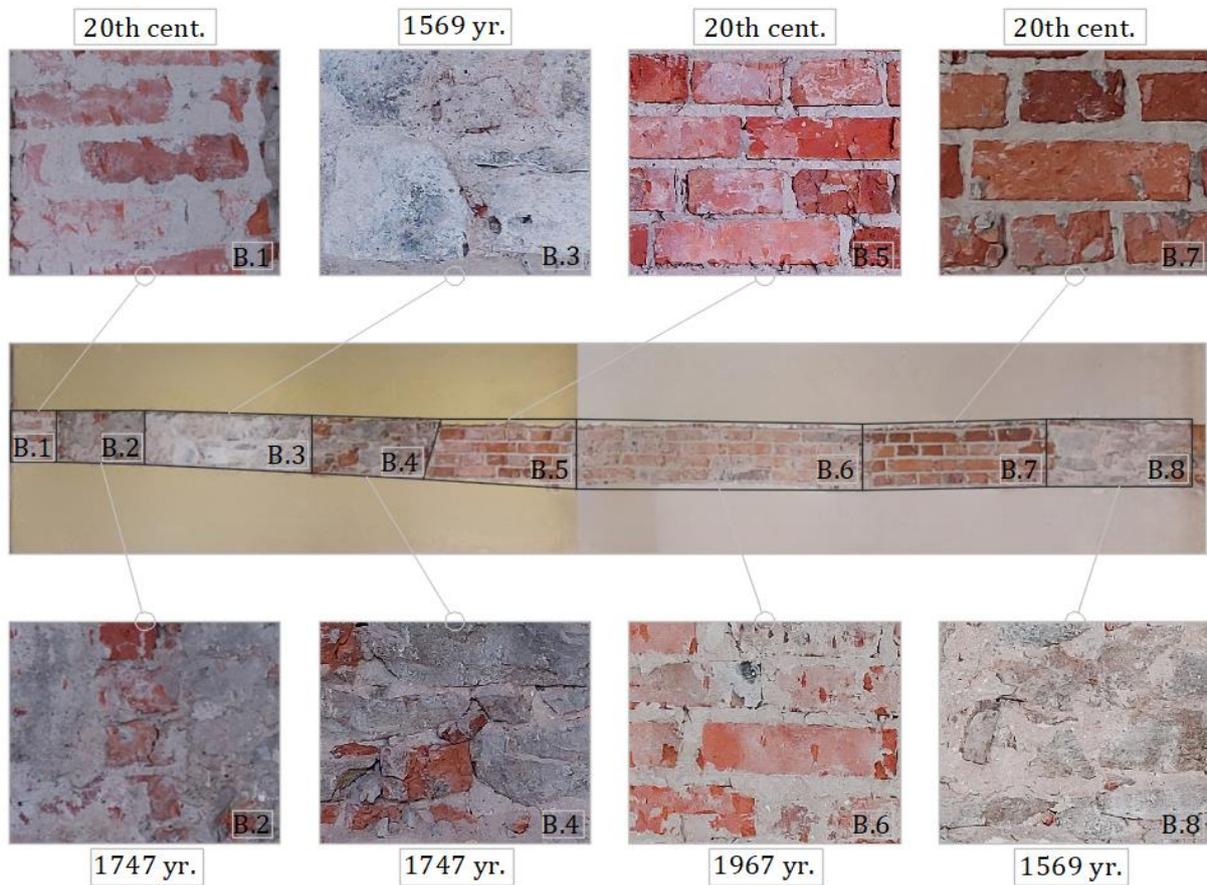
Fig. 1. A view of a segment of the bearing wall of the main hall of the ground floor. Age dating based on architectural analysis. Division into sections subjected to GPR survey in the next stage

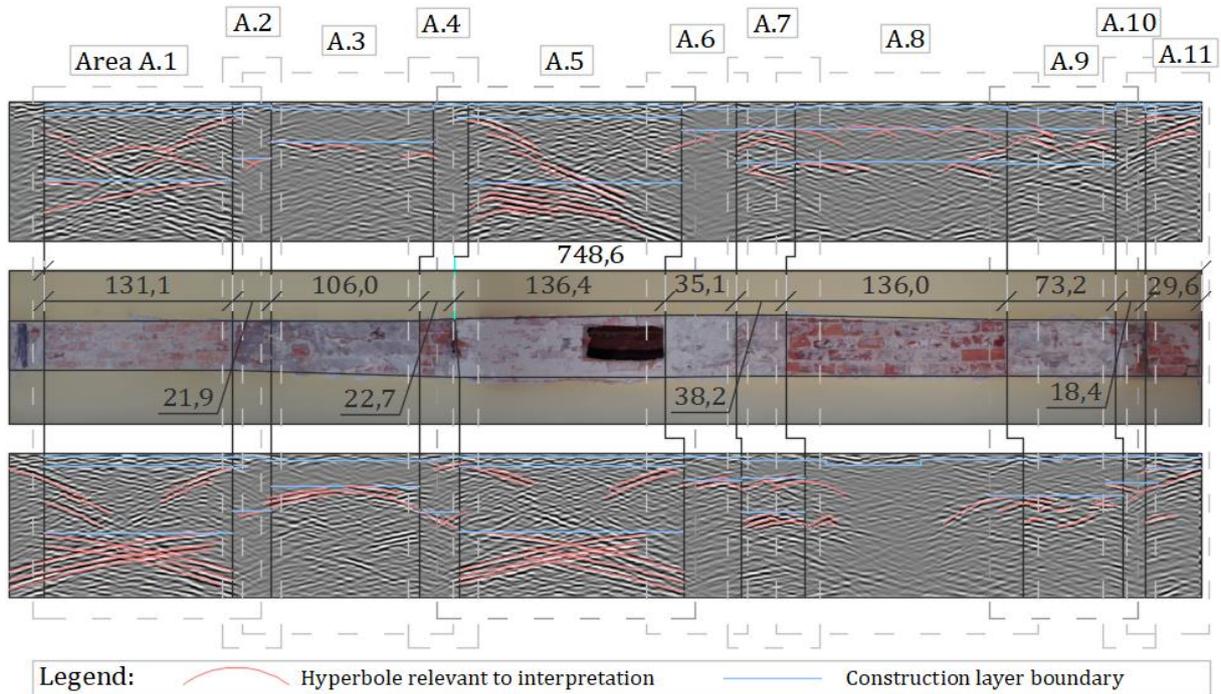
Fig. 4. General view of radargrams collected along path A compared with the view of the wall. Division into sections according to sections of masonry visible after plaster removal

Even a superficial analysis of the individual patterns in the form of a pattern of characteristic hyperbolas suggests similarities between some parts of the wall. And so it can be observed that the area marked A.1 presents a very similar pattern to area A.5.

In addition, in area A.5, a bricked-up void was revealed during the architectural research stage. The considerable similarity of the radar patterns suggests that a similar void is located in areas A.1 and B.6, which was not revealed during the architectural excavations. A section of wall A.8 also exhibits similarities to the aforementioned areas (similar brick pattern and specified width of this section); however, this is not confirmed by the overall patterns on the radargram. To verify the similarity of the wall section, a comparative analysis of the average signal strength with analogous areas was conducted. Below, Figure 7 shows a cutout from a detailed analysis of the radargrams.

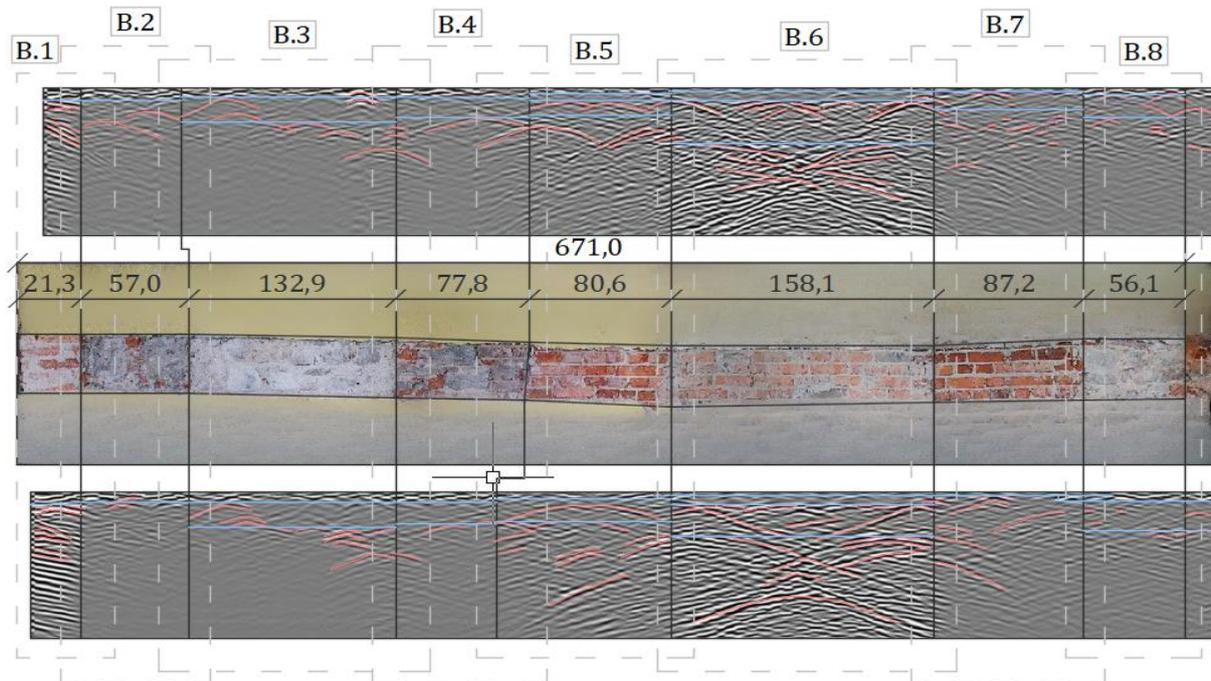
Fig. 5. General view of radargrams collected along path B compared with the view of the wall. All symbols analogous to Fig. 4

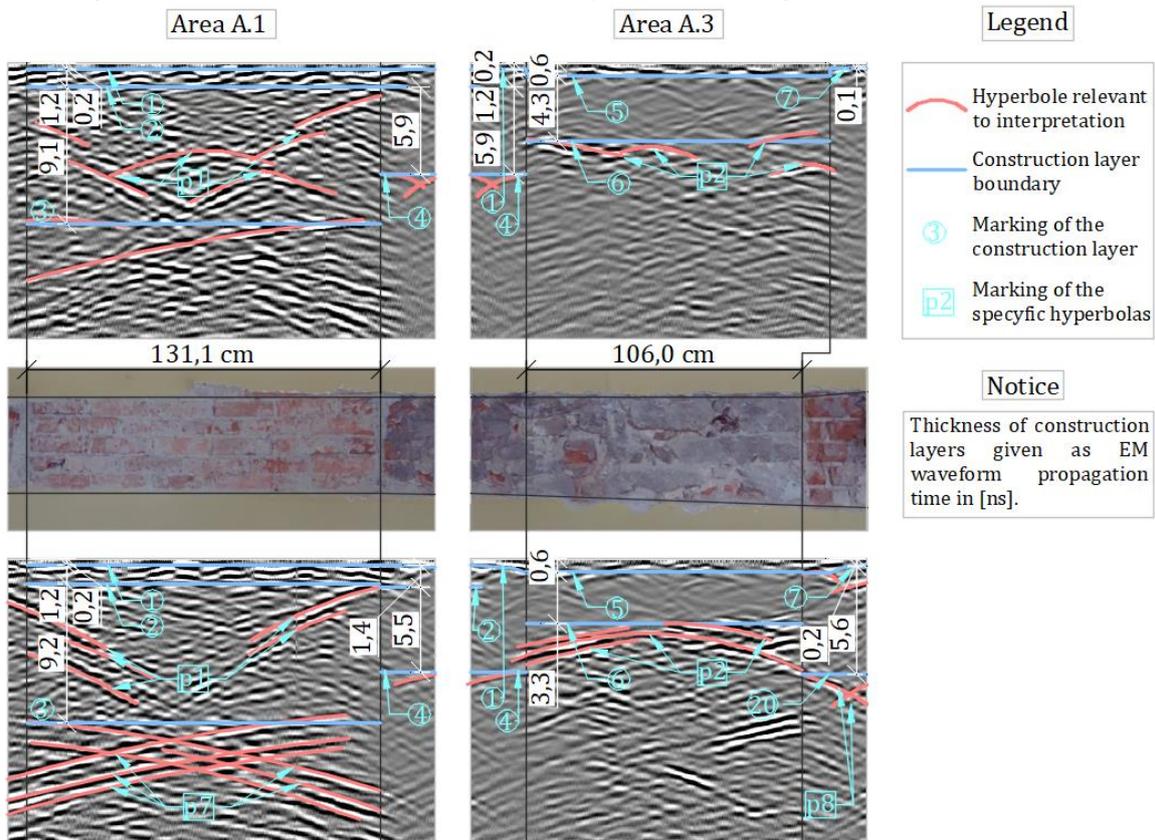
Fig. 6 Excerpt from the detailed analysis of radargrams divided into individual areas. Explanation in the text

All identified structural layers are derived from the corresponding system of hyperbolas. Due to the presence of various materials within the masonry structure, GPR calibration cannot be performed once to determine the exact thickness values of the layers. Instead, it is only possible to ascertain the travel times of electromagnetic waves through a given layer, expressed in nanoseconds. In area A.1, a layer of plaster (1), a single layer of bricks (2), and an air void (3) were identified. Significant interference of electromagnetic waves reflected from the side surfaces of the void was observed (p1). After passing through the void, there is notable interference of waves (p7), making it impossible to determine the thickness of the subsequent structural layer. A layer of plaster (5) was also identified in area A.3, which is much thicker than in neighboring areas (1 and 7) due to the use of erratics instead of regular bricks. The thickness of this stone layer (6) was also determined, thanks to the clear reflections of electromagnetic waves from the outer plane of the layer.

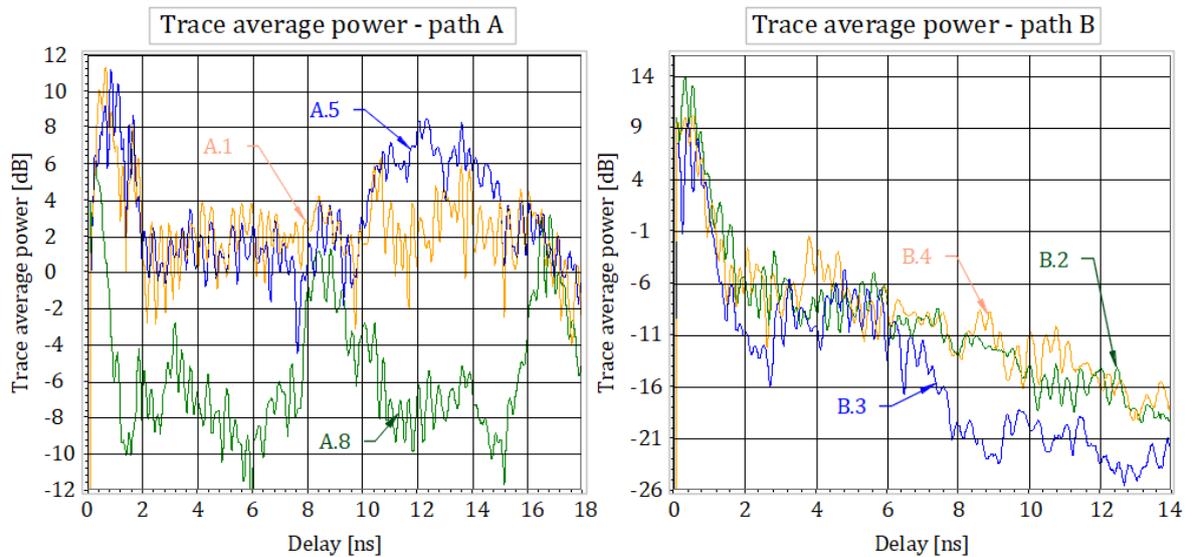
As previously mentioned, a comparative analysis of the average signal power in different areas was conducted (Fig. 7), to assess the material compatibility of the layers indicated by the hyperbola patterns. The comparison of areas A.1 and A.5 demonstrated their twin similarities, particularly evident in the convergence of the average signal power between 2 and 7 nanoseconds. For area A.8, suspected

of containing an air void and being similar to A.1 and A.5, there was no correspondence in average signal power, indicating a different structural nature.

For areas B.2, B.3, and B.4, analyses showed that B.2 and B.4 are constructed of the same materials, as confirmed by the excavations (mixed masonry). Conversely, B.3, built of erratics, exhibited a lower average signal strength than the other two areas. The analysis of the average signal strength confirmed the dissimilarity of these structures, suggesting that they were built at different times, as documented during the architectural analysis.

Fig. 7 Selected graphs of the conducted comparative analysis of average signal power for specific area
