DAMAGE TO THE FORTRESS IN DANKÓW AND RESTORATION OF KRZEPICKA GATE

Abstract

This paper describes conditions of the fortress walls in Danków. Locally they were found to be in very poor condition based on site inspections and non-destructive tests. The previous main gateway to the fortress, that is, the Krzepicka Gate was in the worst condition. Hence, the restoration for the Gate and the plan for its adjustment to become the preserved ruin were prepared. The structure was restored in the years 2021-2023.

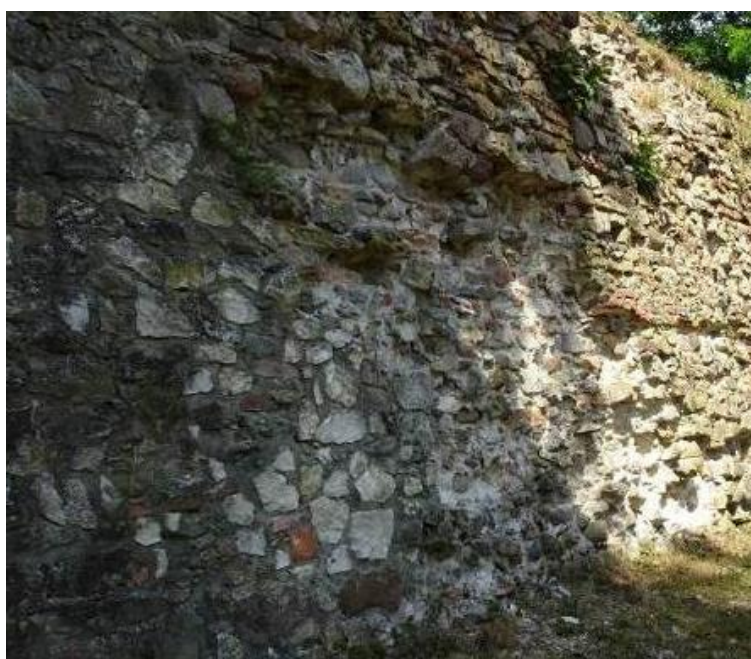
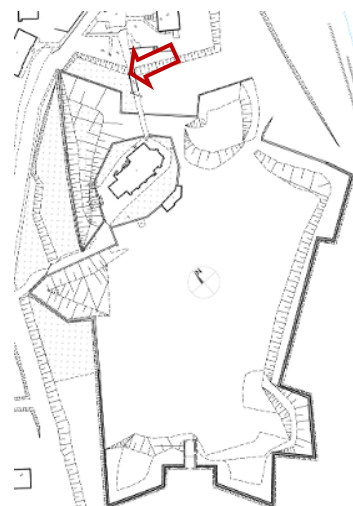
Fig. 8. Loss of masonry units and joints. Growth of planting

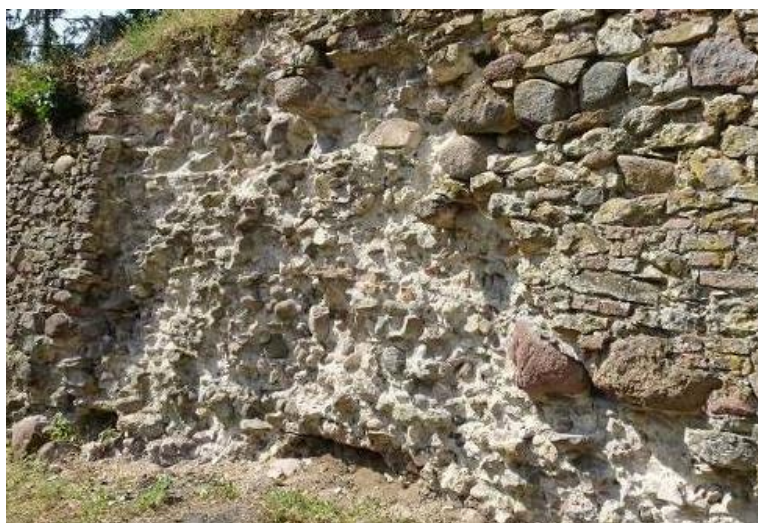
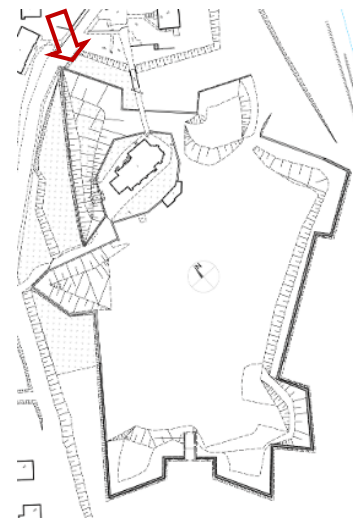
Fig. 9. Loss of masonry units and joints. Growth of planting

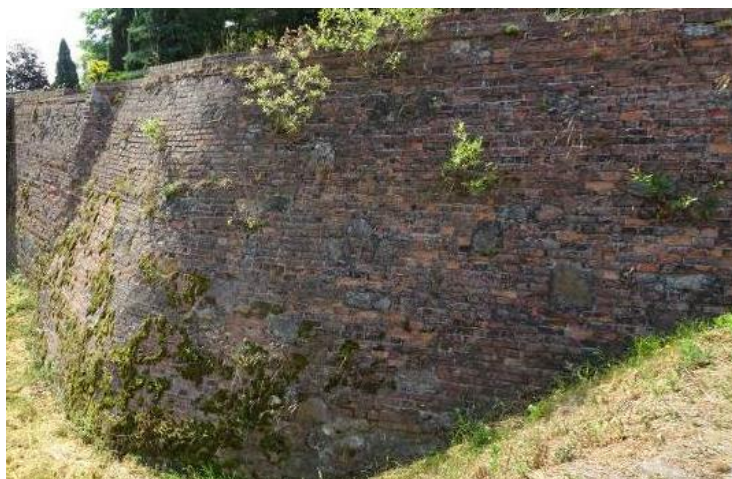
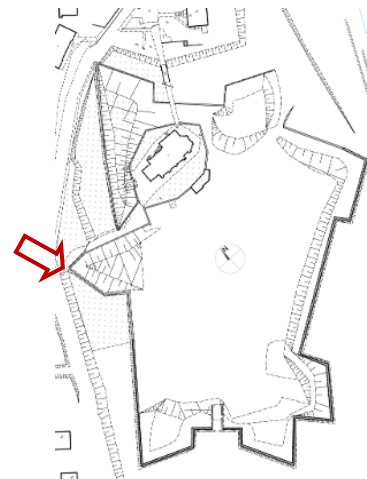
Fig. 10. Loss of masonry units and joints. Growth of planting

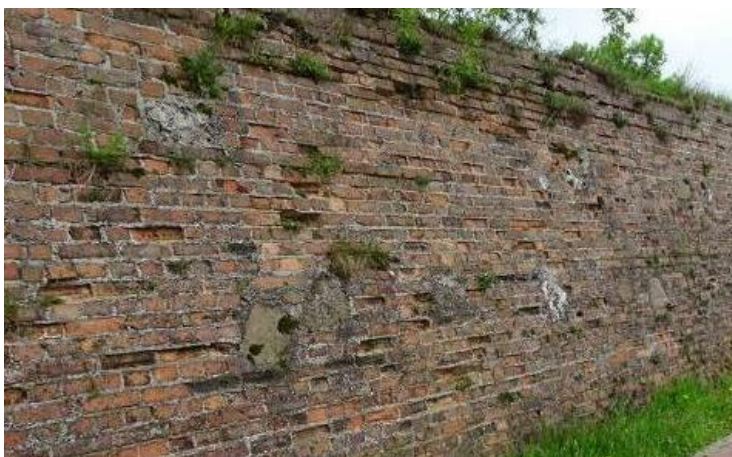
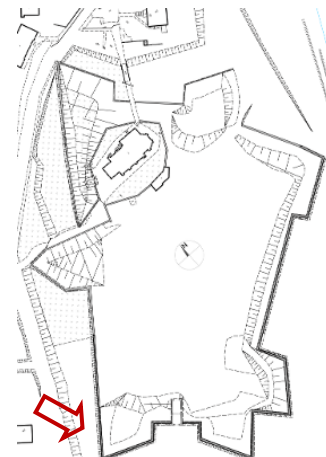
Fig. 11. Loss of masonry units and joints. Growth of planting

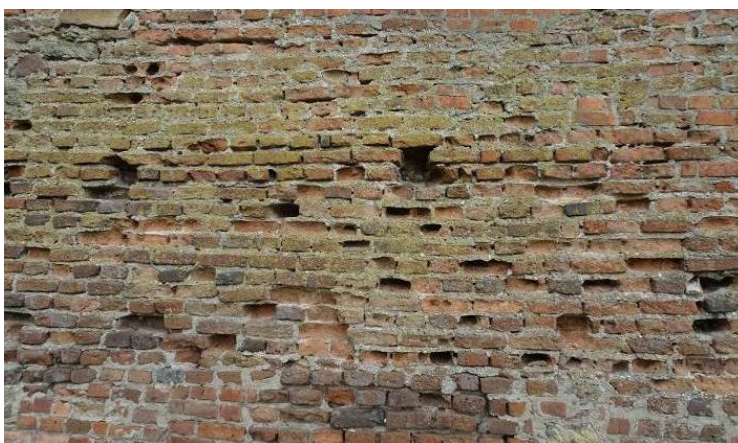
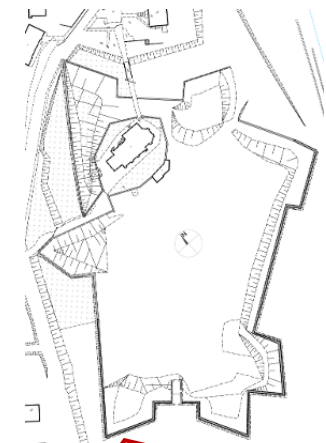
Fig. 12. Detailed loss of masonry units and joints

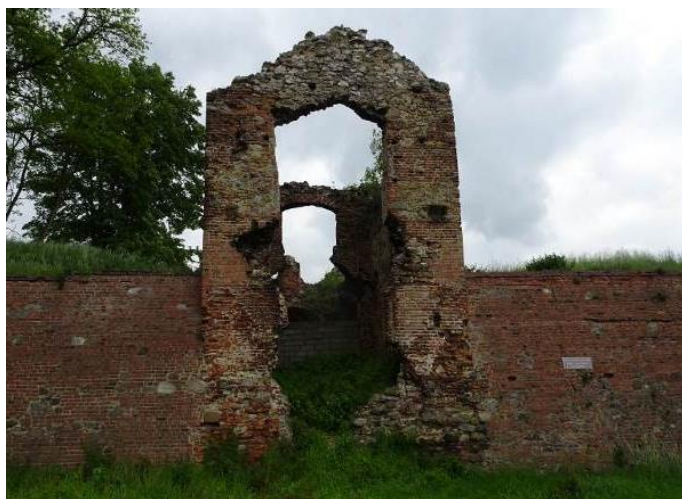
Fig. 13. A view of damage to the Krzepicka Gate

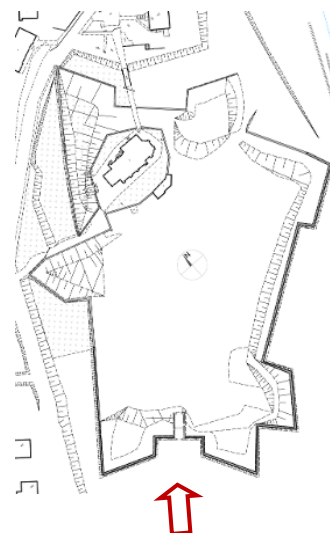
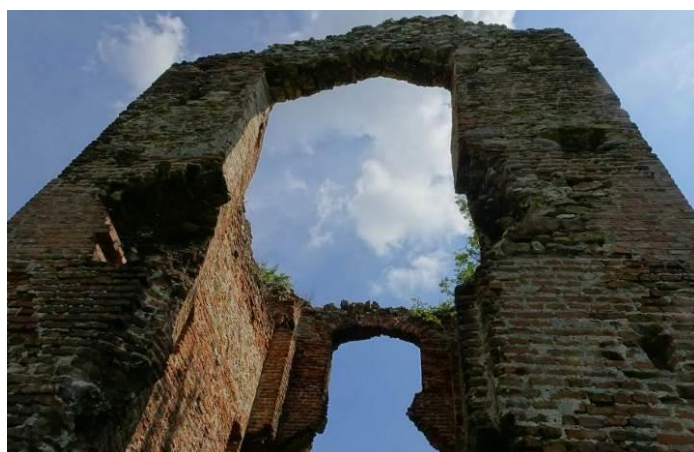
Fig. 14. A view of damage to the Krzepicka Gate

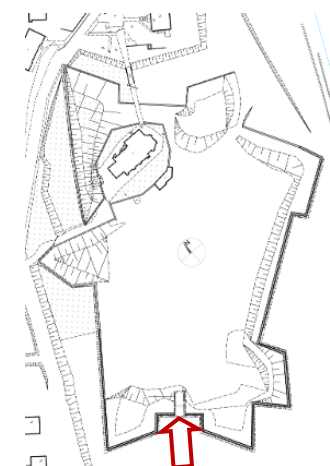
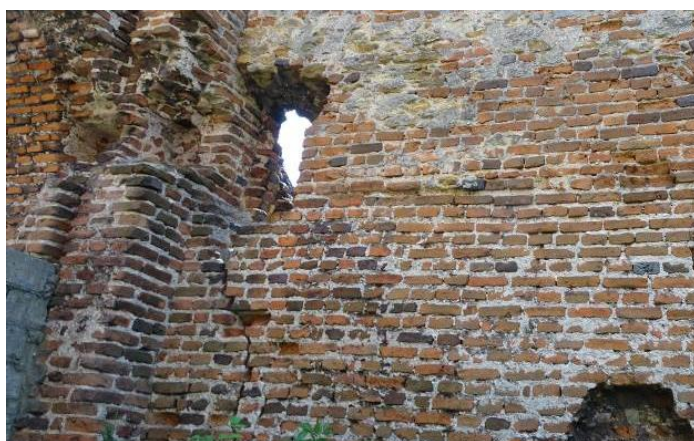
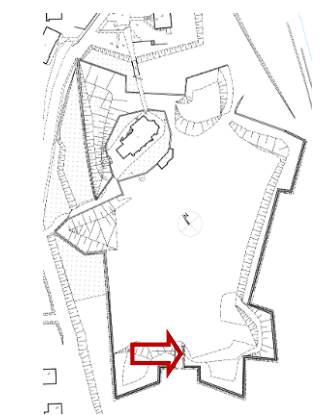
Fig. 15. A view of damage to the Krzepicka Gate

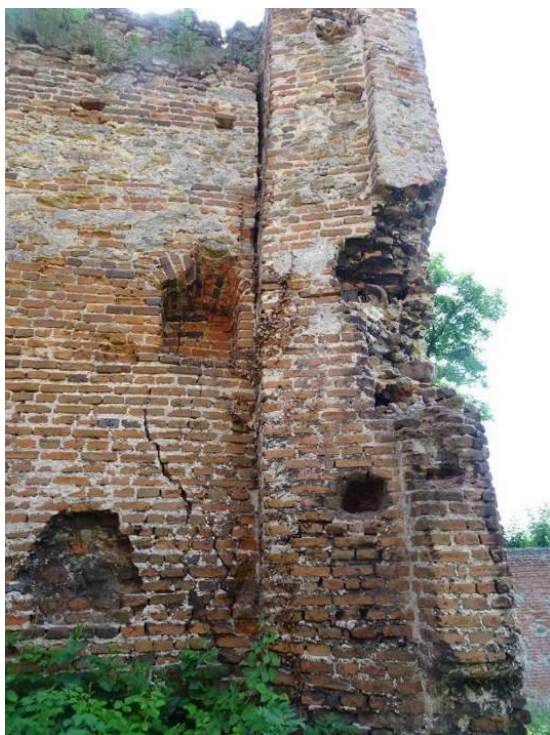
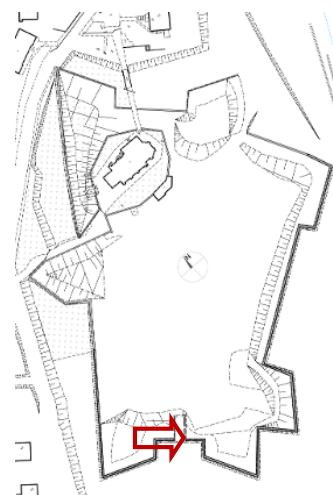
Fig. 16. Cracks and loss of masonry of the Krzepicka Gate

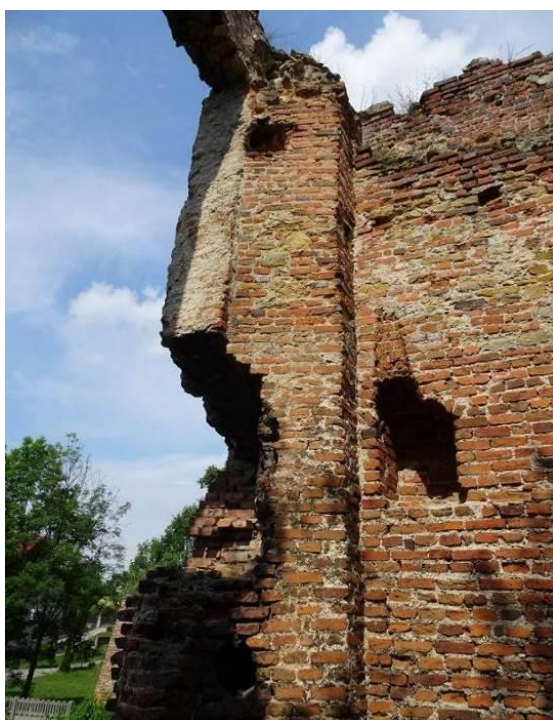
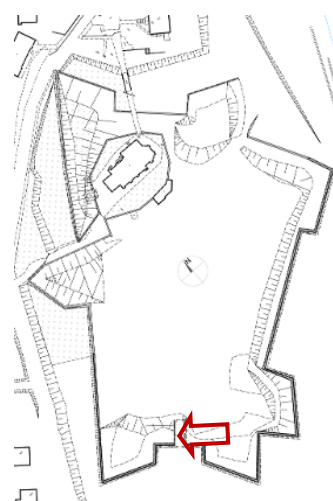
Fig. 17. Cracks and loss of masonry of the Krzepicka Gate

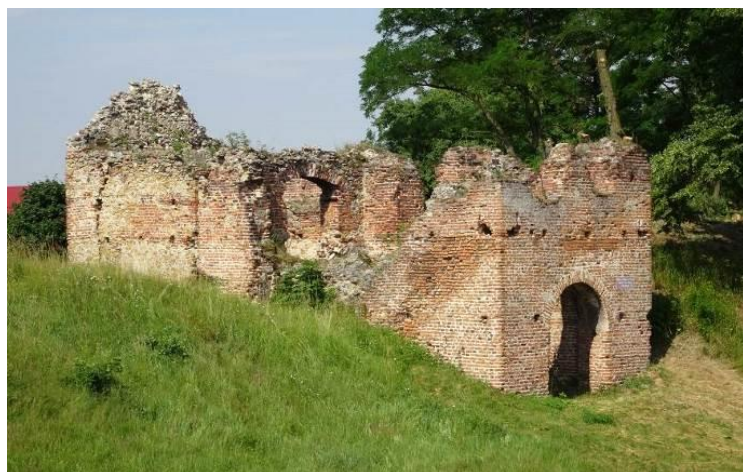
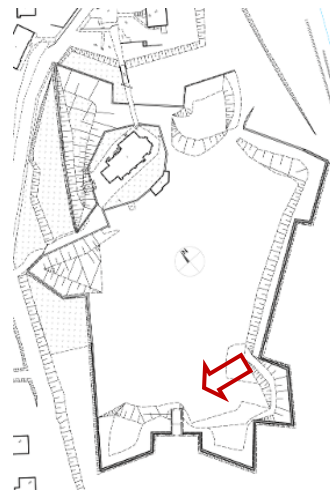
Fig. 18. Cracks and loss of masonry of the Krzepicka Gate

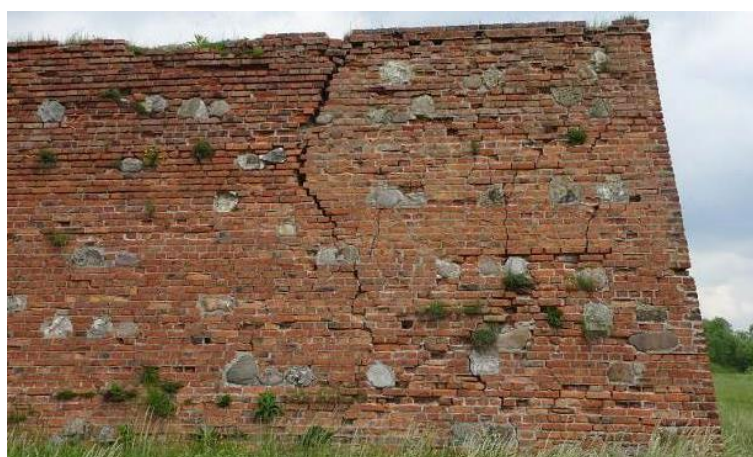
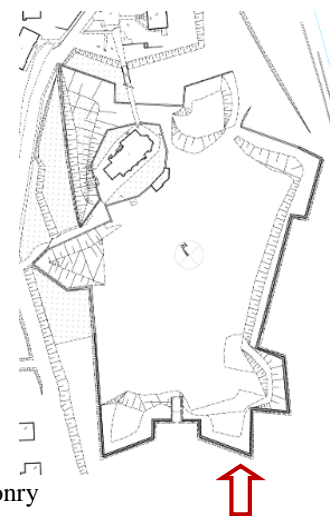
Fig. 19. Loss of masonry and joints. Cracks in masonry

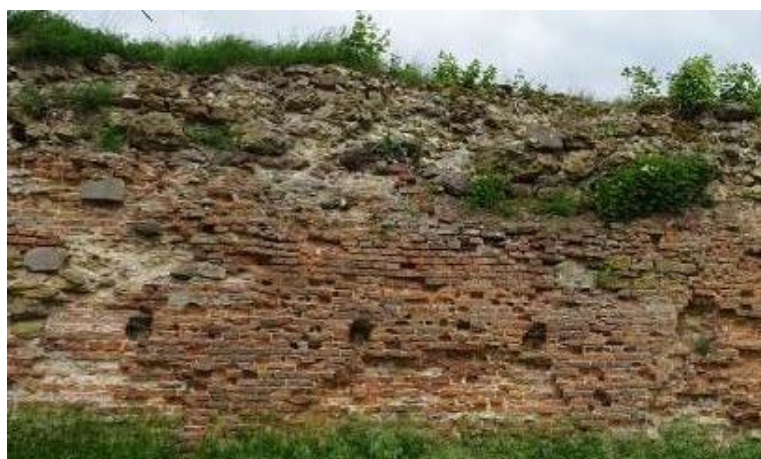
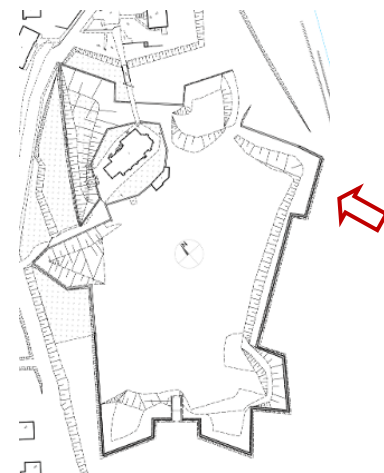
Fig. 20. Loss of masonry and joints. Cracks in masonry

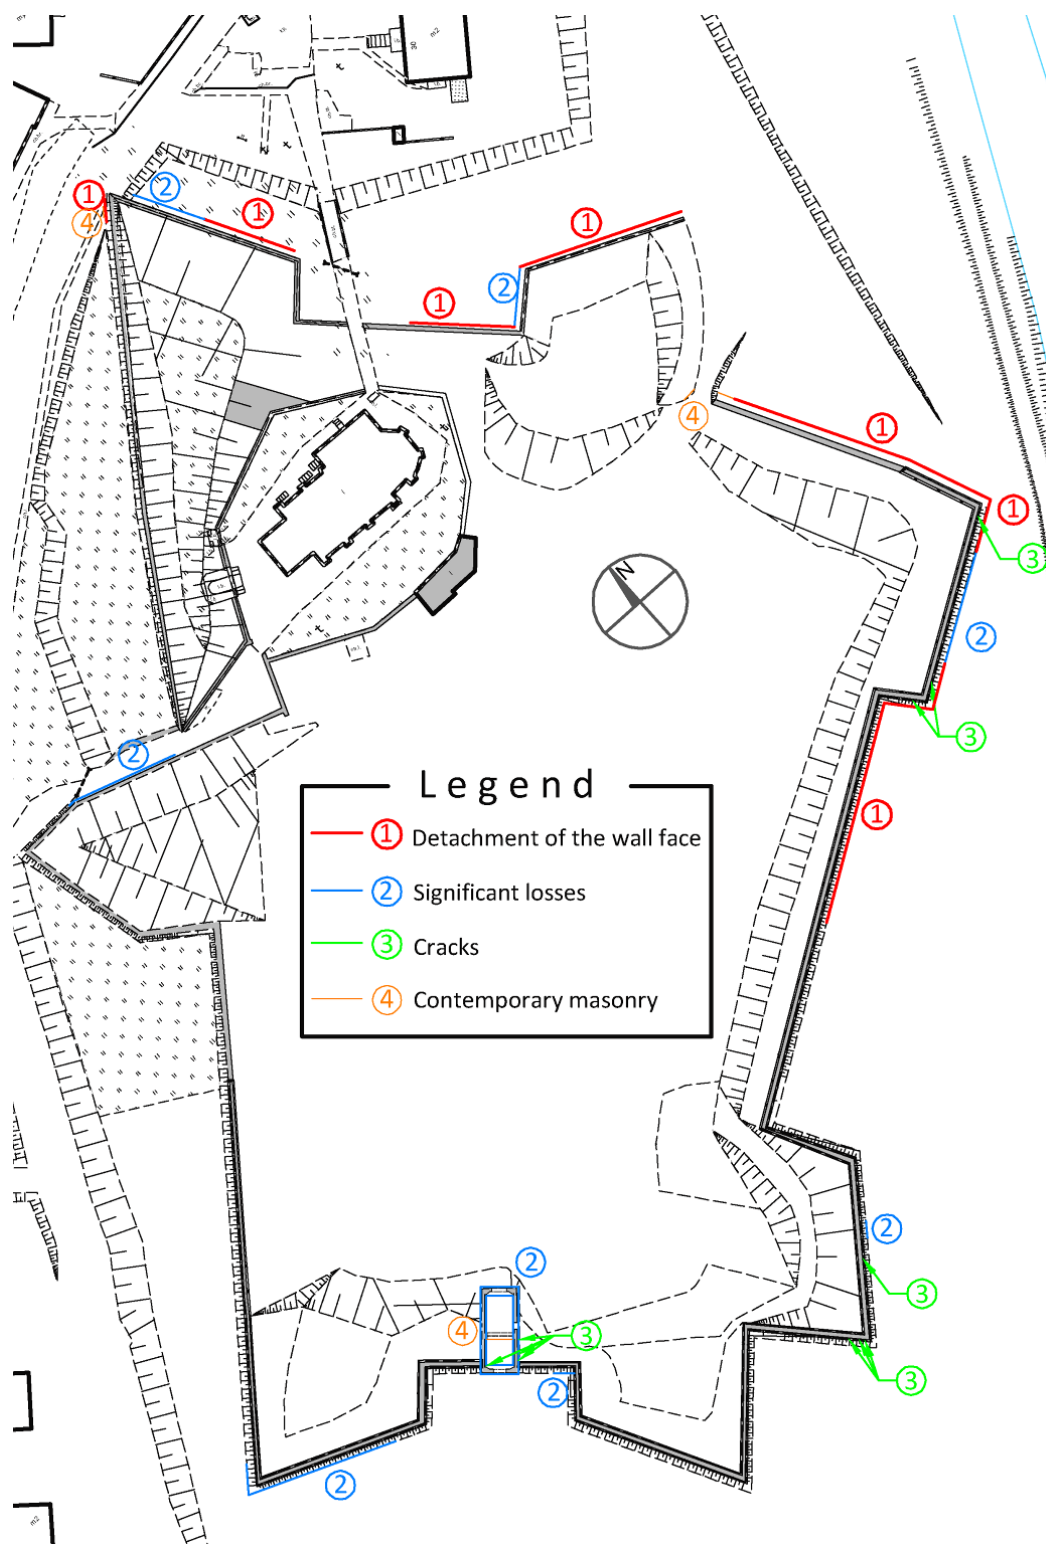
Fig. 21. Locations of most serious damage to the Danków fortress

Condition of the masonry of the Danków fortress ranges from poor to satisfactory. The following elements are in the worst, often pre-failure, condition: the Krzepicka Gate, parts of the masonry (a northern fragment of the south-eastern front with a half-bastion, a north-eastern front excluding the postern area) without brick facing, faced parts of the masonry (in particular a western part of the south-western front) and crack points on the masonry of the Krzepicka Gate and the north and south half-bastions of the south-eastern front.

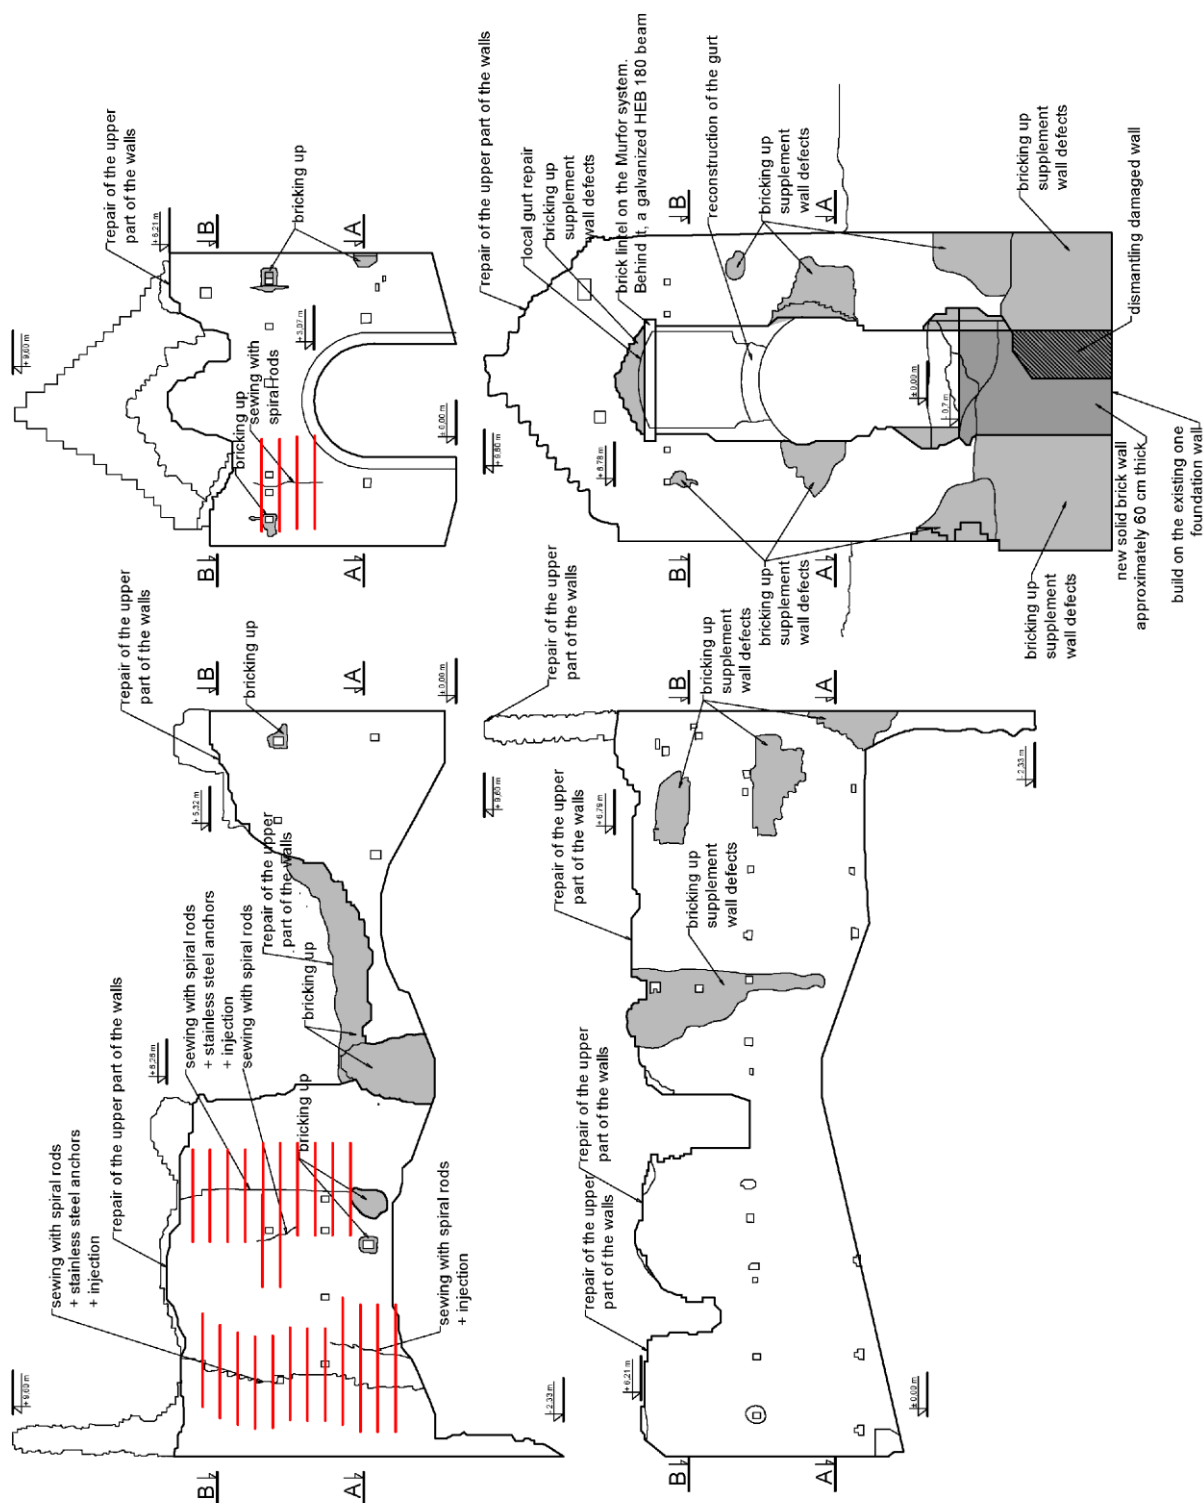
Fig. 24. The planned method of repair of the Krzepicka Gate

The planned restoration and strengthening of the Krzepicka Gate included:

- Stitching of the wall cracks with stitching bas or anchors made of stainless steel. Using anchors for detachment of the facade wall. Filling cracks having a width greater than 1 mm with mineral injection.

- Protecting arches by anchoring stainless steel bars and, if possible, rebuilding and locally supplementary brick laying.
- Placing steel lintel which supports the gate top.

- Restoring two vaults.
- Bricking up ectypal openings.
- Cleaning the wall coping, placing the waterproof membrane, and protecting the wall coping. Laying 1-2 layers of brick above the membrane.

- Removing supplementary masonry made of AAC (Autoclaved Aerated Concrete) masonry units.
- Partial clearing of the floor and performing floor from e.g. stone or rubble.

- Cleaning walls with the blast (or other) method and removing supplementary striking of joints.
- Rebuilding of wall losses.
- Supplementary striking of joints with restoration mortar.

- Performing hydrophobic impregnation of the masonry.
- Placing the steel portcullis.

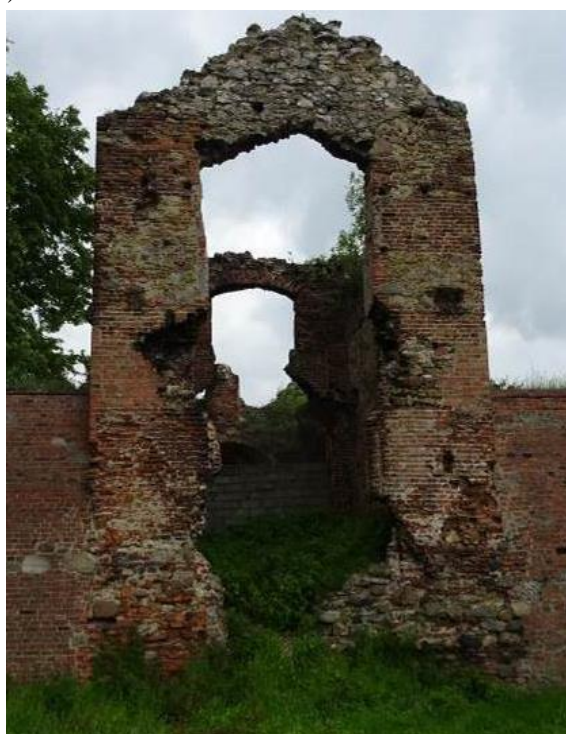
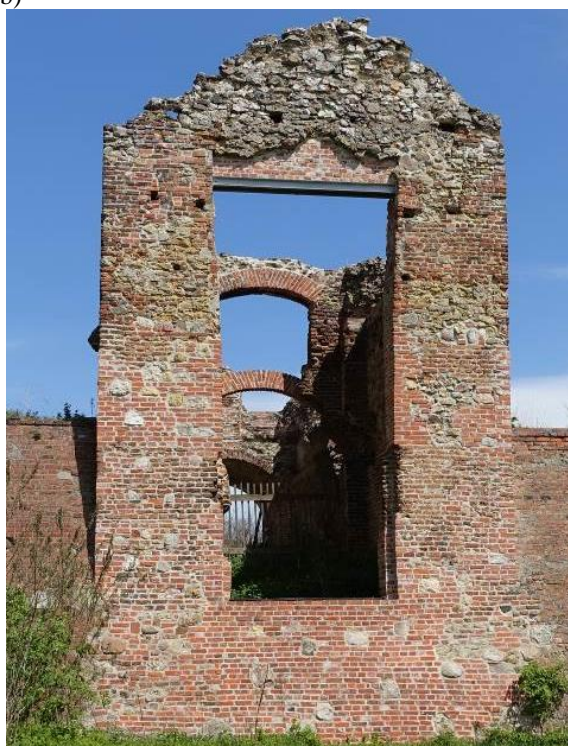
Fig. 25. A view of the Krzepicka Gate from the south-western side: a) before restoration in 2019, b) after restoration (2024)

The restoration works began in 2021. The following works have not been performed: works on the floor and the portcullis, building the lintel covering the steel bar that supports the masonry over the lintel, brick laying of the masonry above the waterproof membrane at the wall coping. The condition in 2020 and 2024 (after the restoration works) is shown in Fig. 25÷20.

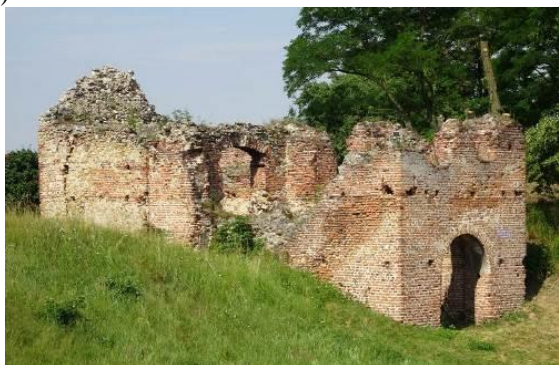
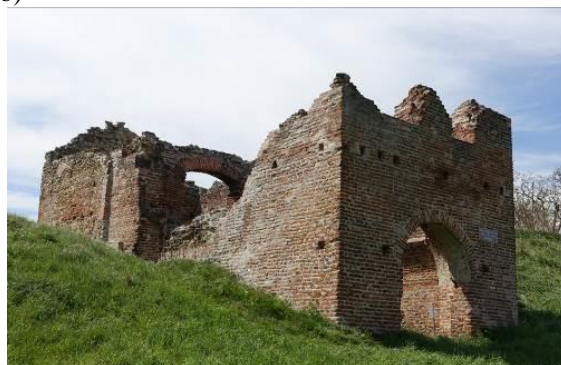
Fig. 26. A view of the Krzepicka Gate from the western side: a) before restoration in 2019, b) after restoration (2024)

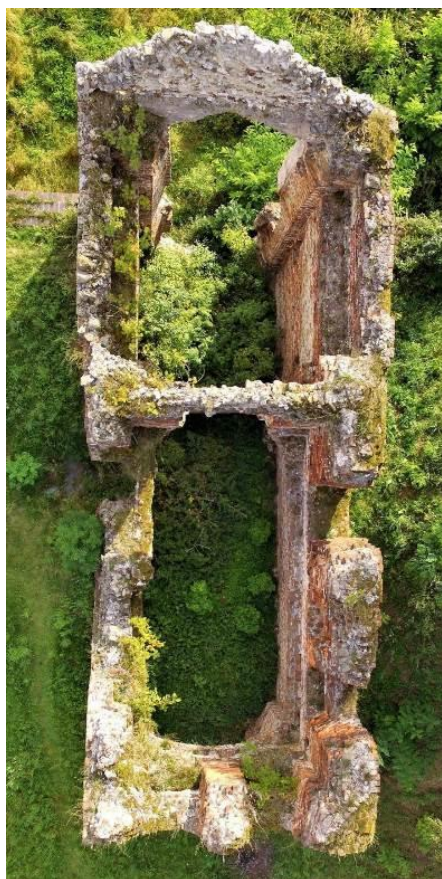
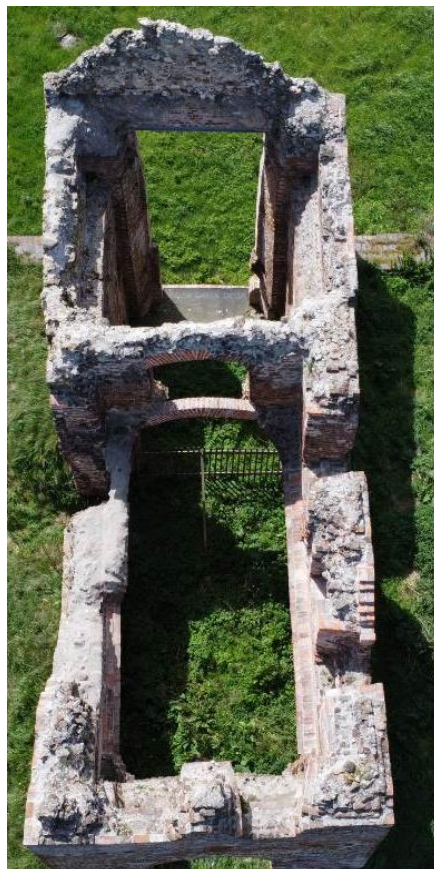
Fig. 26. A view of the Krzepicka Gate from the top: a) before restoration in 2019, b) after restoration (2024)

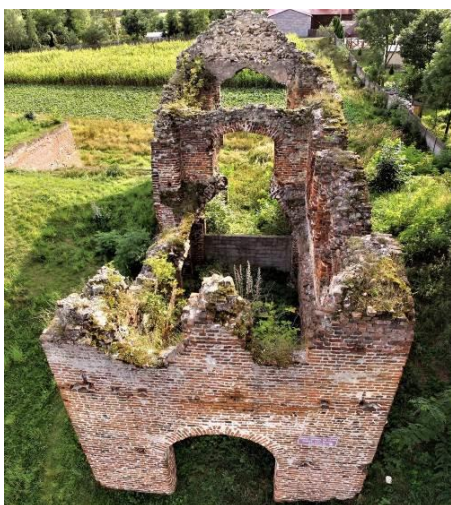
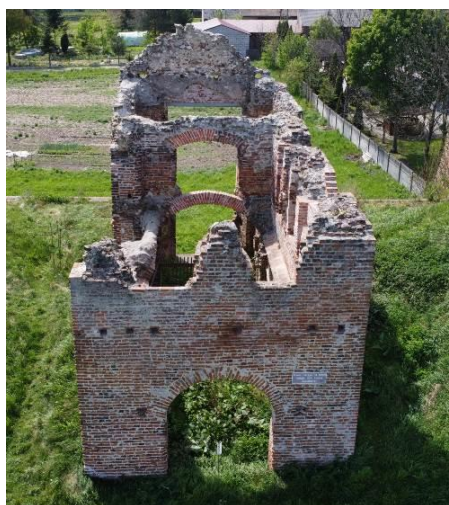
Fig. 28. A view of the Krzepicka Gate from the western side: a) before restoration in 2019, b) after restoration (2024)
