## **PRIORITISING RENOVATION USING CONSEQUENCE ANALYSIS: A CASE STUDY OF A TENEMENT HOUSE IN KOŻUCHÓW**

### 3. CHARACTERISTICS OF THE TENEMENT HOUSE IN KOŻUCHÓW

In 2025, an assessment of the building's technical condition was carried out. The results of the assessment are presented in column 3 of Table 1 and Fig. 3-7. Column 2 contains the results of earlier analyses presented in [12].

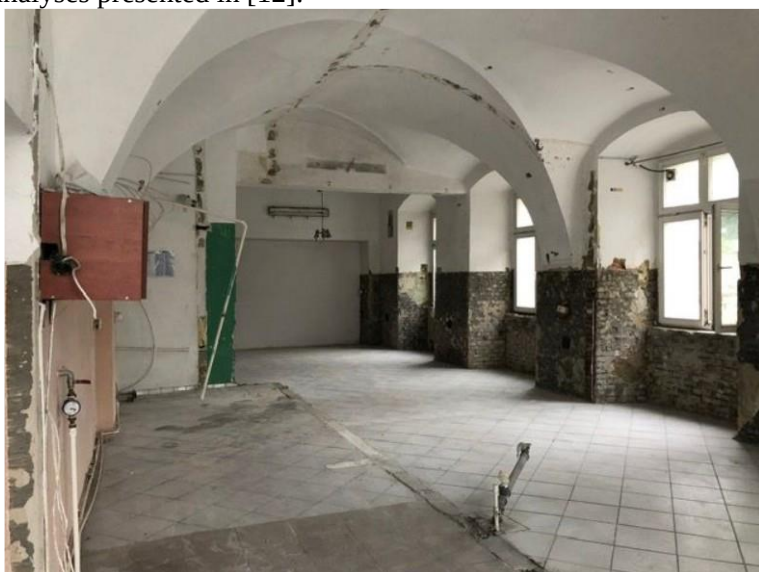
Fig. 3. The first floor space (photo J. Markowska)

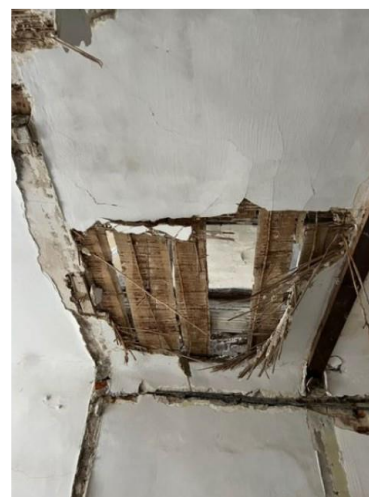
Fig. 4. Damaged ceiling over the ground floor (photo J. Markowska)

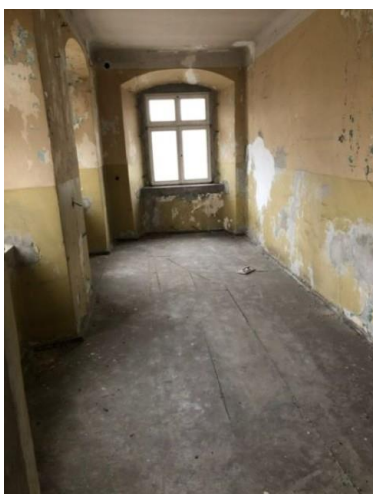
Fig. 5. Damp walls (photo J. Markowska)

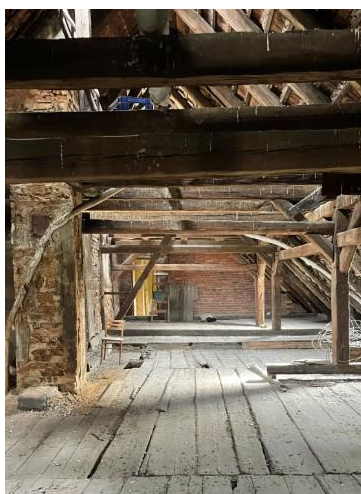
Fig. 6. Damage to the roof structure (photo J. Markowska)

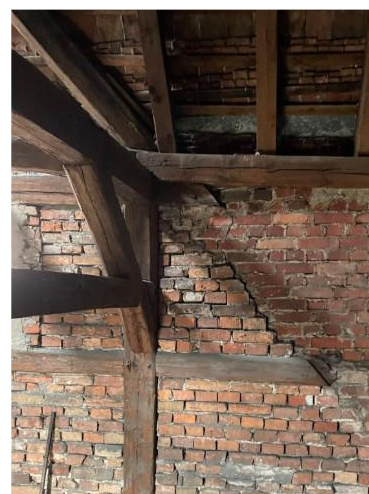
Fig. 7. A crack in the wall (photo J. Markowska)
