CEER 2024; 34 (4): 0307-0327 DOI: 10.59440/ceer/195259 Original Research Article

# COMPREHENSIVE MONITORING OF CHANGES IN THE GEOMETRIC STRUCTURE OF A HISTORIC BUILDING THE "SALA BHP" IN GDAŃSK

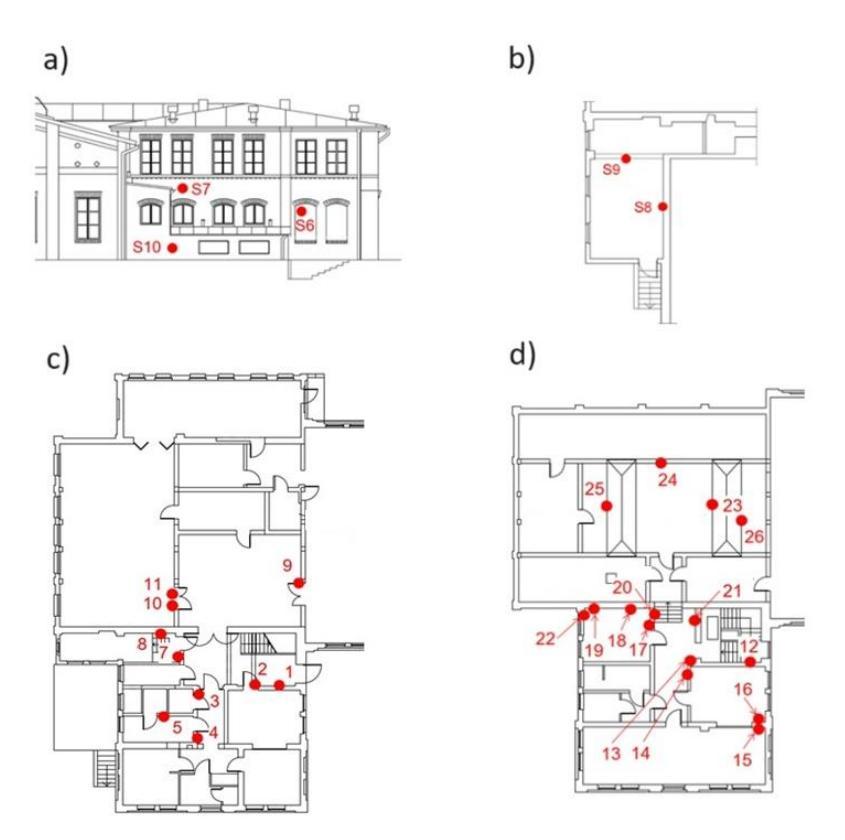
Fig. 11. Location of crackmeters: a) eastern elevation, b) boiler room, c) ground floor, d) first floor

Crackmeters were installed on the building's structural and finishing elements, where scratches were observed (Fig. 11).

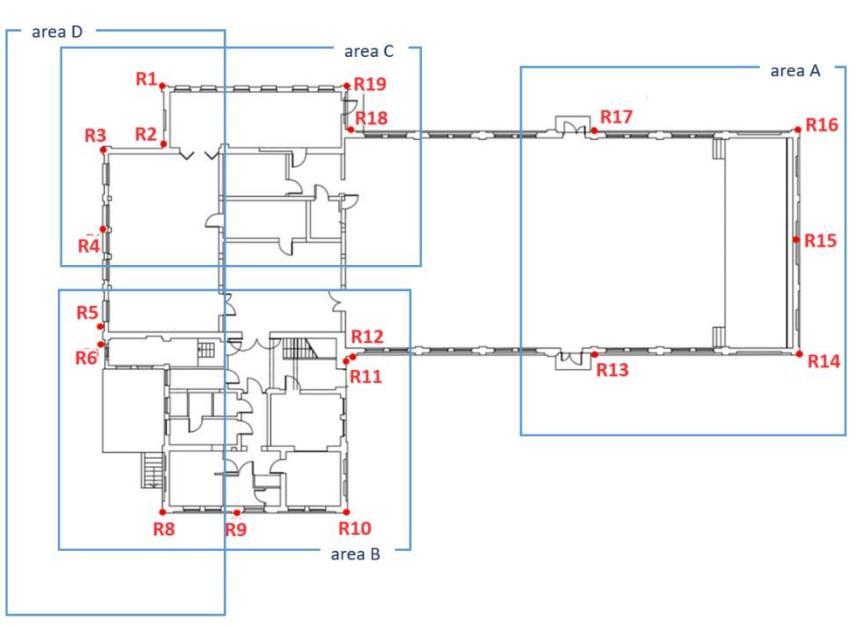
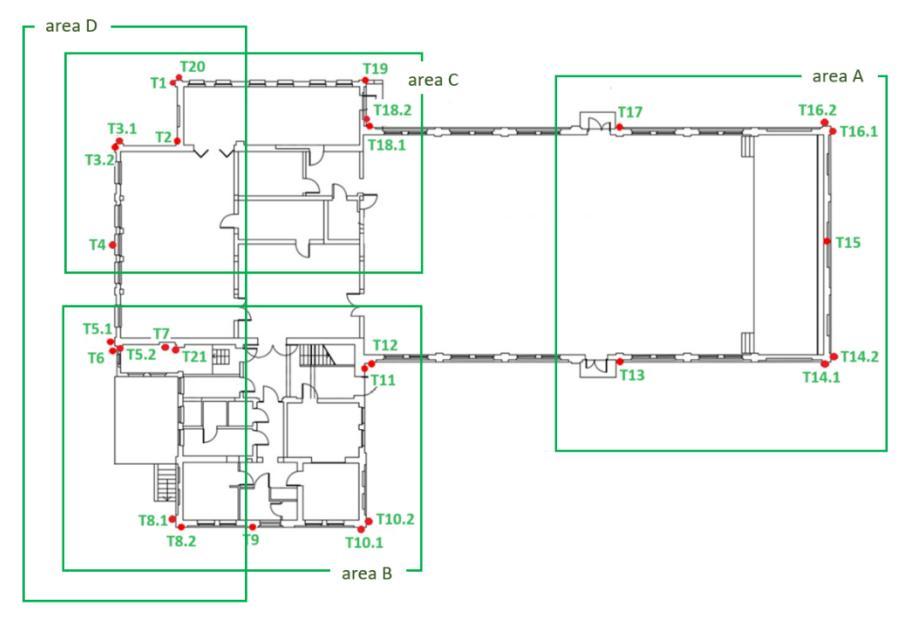
Analyzing the obtained indicator values, one can notice its increased value for zone A. The relationship occurs in both the height transformation error and the horizontal transformation error. Slightly higher values of this indicator in zone A indicate a more uneven distribution of displacements. The obtained displacement values are at a level that does not threaten the facility's use, but their unevenness may cause scratches on the walls both outside and inside the facility. With higher values of this indicator, conducting a more detailed analysis would be recommended.

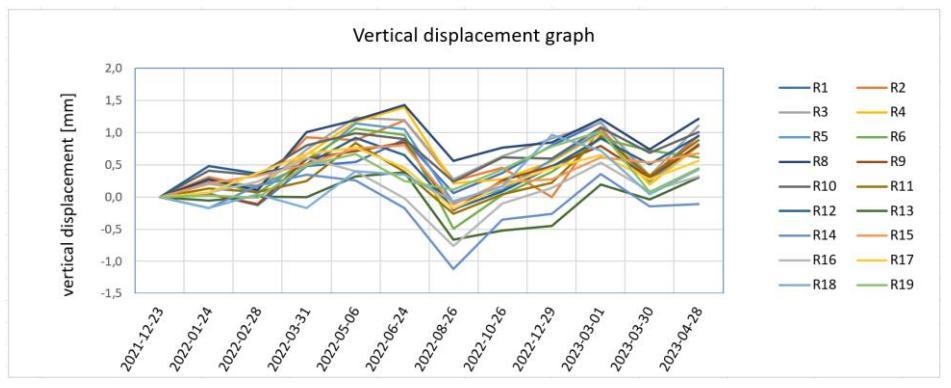
Fig. 16. The vertical displacements of the control points R1- R19

The values of measured vertical displacements of controlled bench-marks mounted on the walls of the monitored facility ranged from -1.12 mm (R14) to +1.43 mm (R8). The average errors of the determined vertical displacements, in most of the measurement series, did not exceed 0.35mm. The exception was the series of 2022.10.26, for which the average error slightly exceeded 0.50mm. These

values are lower than the Serviceability Limit State (SLS) recommended by the Building Research Institute (ITB).

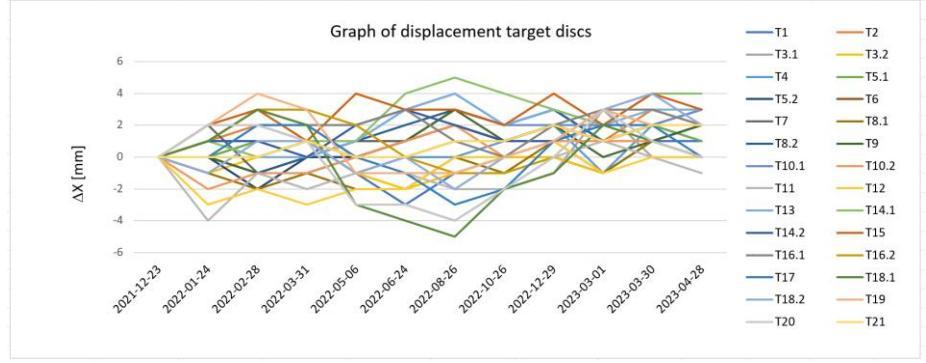
Fig. 17. Horizontal displacements of the discs in the X direction

The maximum horizontal displacement was recorded for the T15 disc in the Y direction and amounted to -8 mm. In the alignment process, errors in the position of the points of the controlled network in relation to the reference points were determined. The values of these errors were a maximum of 1.5mm. According to the currently applicable standard [9], the values of horizontal displacements are permissible in the case of brick buildings, which are considered up to 20 mm on each floor and up to 50 mm along the entire height of the wall.

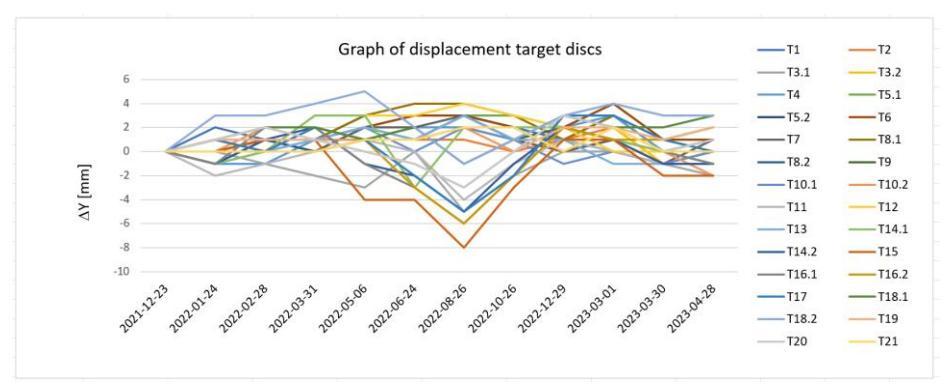
Fig. 18. Horizontal displacements of the discs in the Y direction

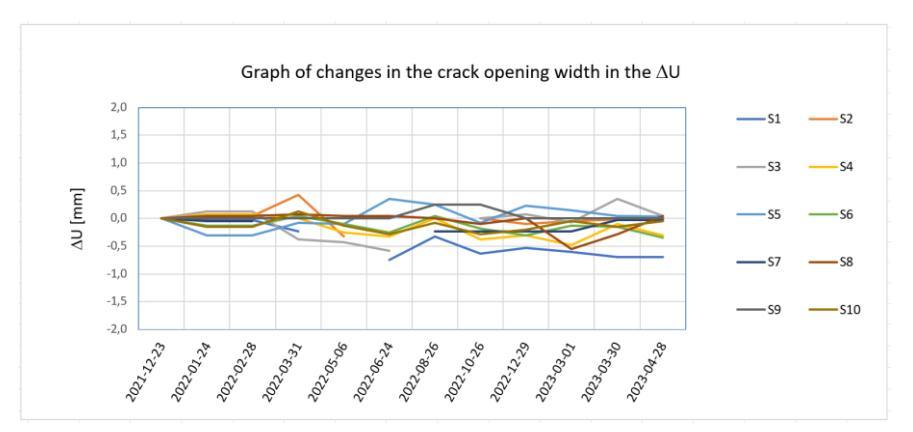
Fig. 19. Changes in the crack opening width in the  $\Delta U$  direction for crackmeters S1-S10

- for direction  $\Delta U$ : min  $\Delta U = -1.00$  mm - crackmeter no. 24, max  $\Delta U = +1.25$  mm - crackmeter no. 25, - for direction  $\Delta V$ : min  $\Delta V = -1.63$  mm - crackmeter no. 25, max  $\Delta V = +2.40$  mm - crackmeter no. S10.

It was found that changes in the width of monitored cracks located on the walls of the building's facade are caused by changes in atmospheric conditions: ambient temperature, humidity, and sunlight. Significant changes in the readings of the S10 crack gauge means that the crack above the lintel is active, and therefore it is recommended to check the lintel's stress and propose ways to strengthen it.

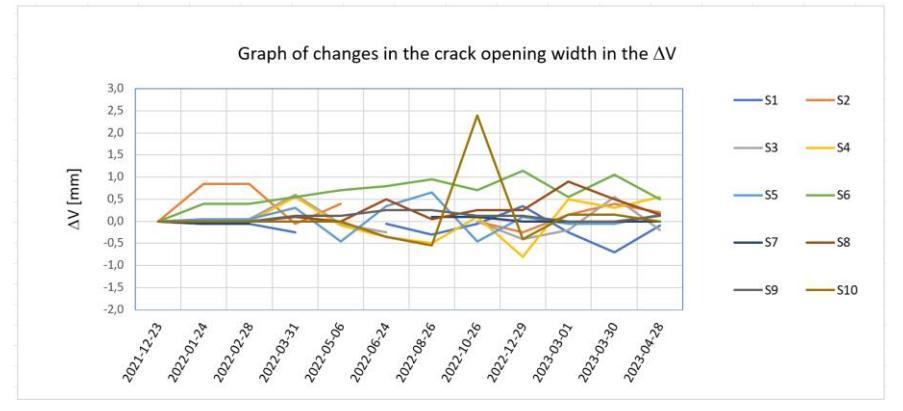
Fig. 20. Changes in the crack opening width in the  $\Delta V$  for crackmeters S1-S10

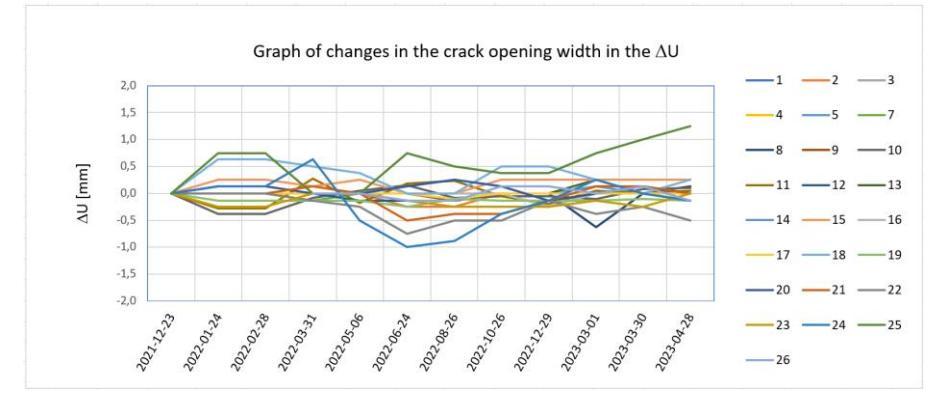
Fig. 21. Changes in the crack opening width in the  $\Delta U$  direction for crackmeters 1-26

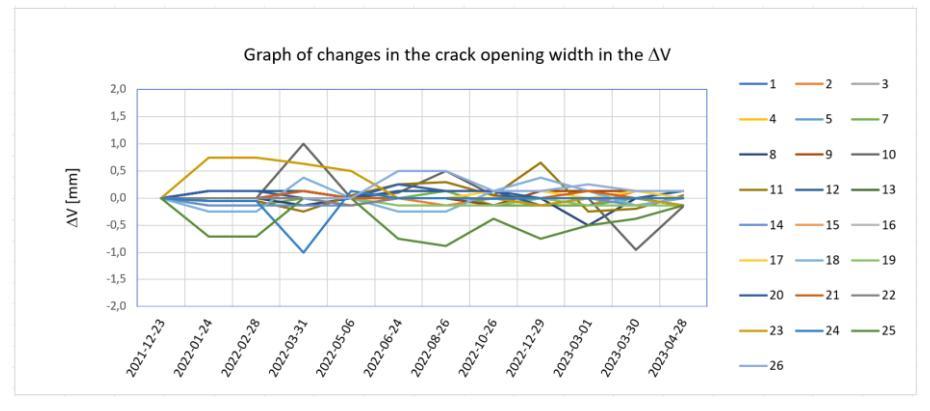
Fig. 22. Changes in the crack opening width in the  $\Delta V$  for crackmeters 1-26

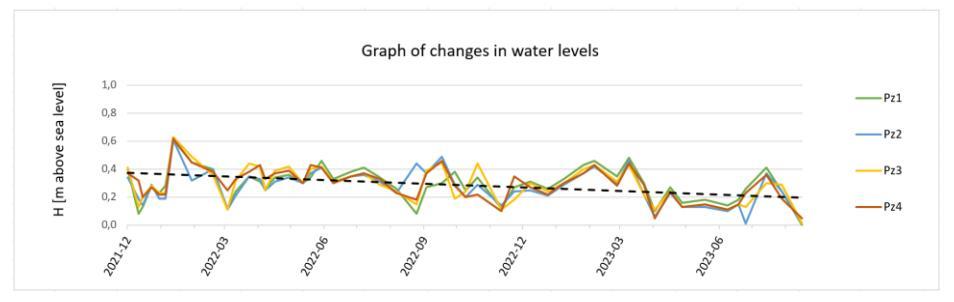
Fig. 23. Graph of changes in water levels in monitored piezometers

Fig. 23 shows the linear regression of changes in the height of the groundwater table in the monitored piezometers as a dashed line. A decreasing trend in the groundwater level near the building was observed in all monitored piezometers.
