## **TIME-LINE BASED AERIAL ANALYSIS FOR IMPACT OF RAMPANT URBANIZATION ON LAKES OF BENGALURU (INDIA)**

### **Abstract**

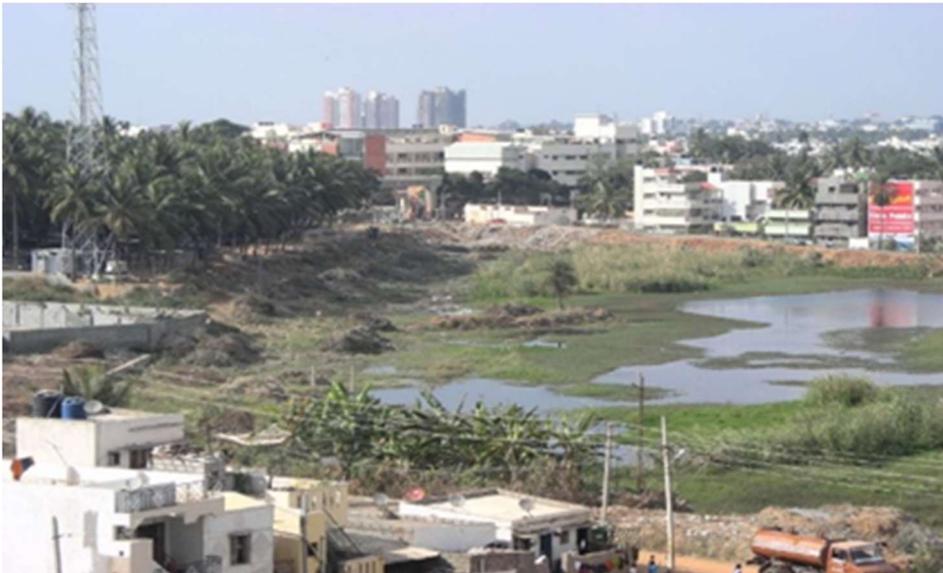
Fig. 5. Encroachment of Sarakki Lake [Google]

was set-up in the encroached area of 64,710 sq.m. of Hebbal Lake. Ironically, while 29,116 sq.m. of Rachenahalli Lake was used by BDA to build layout, private luxury villas came-up on 16,116 sq.m. of Sarakki Lake (Figure 5). While few Lakes such as Putenahalli Lake (Figure 6) lost a small portion of 3,564 sq.m., Bellandur was worst hit with loss of about 88,9153 sq.m. for construction activity of urban infrastructure expansion.

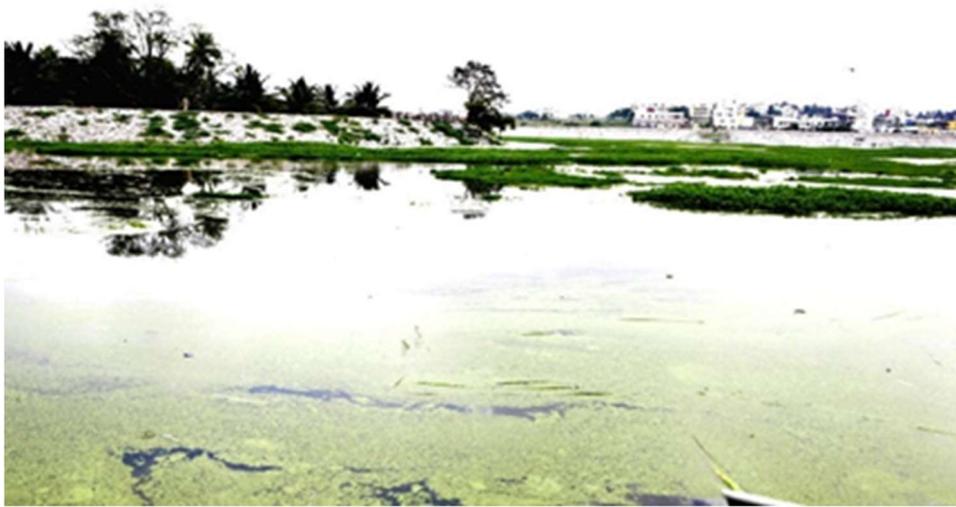
Fig. 6. Construction upon Putenahalli Lake [Google]

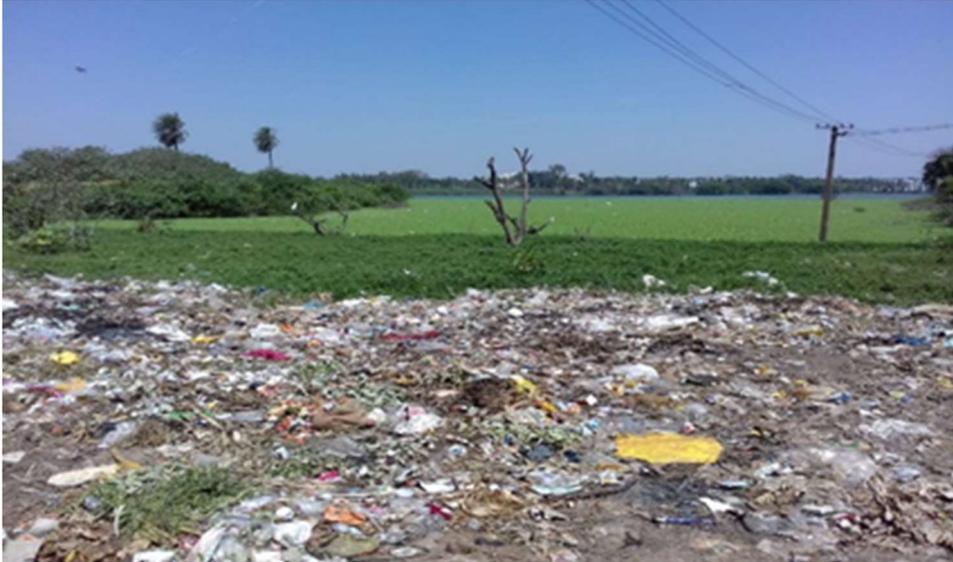
Fig.7. Waste dumping in Chikkakabanavara Lake [Google]

From the present research, it was found that the Lakes of Bellandur, Varthur and Chikkabanavara (Figure 7) had been transformed to illegal waste disposal sites were severely being affected by eutrophication as it was located in proximity to the polluters. Bellandur Lake (Figure 8) is now experiencing forth formation and fugitive fire breakouts due to mixings of various chemical wastes released from industries and sewage disposal from the adjoining communities.

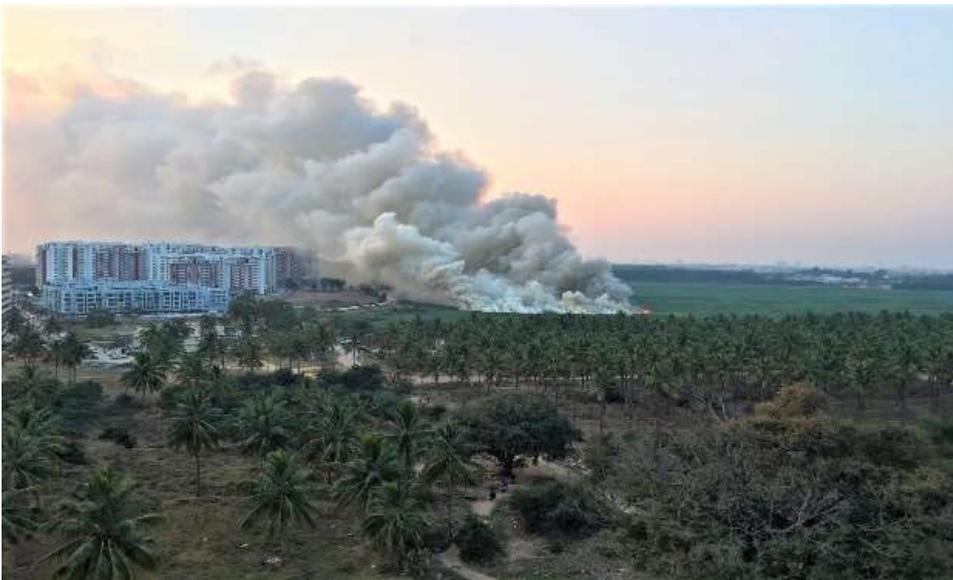
Fig.8. Fire Break-out in Bellandur Lake [Google]

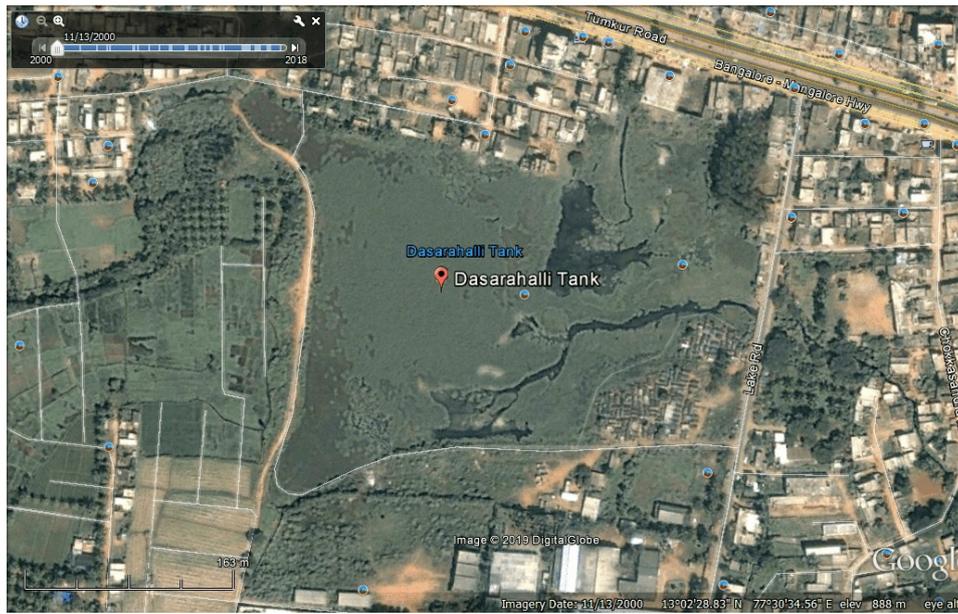
Fig. 9. Eutrophic' Dasarahalli Lake [Google]

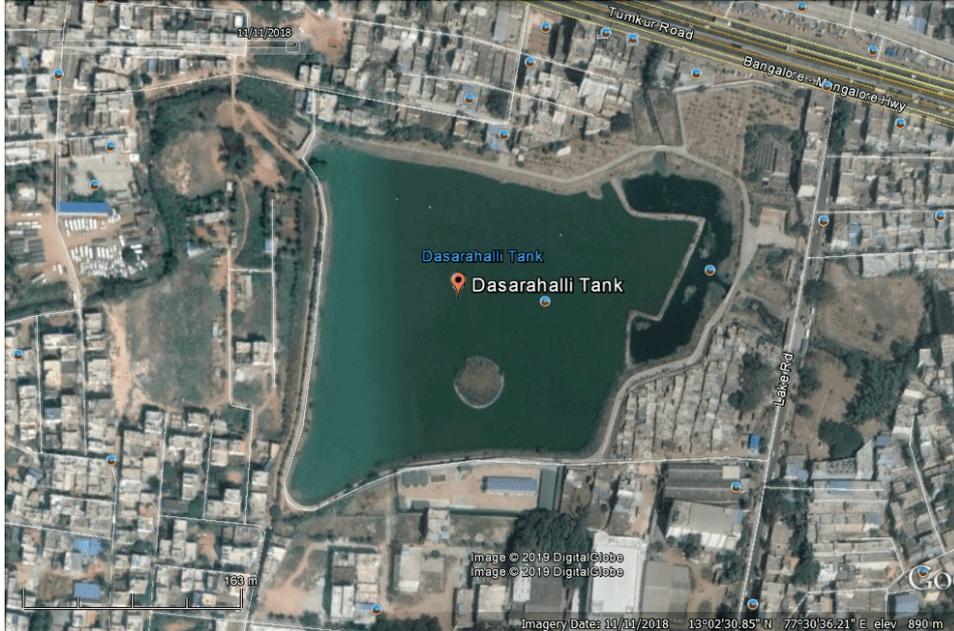
Fig. 10. 'Oligotrophic' Dasarahalli Lake [Google]

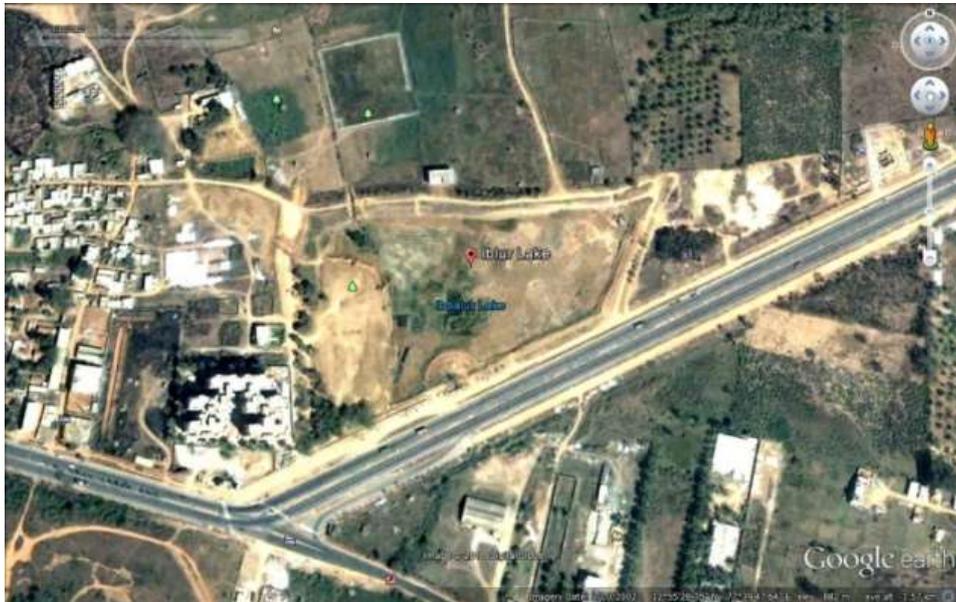
Fig. 11. Iblur Lake as dry land in 2002

As represented through Figure 11 & 12, Iblur Lake for instance has witnessed drastic transformation during dry and wet spells. Since lakes are mainly dependent on rainfall and runoffs, its replenishment is seriously disoriented due to rising Urbanisation and sewage outfalls. This eventually paves way for its encroachment and transformation for a built-up space.

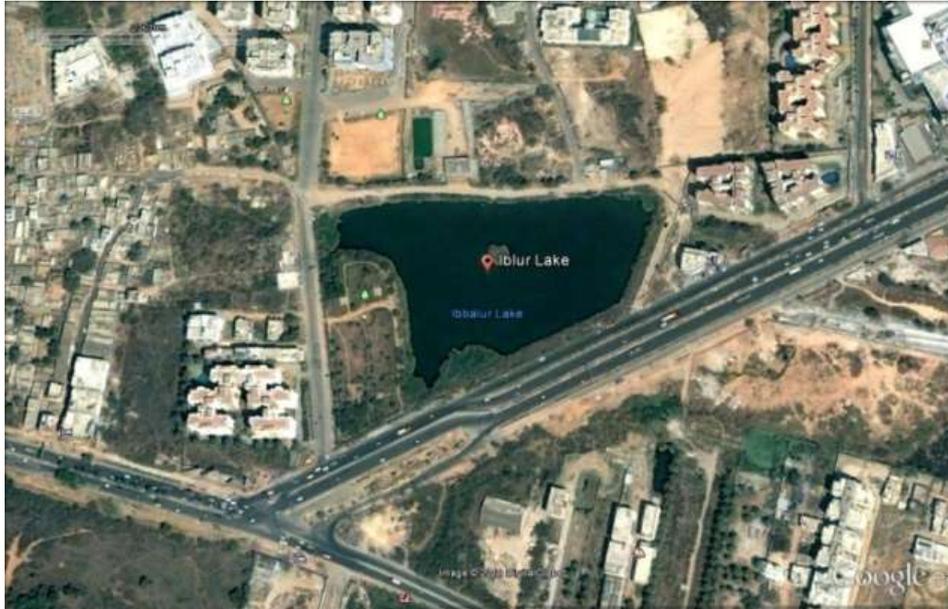
Fig. 12. Replenished Iblur Lake in 2009

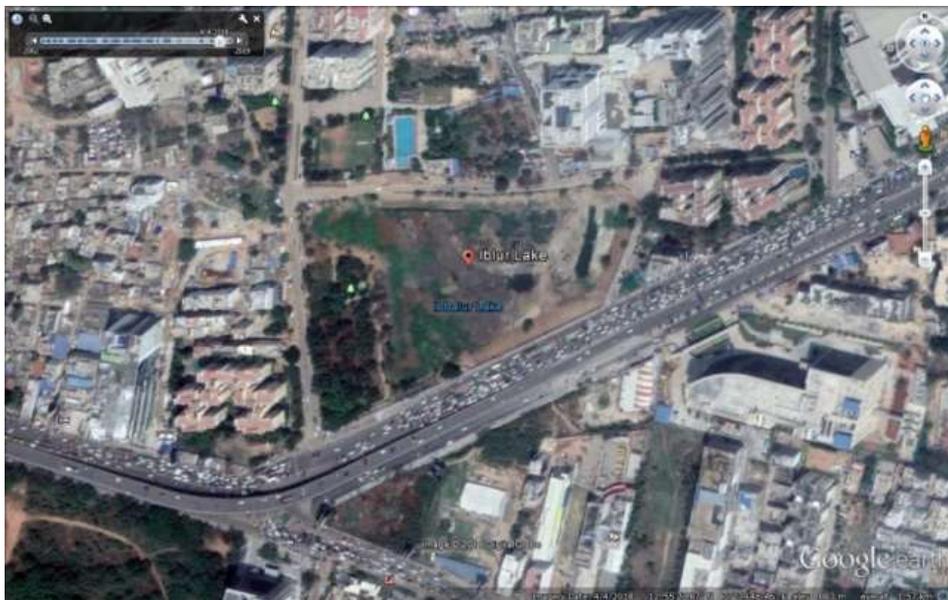
Fig. 13. Dried-up Iblur Lake in 2018

As can be seen from Figure 13 & 14, Iblur Lake was encroached upon for outer ring road, reducing its expanse by more than 50%. Off-late bowing to public pressure and proactive action by responsible stakeholders, the lake was restored back to its original glory in 2019. In 2003-04, 80% of Lakes faced drought, and again in 2006-07 they had dried up with no groundwater to recharge it as complimentary capillary action [13].

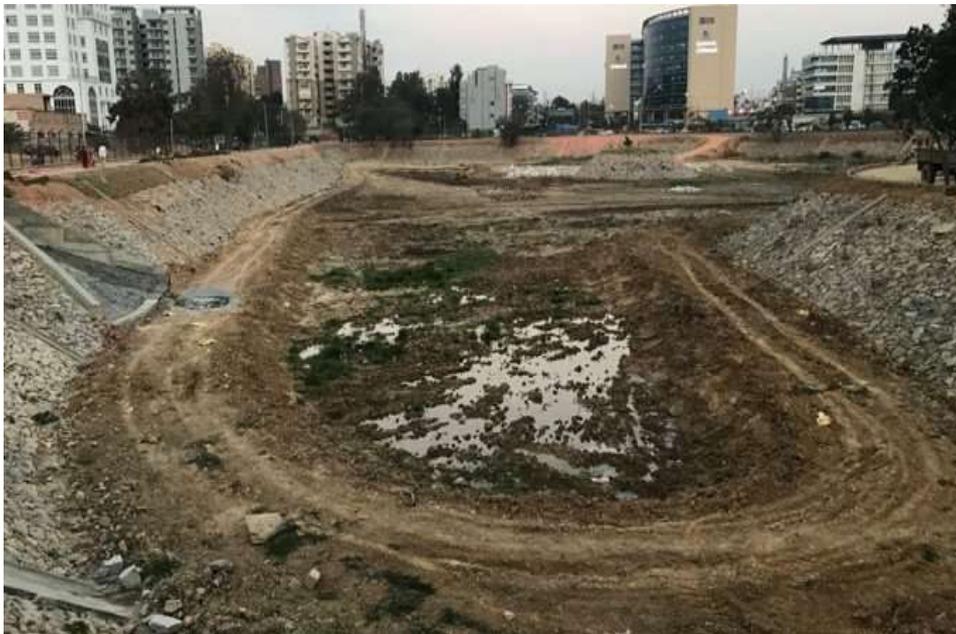
Fig. 14. Iblur Lake restoration in 2018 [Google]

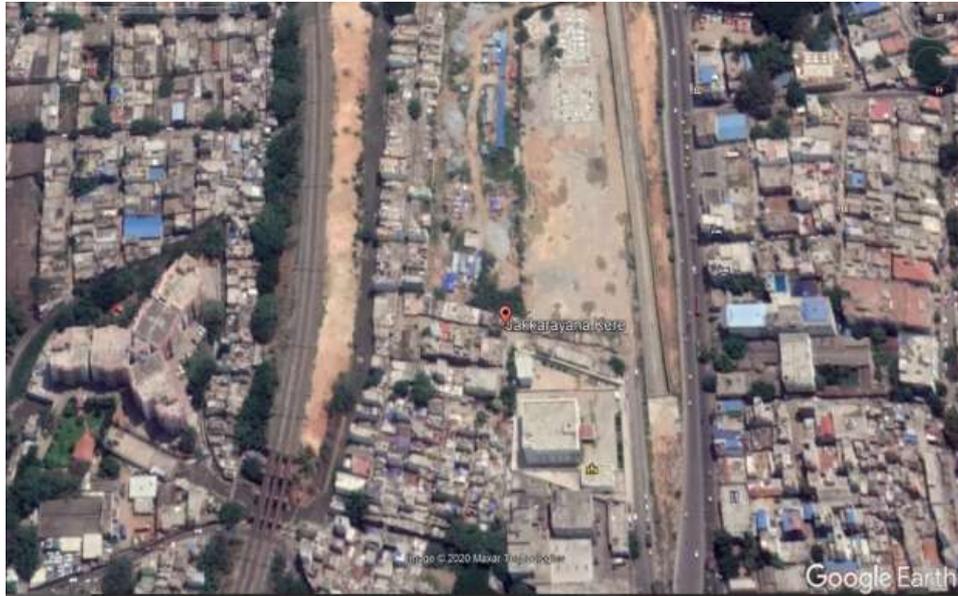
Fig. 15. Lake Loss of Jakkarayana Lake

The case of Jakkarayana Lake and Koramangala Lake is even more dreadful, as they have totally disappeared from the face of Bengaluru; with transformations into urban built-up structures and layouts. The same has been depicted in Figure 15 and Figure 16 respectively.

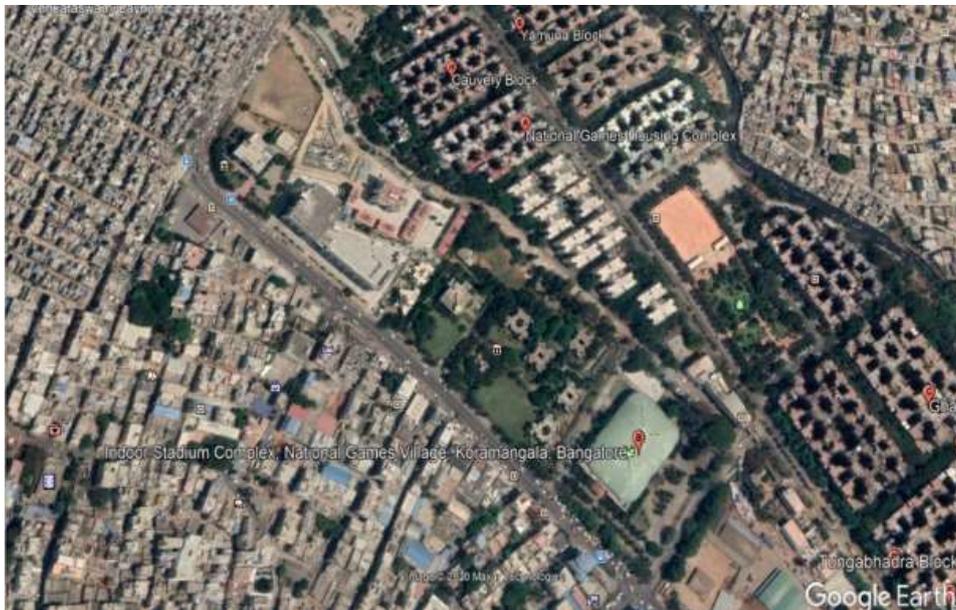
Fig. 16. Loss of Koramangala Lake
