**RECONSTRUCTION OF THE RAILWAY STATION
BUILDING IN ŚWIEBODZICE AS THE AVANT-GARDE
OF THE MODERN RENOVATION.
ARCHITECTURE OF THE BUILDING SPACE IN THE
CONTEXT OF THE CREDIBILITY FEELING SPACE**

Agata GAŚOWSKA-KRAMARZ¹

Faculty of Architecture, Silesian University of Technology,
Gliwice, Poland

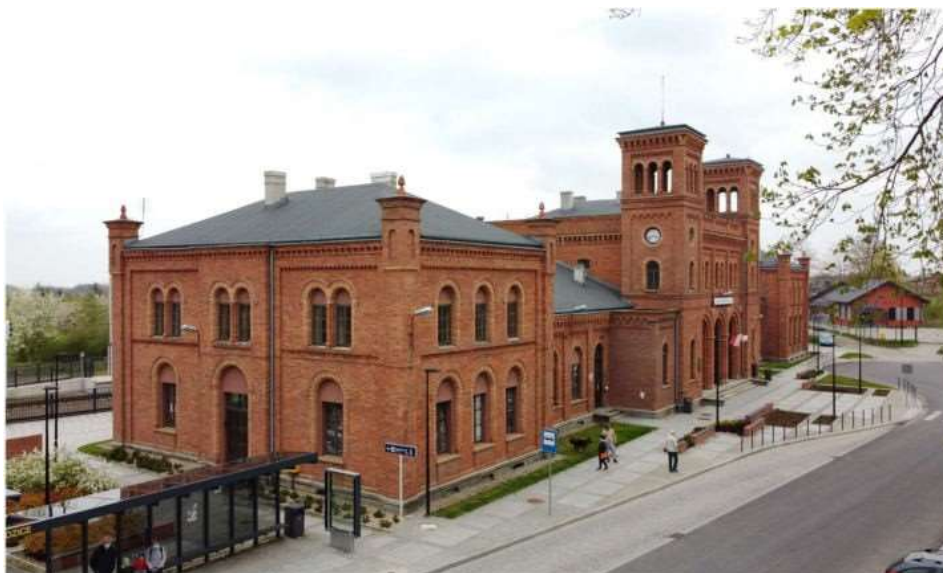
Fig. 14. Bird's eye view after renovation and modernization, photo credit: author, 2021

- Cleaning (grinding) old, damaged paint coatings from the surface of a brick facade.
- Drying and insulation of the wall with the method of hydrophobic blockades.
- Reconstruction of brick threads in places being rebuilt and supplementing or replacing bricks in the places of any defects and gaps in the facade.
- Repair of damaged architectural details.
- Replacing the joints in the wall.
- Hydrophobic impregnation of the brick façade [9].
- The facade before renovation is shown in Figs.11,12. The façades after cleaning and renovation are presented in Figs.13,14.

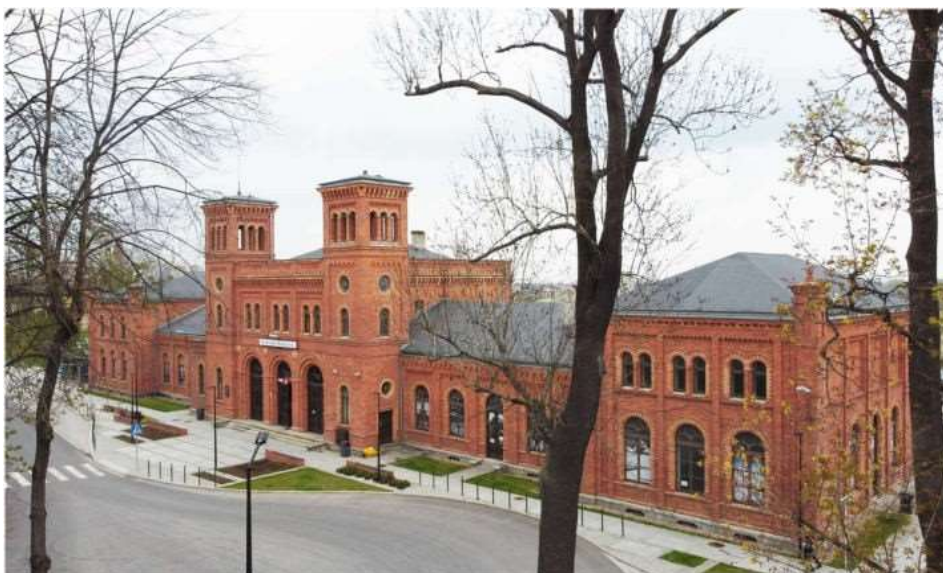
Fig. 15. Bird's eye view after renovation and modernization, photo credit: author, 2021
