## EXPERIMENTAL TESTS OF THE VECTOR II SLAB IN FIELD CONDITIONS, SLAB AND STRIP MODEL

Vector II slab was tested on a natural scale (a slab with a dimension of  $6.30 \times 6.30$  m) and a strip 6.30 m long and 1.20 m wide. The Vector II slab is built by precast panel 60 cm wide, 4 cm thick and 14-20 cm thick concrete overtopping on the construction site. The main purpose of the slab tests on a natural scale was to observe the "faulting" effect and temporary deflections. During the tests, the displacements in the area of the panel joints in the middle of the slab span were recorded. The maximum difference in displacement between adjacent panels of the slab model was 0.16 mm, and the vertical displacement was 1.9 mm. The strip model had no cracks that could indicate a interface cracks between the precast element and the concrete overlay. After completion of the field tests, the load was left on the slab model to verify long-term effects.

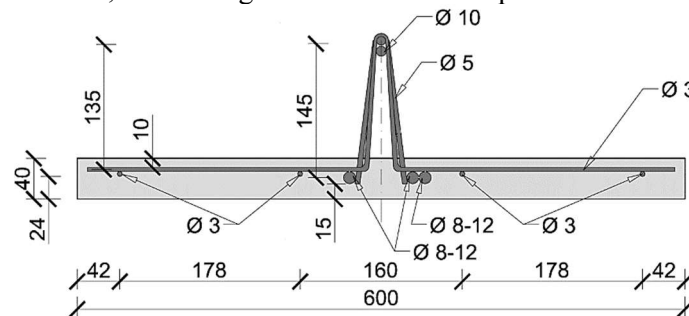
Fig. 1. Vector II cross-section [1]

slabs [1-3]. The Vector slabs are unidirectional structures, consisting of 600 mm wide panels (Fig. 1). The panels have a specially prepared upper surface that meets the requirements of the notched surface [6]. The significant thickness of the concrete overlay concerning the precast element is responsible for the transfer of shear forces between the panels. This provides the basis for drawing adjacent panels into cooperation, similar to the other described prefabricated solutions [4, 7-9].

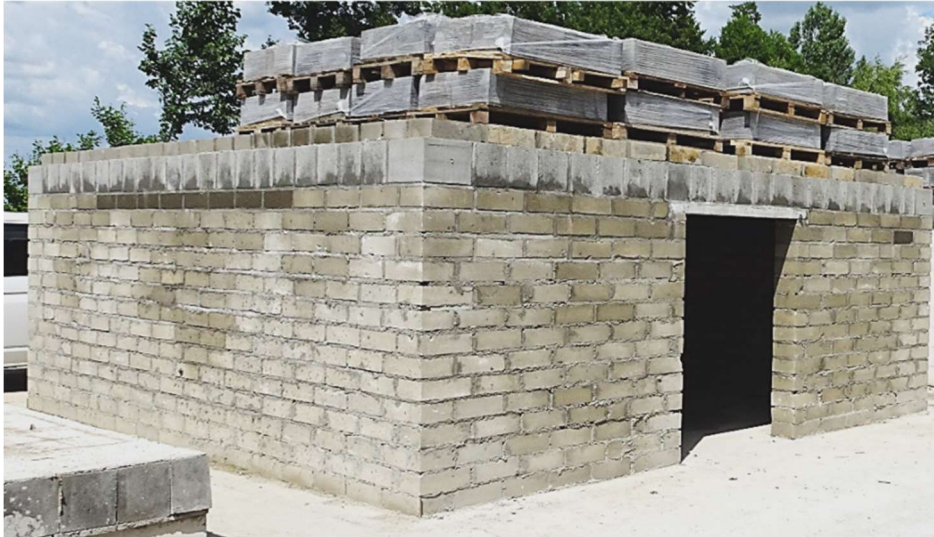
Fig. 2. General view of the model

The tests were carried out on a full-size model of the Vector II slab. The model was made on walls made of 240 mm concrete blocks. Precast ring beam elements are placed on the walls (Fig. 2). Two openings were made in the walls, covered with prestressed concrete system lintels SBN 7.2/12/180 and SBN 12/12/210. The dimensions of the model are  $6.30 \times 6.30$  m, and the total height is 2.24 m (Fig. 4). The slab was designed following the producer guidelines as Vector II 20/60 4.81, where the symbol defines the type and reinforcement of the precast element. The total thickness of the slab was 200 mm (160 mm of concrete overtopping). Both the precast element and the concrete topping were made of C20/25 class concrete. There are two distribution ribs, consisting of an upper and lower bar  $\phi 10$  mm (class C) and stirrups type S  $\phi 6$  mm (made of steel class A), spaced every 300 mm. The distribution ribs were placed on the precast plate (Fig. 3). In the axis of the lattice, support reinforcement was made of one  $\phi 10$  mm rebar ended with a straight hook in the ring beam.

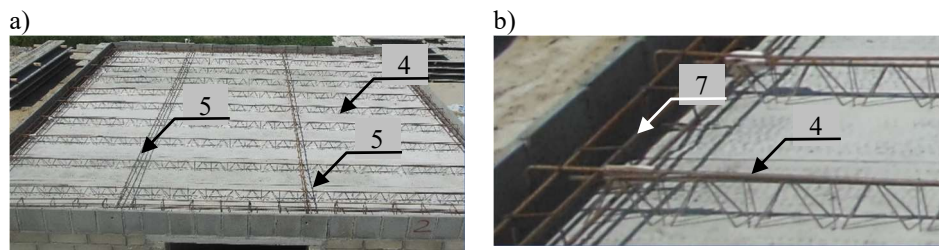
Fig. 3. Research model: (a) Lattice girder panel laying, (b) Lattice girder panel support reinforcement

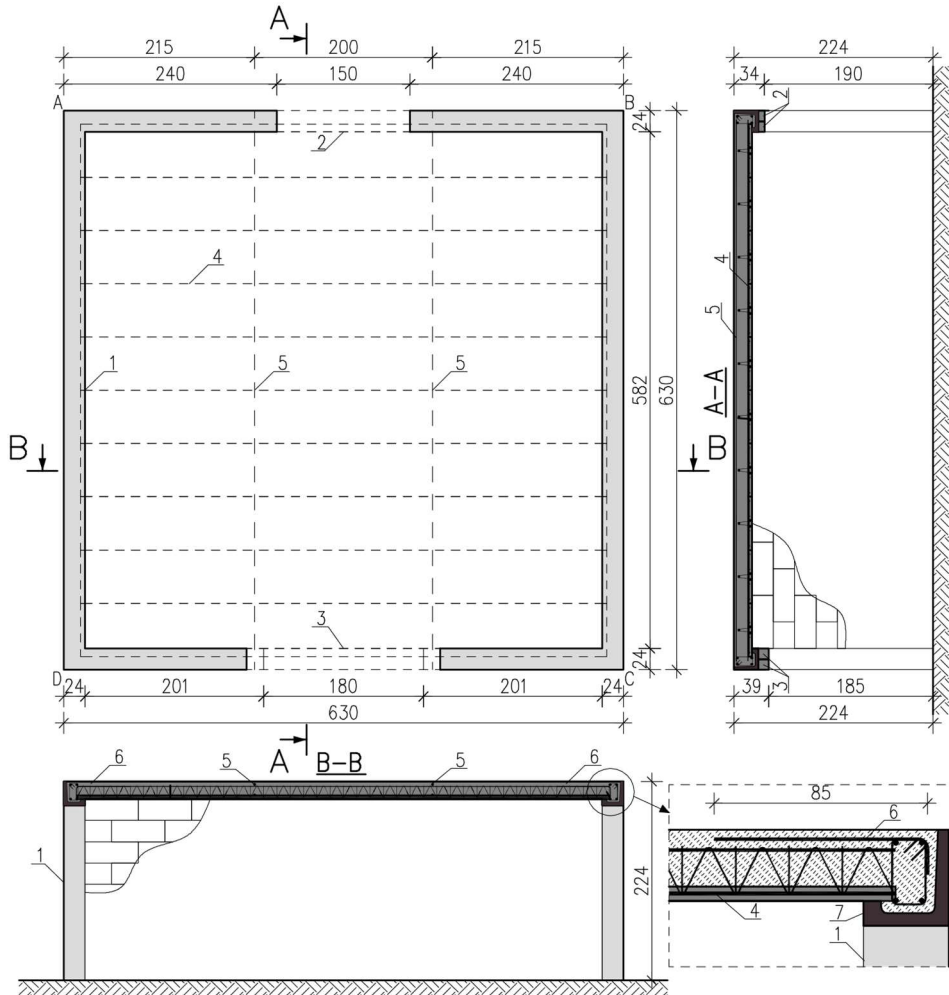
Fig. 4. Geometric dimensions: top view, A-A cross-section, B-B cross-section (1-wall, 2-lintel  $2 \times$  SBN 7,2/12/210, 3-lintel  $2 \times$  SBN 12/12/180, 4- Lattice girder panel, 5- distribution ribs, 6- support reinforcement, 7- precast form)

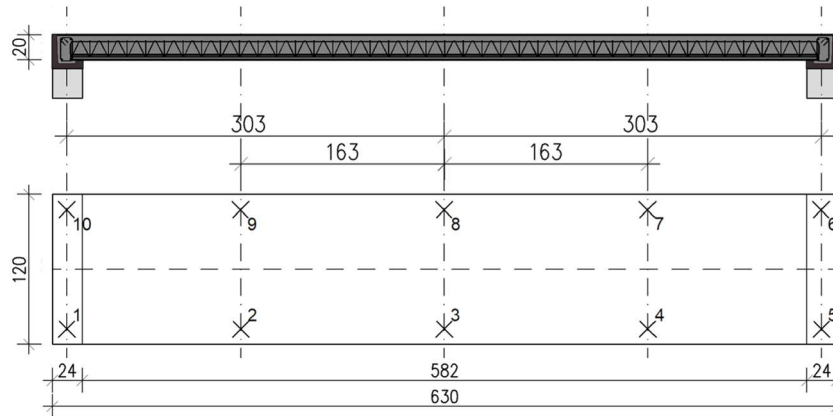
Fig. 5. Cross-section of the strip model with measurement points

The same type of Vector II panels was used to make the strip model. The strip model is based on two edges (Fig. 5), achieving a one-way work, consistent with the producer design tables. The total length of the panel was 6.30 m and a width of 1.20 m - two Vector II panels. A 160 mm thick concrete overlay was made. Different support reinforcement was used, one of the supports had bars anchored from the top surface in the rim (Fig. 6a) with the upper bar ended with a hook in

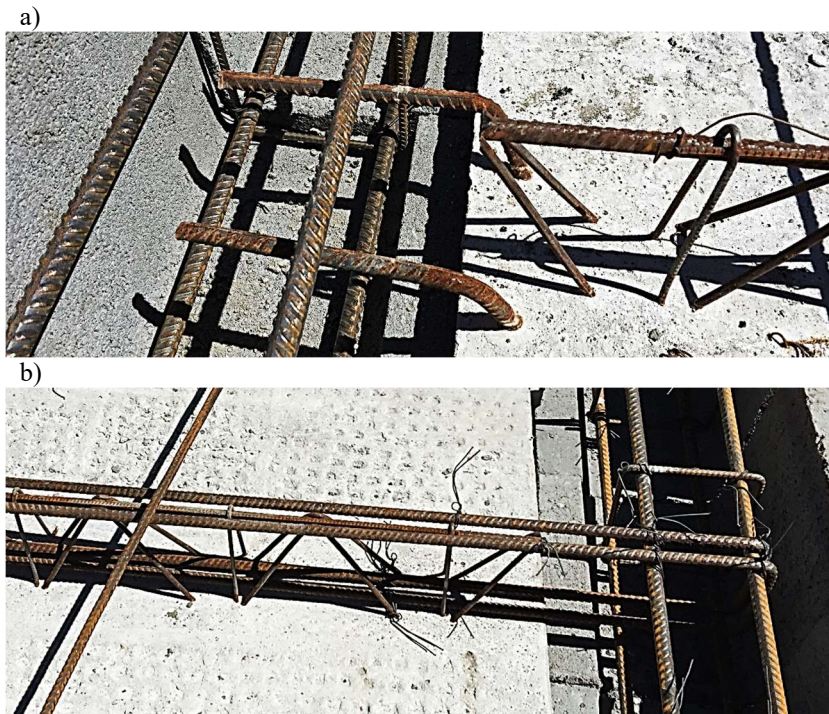
Fig. 6. Support reinforcement: a) rebars anchored from the top surface, b) U-type rebars

the rim, and the other U-type bar (Fig. 6b) played onto the surface of the precast element. The panels did not rest on the ring beams but ended up touching them.

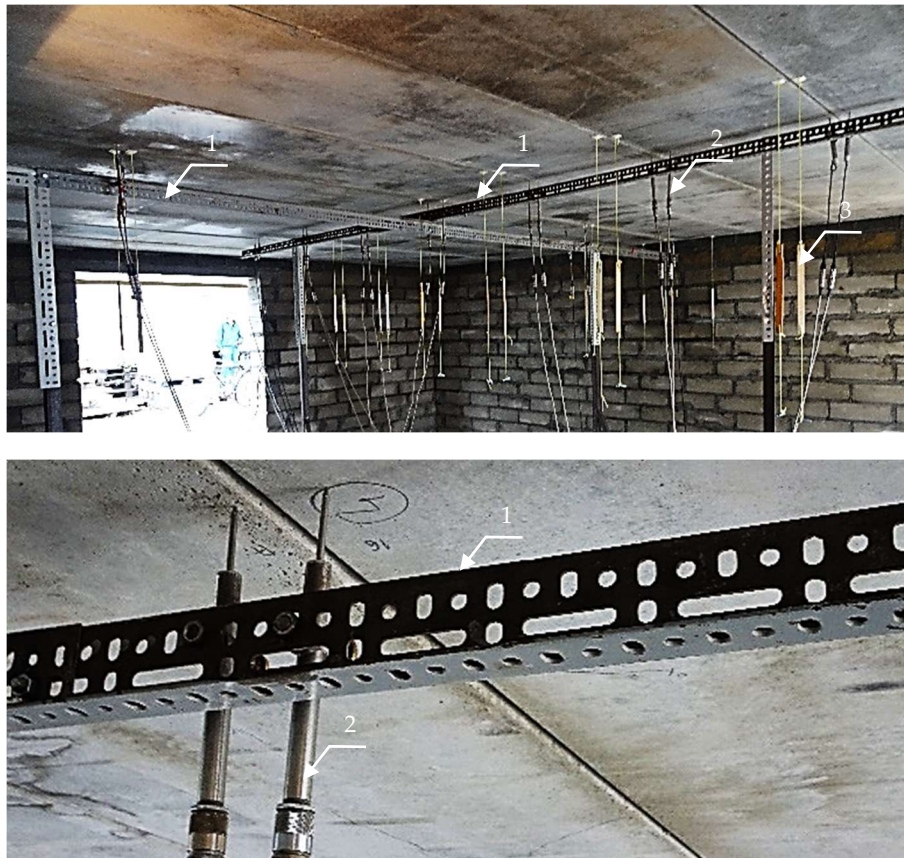
Fig. 7. Overall view of inductive sensors arrangement: 1- steel frame, 2- LVDT sensor, 3- geodetic marker

Short-term displacements were recorded using linear displacement transducers (LVDT) of the PJX-10 and PJX-20 type with the accuracy of indications equal to 0.002 mm. The sensors were attached to a steel frame support on a reinforced concrete slab (Fig. 7). Fig. 8 shows the arrangement of the sensors along the axis of the door openings and the joint of the middle panels. The sensors were placed approximately 25 mm from the panel joint; the distance between adjacent sensors was about 50 mm. In the strip model, displacements were measured in a geodetic manner in points located on the upper surface of the model (Fig. 5). The accuracy of the measurements was 0.5 mm.

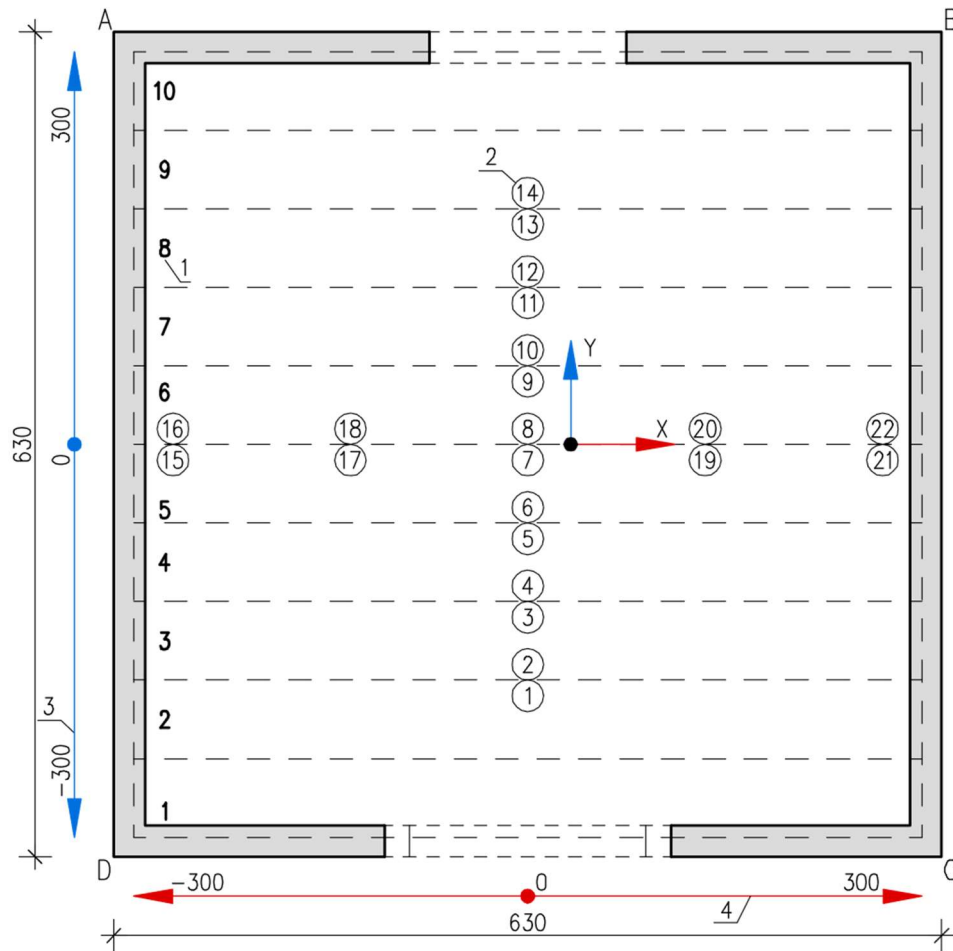
Fig. 8. Arrangement of the transducer and geodetic sensors for measuring vertical displacements on the lower surfaces of the tested slabs: 1- plate number, 2- sensor number, 3- measurement direction transverse to the main direction of the panels (Y-axis), 4- measurement direction along the length of the central panels joint (X-axis)

The results of the test were presented in the form of diagrams of displacements in measurement locations, the location of which is shown in Fig. 8. Fig. 12 shows the values of slab displacements along the Y-axis from each load scheme. Along with increasing the value of the load, the displacements gradually increased. Despite the significant relief of the slabs 1-5 and the transfer of part of the load (diagram K, L) to the slabs 6-10, no reduction of the lightened part of the slab was observed. With the last load scheme, the maximum displacement was 1.9 mm, and the difference in displacement between adjacent sensors was 0.16 mm for the scheme I (Fig. 13).

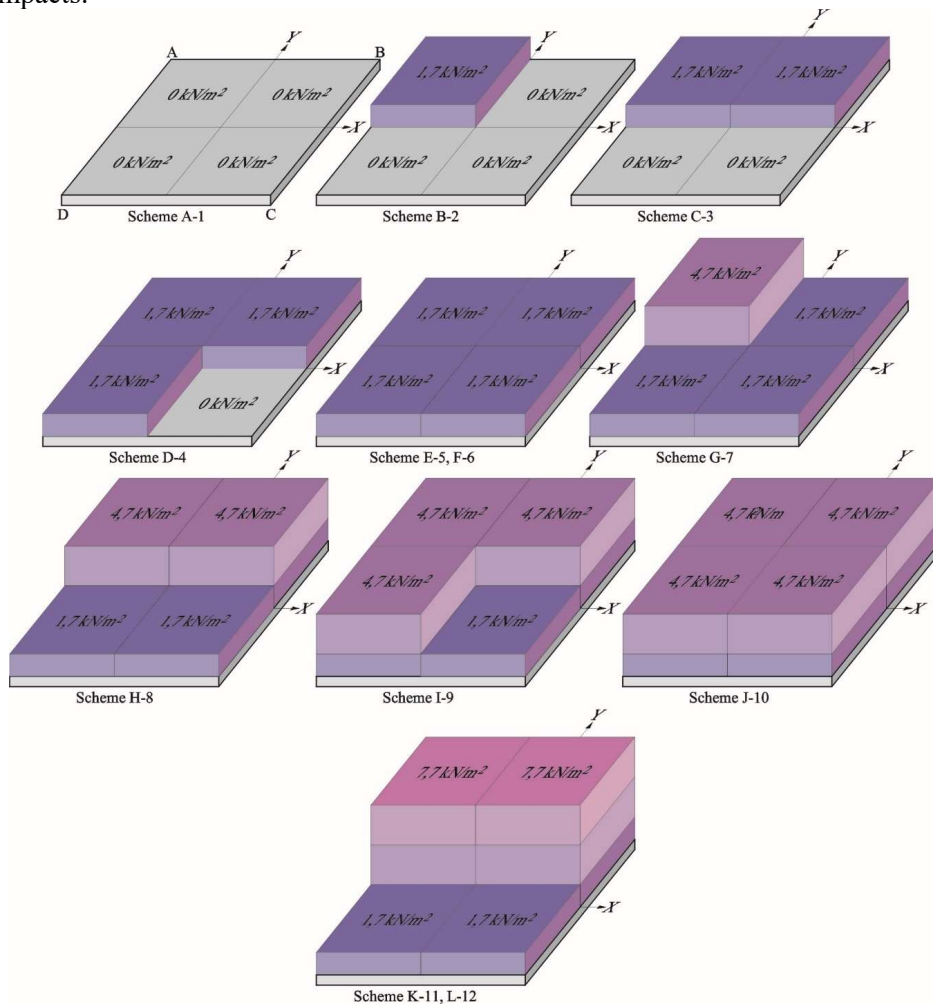
Fig. 9. Load schemes

The model was loaded by concrete blocks according to the established schedule. The total load above the self-weight of the slab with a value of  $4.7 \text{ kN/m}^2$  was divided into two parts:  $1.7 \text{ kN/m}^2$  (concrete blocks) and  $3.0 \text{ kN/m}^2$  (pallets with concrete blocks). The load was applied, as shown in Fig. 9. The view of selected load schemes is shown in Fig. 10. Displacement readings were performed each time 15 minutes after the load was placed. Schemes F and L were a continuation of the earlier schemes E and K, with the displacement readout being carried out in an hour interval. The last scheme was left for one year to verify long-term effect impacts.

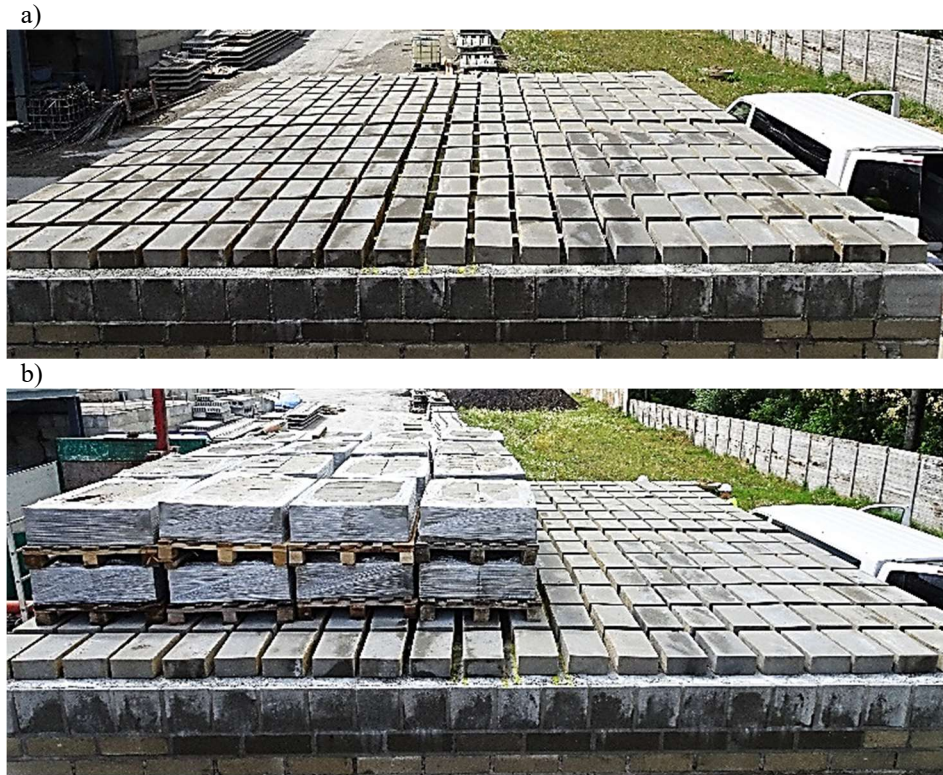
Fig. 10. Load scheme: a) E, b) K, L

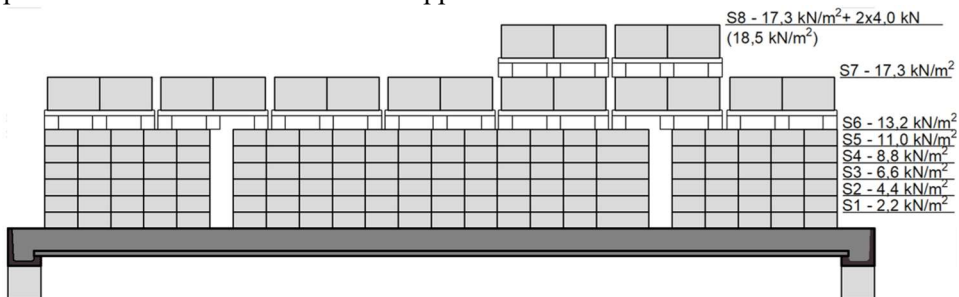
Fig. 11. Strip model load schemes

The load of the strip model was carried out by concrete blocks (Fig. 11). In the first six schemes, the layers of blocks were arranged, achieving a total uniform load equal to 13.2 kN/m<sup>2</sup>. Then, in Scheme 7, pallets with blocks were placed, obtaining a total uniform load of 17.3 kN/m<sup>2</sup>. In scheme 8, additional pallets were placed next to one of the model's support zones.

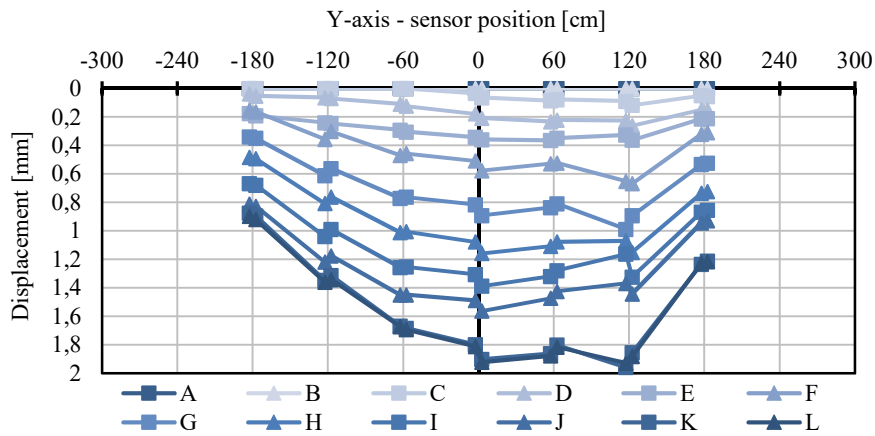
Fig. 12. Displacements in the Y axis - transverse to the plates

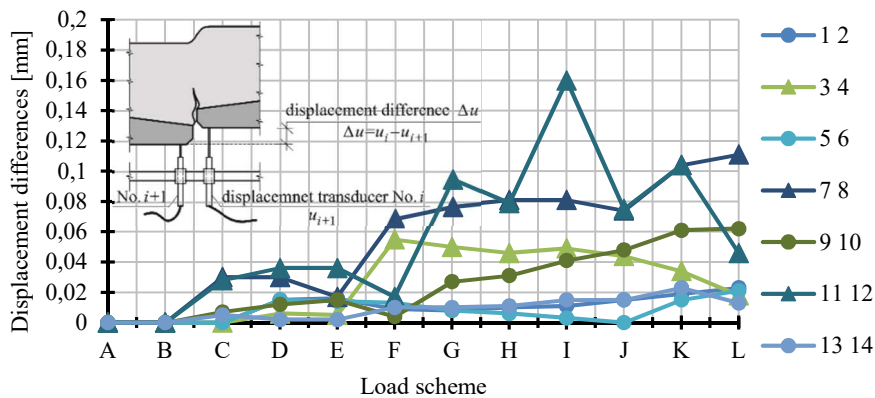
Fig. 13. Displacement difference between sensor pairs

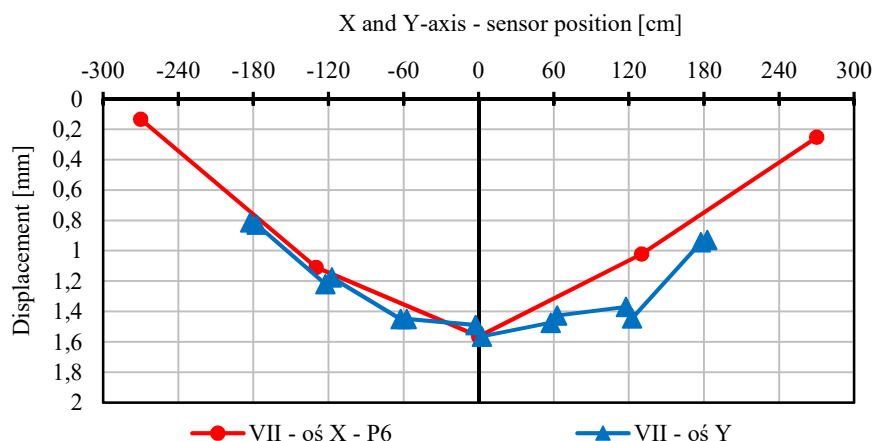
Fig. 14. Comparison of displacements of the X and Y axis (plate 6) - scheme J

Fig. 14 shows a comparison of the charts of displacements in the X and Y axis (plate no. 6) for the scheme J - uniform load on the entire surface. The curve of the displacements in two perpendicular directions undoubtedly indicates a two-way operation of the slab, even in the absence of transverse reinforcement of panels and joints.

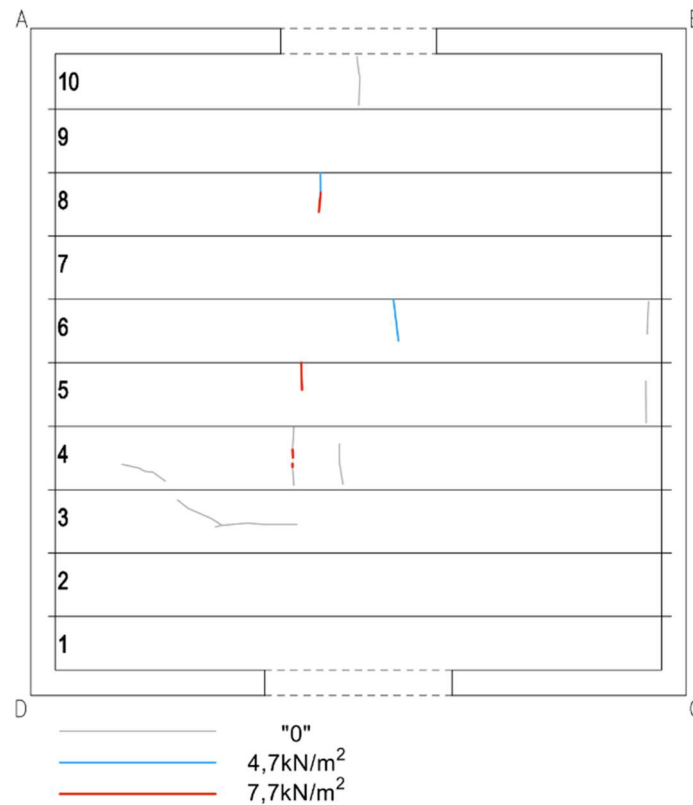
Fig. 15. Crack patterns on the bottom surface

Before starting the tests, the lower surface of the Vector II floor had single cracks with an opening of less than 0.05 mm (Fig. 15). At a load of 1.7 kN/m<sup>2</sup>, no changes were observed on the lower surface. After increasing the load (diagram J), the appearance of new cracks on panels 6 and 8 was noticed. The last control was carried out after transferring the load (diagram L) to half of the slab (panel 6-10), new scratches were observed (panel no.5) and the opening of the existing ones were increased (panels no. 4 and 8). There were no scratches wider than 0.3 mm. A complete inventory of the roof scratches, including the upper surface, and possible interface crack (by drilling the cores) was planned after the second phase of the research, under long-term loading. During the research, measurements of wall deformation and lintel displacement were also performed. The measured values of deflection of the lintels did not exceed 0.1 mm. No impact of openings in the walls supporting the ceiling on the scratch pattern in the floor slabs was found.

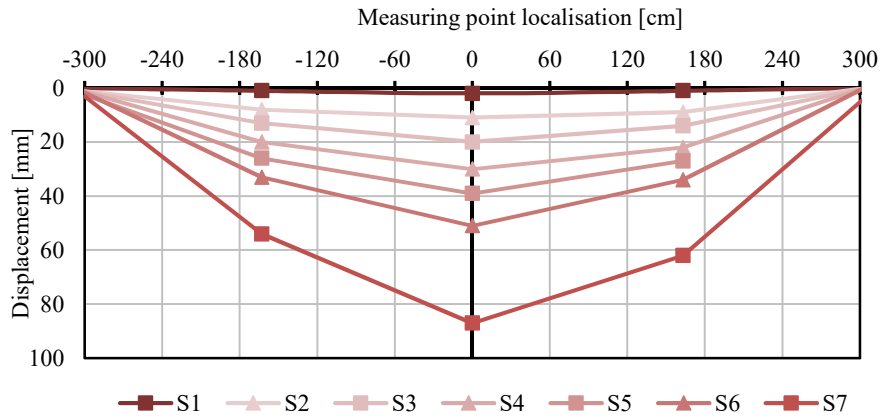
Fig. 16. Displacement of points 1-5 in each of the schemes

The results are presented for the edge covering measurement points number 1-5. The difference in displacements between the edges was not more than 3 mm. The increase was proportional to the load, up to the value of 51 mm at 13.2 kN/m<sup>2</sup> (Fig. 16). After this step, the crack width exceeded 0.2 mm (Fig. 17a). The last complete reading was taken in scheme 7, where the displacement of 87 mm was recorded. The maximum load was over 18.5 kN/m<sup>2</sup>, and its distribution along the panel length was not even. There was a sharp increase in the crack opening in the middle of the panel span (Fig. 17b). With the load under the diagram 8, the maximum displacement of 122 mm was recorded. There were no cracks of the joint between the precast element and the concrete topping in the zone above the support - Fig. 17c. The image of the cracks on the side edge of the model after destruction is shown in Fig. 17d.

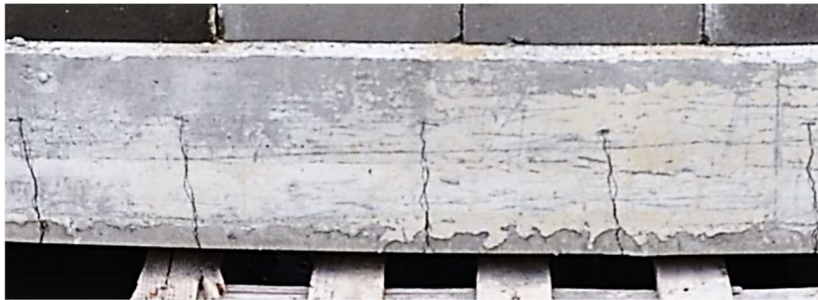
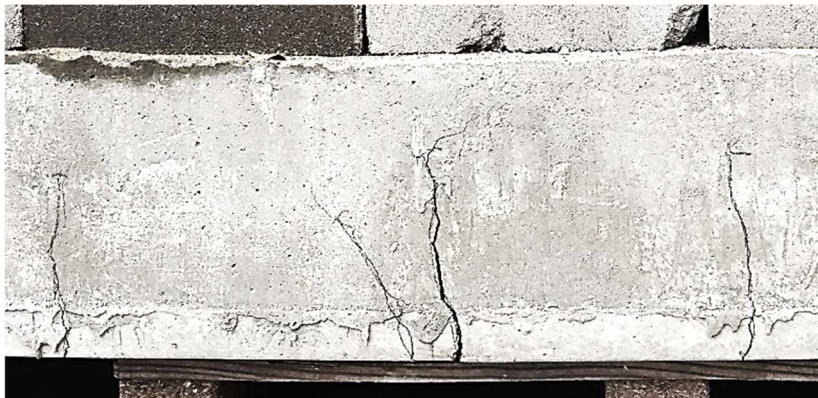
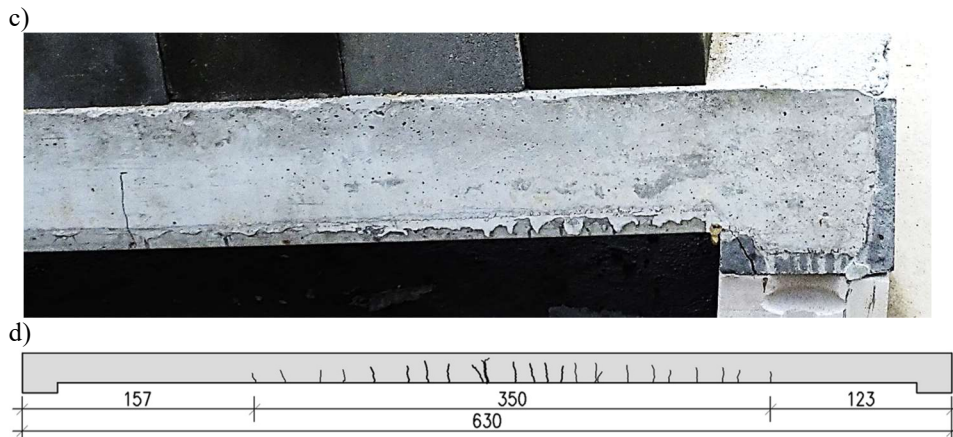
Fig.17. Cracks of the strip model: a) load  $17.3 \text{ kN/m}^2$ , b) crack in the middle of the span after failure, c) cracks near the support, d) view of cracks along the length of the slab after failure

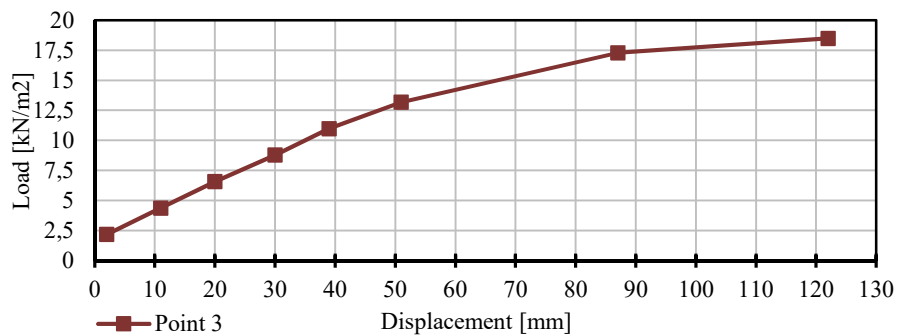
Fig. 18. Displacement of point no. 3

Fig. 18 shows the dependence of the displacement of the midpoint no. 3 on the applied load. The model was destroyed in diagram No. 8 - after adding pallet with a weight of  $4 \text{ kN}$  in the middle of the span. Above the load of  $13.2 \text{ kN/m}^2$ , a significant decrease in the stiffness of the panel was visible, related to the appearance of bending cracks with an openness exceeding  $0.3 \text{ mm}$ .

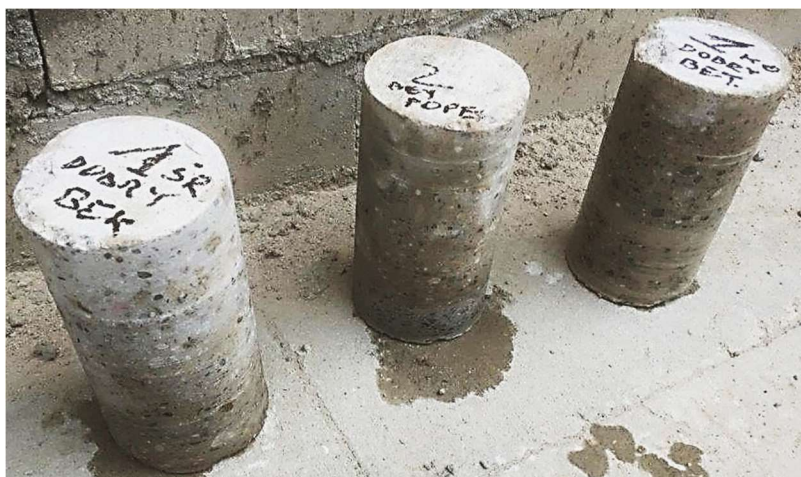
Fig. 19. Cores from the mid-span and support zones

After completion of the tests, five core samples were taken from the panels, which were used for the internal visual inspection of the joint between the precast element and the concrete topping and to determine the compressive strength of the overlay. Based on the performed visual inspection, no interface cracking was found at any point in the model (Fig. 19). Strength tests and then qualification carried out following PN-EN 13791: 2008 showed that the characteristic

compressive strength was  $f_{ck, is} = 29.5 \text{ N/mm}^2$ . On this basis, the concrete overlay can be classified to the strength class C30/37 (against the designed C20/25).
