TECHNICAL PROBLEMS IN THE RENOVATION OF HISTORIC BRIDGES. CASE STUDY – ROAD BRIDGE IN CIGACICE

A b s t r a c t

The road bridge in Cigacice is a very good example of and testimony to the level of knowledge and skills in interwar engineering art. The bridge is almost 100 years old, put to use in 1925, and was designed and manufactured by Beuchelt & Co. in Zielona Góra. The bridge has 10 spans with a parabolic main span, and the supporting structure for the spans is made of steel lattice girders. The object has been strengthened and modernized several times. Currently, renovation works are also being carried out, resulting from identified unfavorable corrosion of the steel elements of the bridge and the concrete bridge slab. The historic steel structure and the bridge supports are being renovated according to the conservation recommendations.

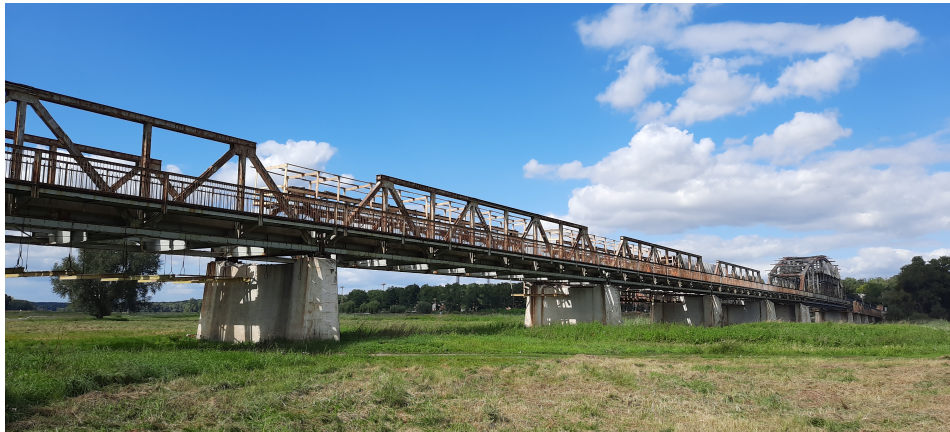
Photo 2. Bridge in Cigacice. South-east view

The Monbart Bridge is a 384-meter crossing over the Oder River, along the district road no. 1187F, and connects Zielona Góra with Cigacice. It is a 10-span structure with a static diagram of a simply-supported beam (Photo 2).

The first five spans (counting from the Zielona Góra side) are 33.8 meters long and 4.0 meters high, followed by a navigable span with a length of 87 meters and a variable construction height ranging from 6.0 m to 12.0 m, the remaining four spans are 32.0 meters long and of a constant height of approx. 4.0 m [10]. The load-bearing structure of all ten spans consists of steel lattice, made of elements with multi-branch sections, connected with rivets. The lattices (differing in line with the breadth and height of individual spans) are connected in the lower chord with crossheads, which are made of several profiles forming an I-beam section. Then, ledgers are supported on them; in the case of the main span, the height of the ledgers is 616 mm, in the remaining spans, the ledgers are made of 320 mm high sections [10]. On the steel grillage of ledgers and crossheads, a 22 cm thick reinforced concrete bridge slab was made, with smooth steel reinforcement except for the main span, where ribbed bars were also used. The entire steel structure is rested on two abutments (extreme supports) and nine pillars (middle supports).

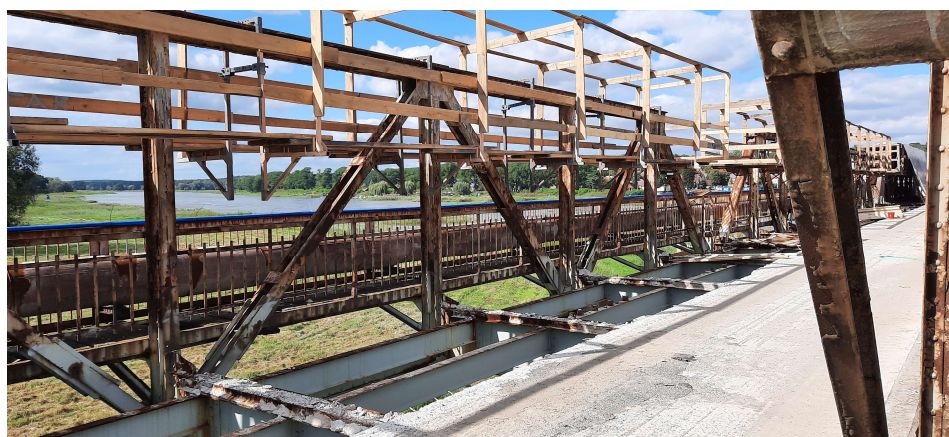
The structure of the bridge did not require excessive interference and only a few elements were replaced. Most of the steel load-bearing elements only had surface corrosion (Photo 3). After cleaning, anti-corrosion coatings were applied and, in agreement with the Lubuski Provincial Conservator of Monuments, the entire structure was covered with a dark shade of gray paint.

Photo 3. Renovation of the bridge steel structure

Elements damaged by pitting corrosion were reinforced with inserts welded using the MIG/MAG method, and in some places (such as the webs of the extreme crossheads over expansion joints), joining with fitted bolts was additionally applied. Due to the poor technical condition of the reinforced concrete bridge slab, it was planned to be replaced with a slab made of concrete, while maintaining the geometry of the existing dilatational slab (Photo 4). The slab was fully reinforced with ribbed steel bars, and the element was joined to the steel structure with steel ledgers welded to the upper shelf. The crossheads were reinforced, the lower braces were complemented, and their fixing was strengthened. The gusset plates as well as the lower chords within the diagonals were strengthened. The missing lower braces were supplemented, and their fixing was strengthened. The damaged posts were restored to their original geometry, and they were also strengthened in sections.

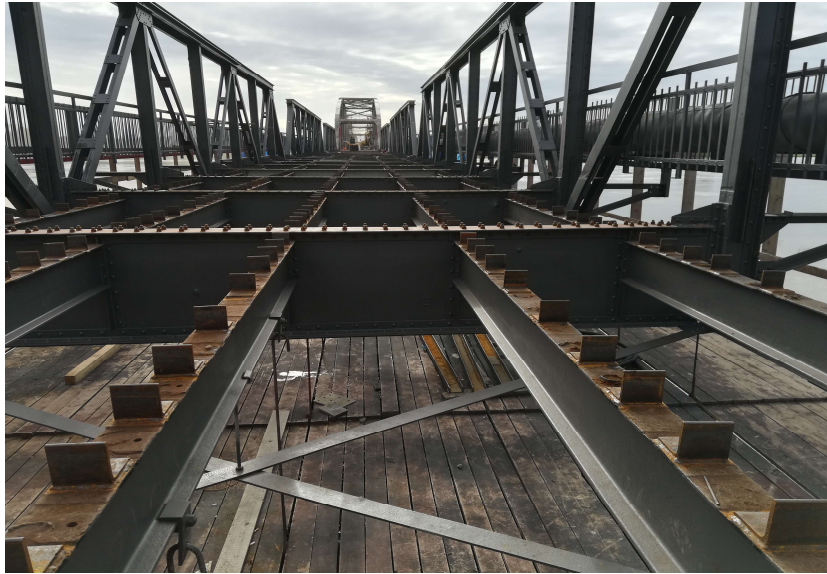
Photo 4. Replacement of the bridge slab

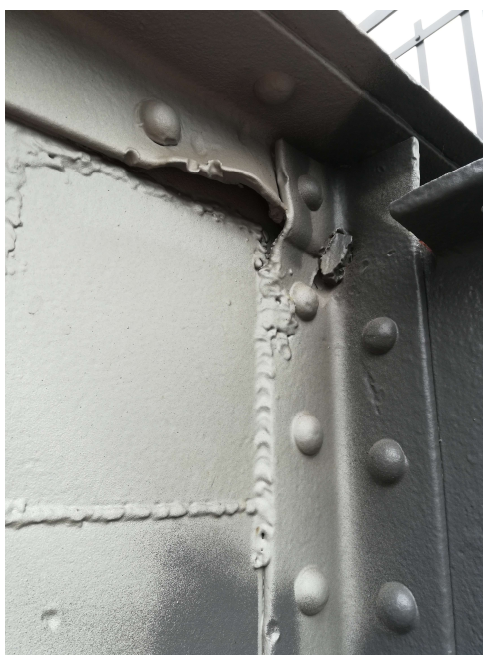
ZOO train shed, Damascus-Baghdad railway, or the bridge in Tylża). Additionally, we have here historical evidence of warfare, which is still visible today on the steel structure elements (numerous dents or slivers - Photo 5).

Photo 5. Visible damage resulting from armed conflicts
