ANALYSIS OF VERTICAL DISPLACEMENTS OF THE ESPERANTO FOOTBRIDGE IN BYDGOSZCZ

The subject of the research is a footbridge across the river Brda in Bydgoszcz. The measurements of the footbridge displacements with the test load were undertaken. The paper presents the results of the measurements and compares them with the theoretical results obtained using the finite element method (FEM). On this basis, discrepancy between actual work of the structure and numerical simulations was found. Attempt to explain the reasons for the observed differences and direction of further research were included in the conclusions.

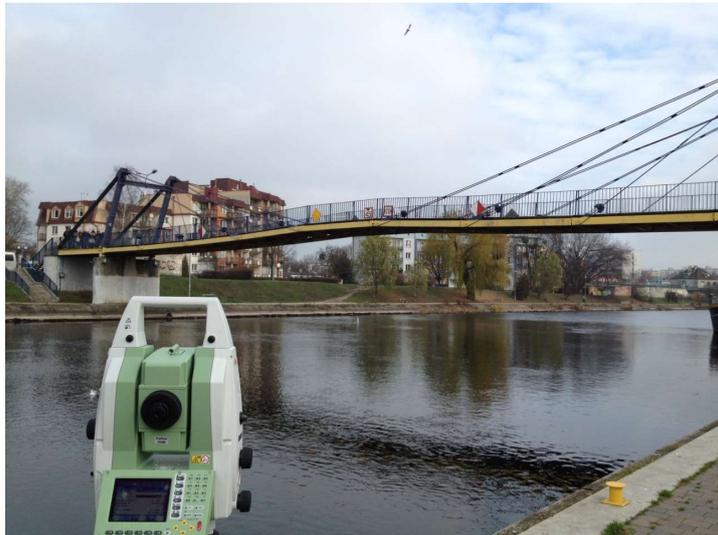
Photo 1. View of the footbridge

The subject of study was the Esperanto footbridge in Bydgoszcz. It is perpendicular to the Jagiellońska street and parallel to the Krakowska street, and is a crossing on the Brda river designed for passers-by and cyclists. It connects the Skrzetusko and Babia Wieś (where the “Łuczniczka” Sport, Show, and Fair Arena is located) districts. The view of the footbridge has been presented in Photo 1.

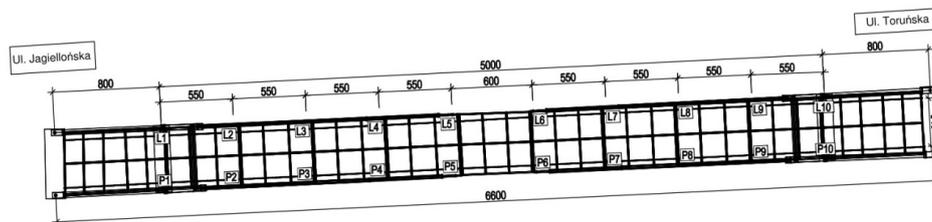
Fig. 1. Plan view of the footbridge

The footbridge is a three-span construction with a suspended steel structure. It consists of spans of the following lengths: 8.00 m + 50.0 m + 8.0 m (Fig. 1). Extreme spans are placed entirely above the riverbanks and the 50.00 m span is the main span. The footbridge has two intermediate supports placed at the edges of the banks and founded on piles. The upward pulling extreme supports are founded on wells and connected to the span structure with bolts. Extreme spans of the footbridge were designed as spans freely supported by reinforced concrete supports. The central span consists of eight segments, each 5.5 m long, and one central segment that is 6 m long. The segments are connected with joints and hanged on stay cables attached to the pylon top. The central segment and the right-bank pre-central segment are connected in a way that allows longitudinal movement. Steel pylons are inclined toward the central span at an angle of approx. 65° from the horizontal plane and supported by intermediate supports using joints, whereas their heads are connected with extreme supports using stays. Total deck width is equal to 4.10 m, the width between handrails is equal to 3.40 m [survey from 1992].

Control points were placed at the outer edges of footbridge spans, above stay cable fixing points. Arrangement of control points and load application points has been presented in Fig. 1 and Fig. 2. Control points on the left lane of the footbridge were labelled with the letter L, those on the right lane – with the letter P, and load application points were labelled with letters A through H. Movements of points were recorded from two positions located outside the studied structure, placed on a sturdy foundation: from the S1 position for loads A through D and from the S2 position for loads E through H.

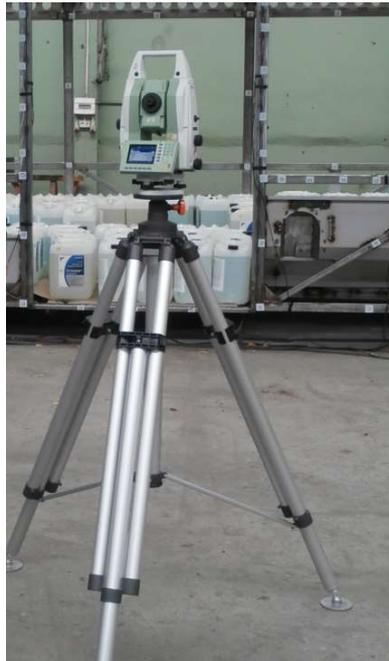
Photo 2. Coordinate laser station of the Leica brand, model TDRA 6000

Measurements were performed with the Leica TDRA6000 laser station (Photo 2) from two points located at footbridge abutments using the trigonometric method. The device is able to provide accurate measurement to 1.5" RRR prism that allows determining vertical displacements with a 0.2 mm accuracy [1].

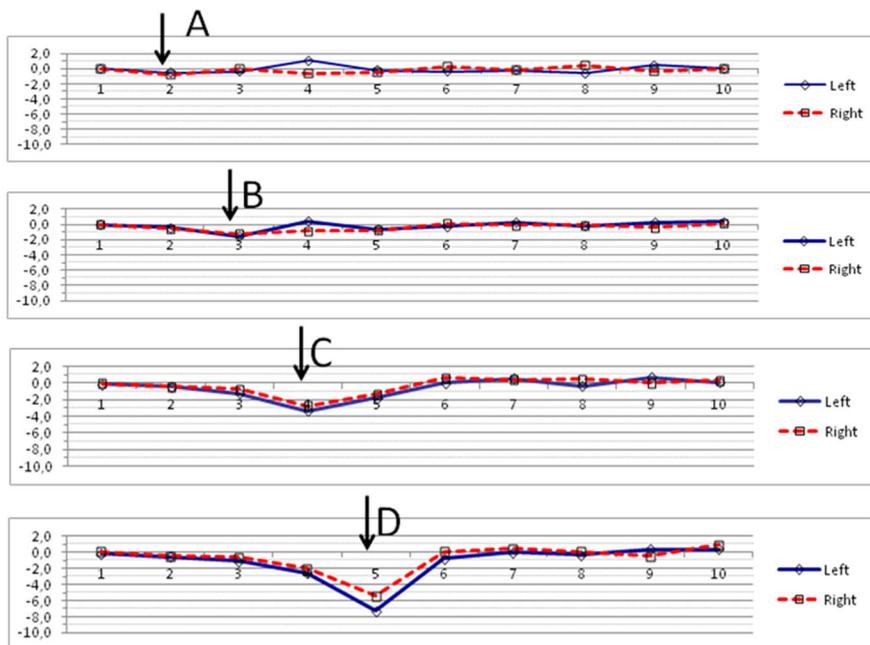
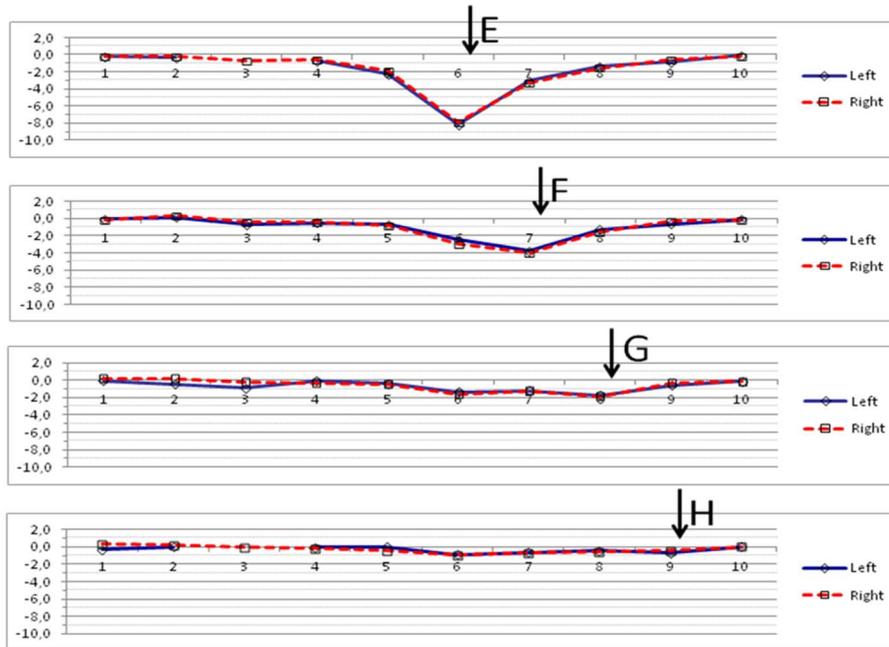
Fig. 4. Charts for recorded displacements of control points

Displacements of control points have been presented in Table 1. Graphical representation of displacements has been shown in Fig. 4.

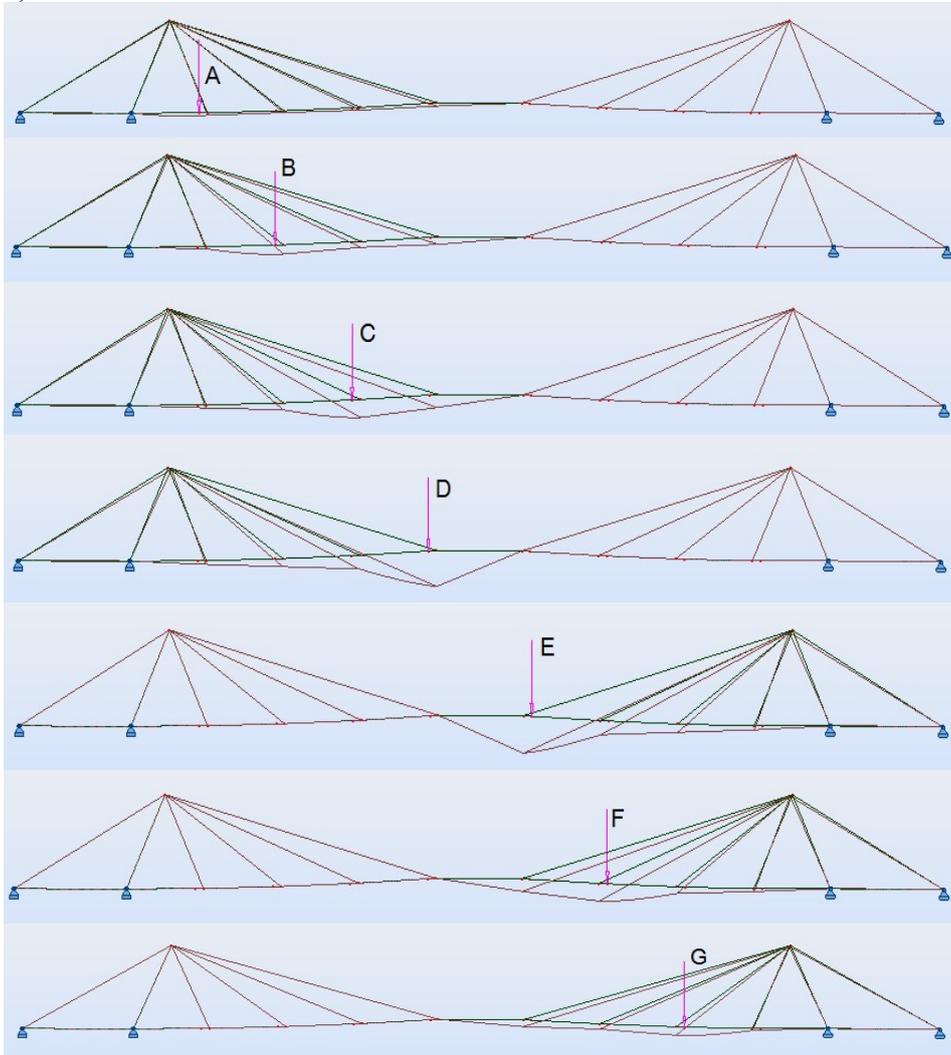
Fig. 5. Visual representation of displacements in the theoretical model, a) node numbers, b) displacement map for load patterns A through H

The theoretical model of the footbridge was developed in the Autodesk Robot Structural Analysis software. Results of control point displacements have been listed in Table 2. Visual representation of displacements has been shown in Fig. 5.

1. In theoretical calculations, footbridge displacements in all cases were achieved only on the half where load had been applied. It is reasonable as displacements of particular segments of the main span are the result of elongation of stay cables and displacement of top nodes of pylons (there are no such displacements or deformations noted at the unloaded part of the footbridge). The map of measured displacements is different from that of

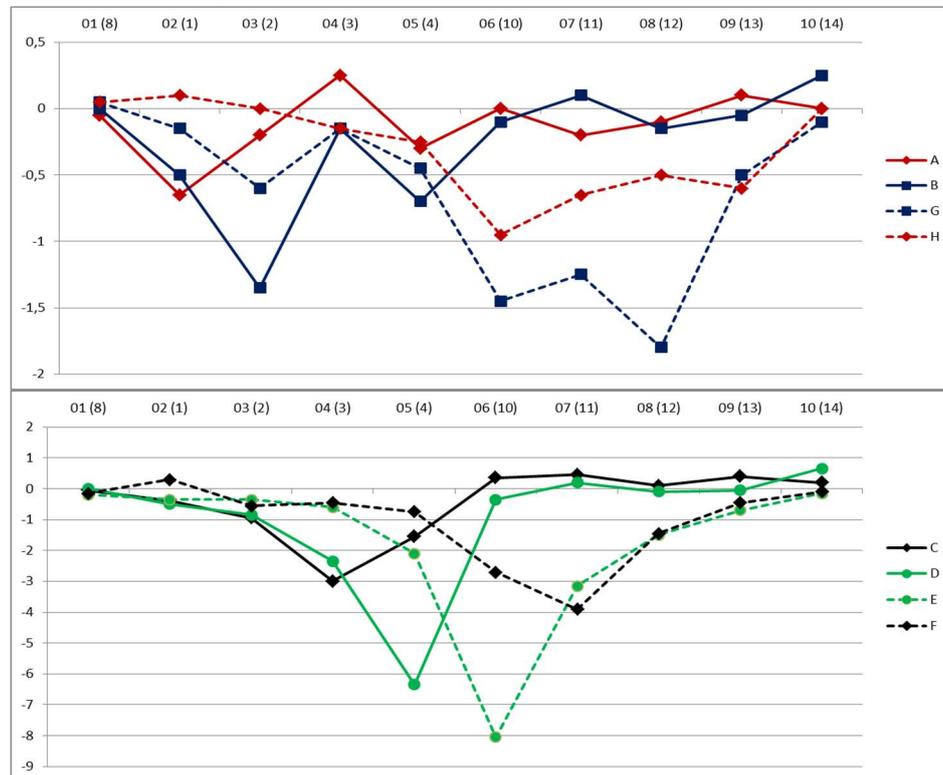
Fig. 6. Distribution of average displacements along the footbridge axis for particular load patterns

During analysis of distribution of measured vertical displacements in the footbridge along its axis, average values of these displacements in particular

cross-sections have been used. Displacements for the entire structure have been presented in the following chart (Fig. 6).

Lines of the same colours in Fig. 6 should be close to symmetrical, i.e. the line for load A (red solid) should be symmetrical to the line for load H (red dotted), the line for B (dark blue solid) should be symmetrical to the line for G (dark blue dotted), etc. The anticipated symmetry is not present. What is observed instead is that values of footbridge displacements occurring when load is applied at the side closer to Toruńska street (load patterns E÷H) are greater than values of displacements occurring when load is applied at the side closer to Jagiellońska street (load patterns A÷D).

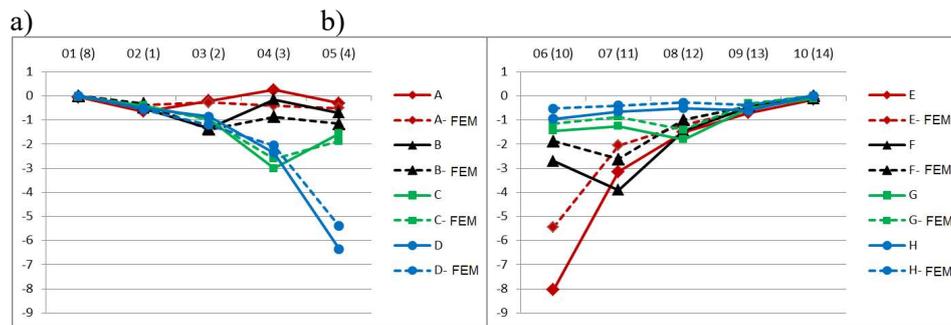
Fig. 7. Comparison of measured (average) displacements and calculated displacements, a) for the half of the footbridge closer to Jagiellońska street, with load on that side, b) for the half of the footbridge closer to Toruńska street, with load on that side

In addition, relationship between values of vertical displacements that were measured and those calculated using FEM were analysed. The analysis included average displacements and referred to the footbridge axis.

Comparing solid and dotted lines of the same colour, it is evident that values of measured displacements are greater than values of displacements calculated using the FEM algorithm. These differences are greater on the half of the bridge closer to Toruńska street, which is a result of their asymmetric distribution shown in Fig. 7.
