## **MONITORING AND NUMERICAL MODELING OF A ROAD IN LANDSLIDE TERRAIN**

Janusz P. KOGUT<sup>1</sup>, Elżbieta PILECKA<sup>1</sup>, Dariusz SZWARKOWSKI<sup>1</sup>  
Cracow University of Technology, Kraków, Poland

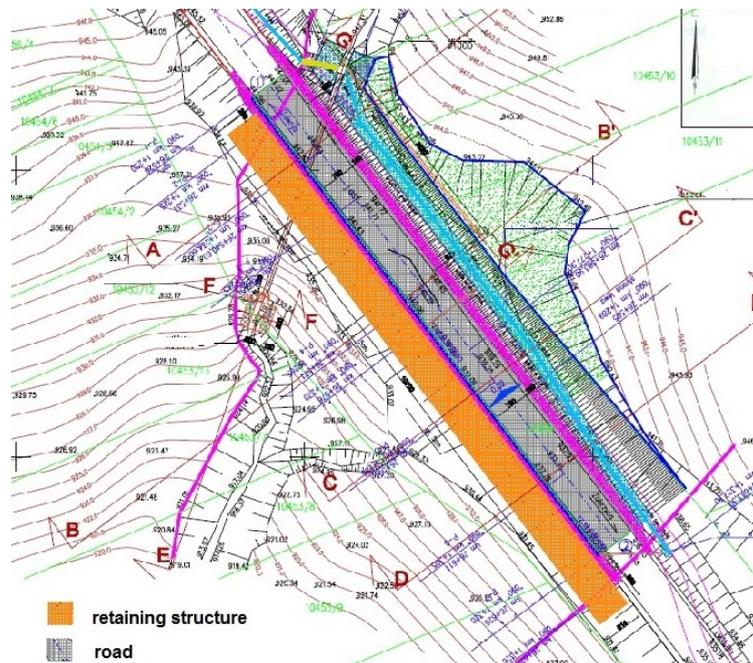
Fig. 2. Plan of development within the landslide and the local road

The landslide consists of a main slope of about 4 m high. In the upper part of the colluvium, there is a local road exposed to soil mass movements. On the asphalt surface, despite the renovation works, one may see the contour of a landslide niche. Above the local road, under the secondary escarpment, there is a zone of large wetlands, additionally supplied with a stream that flows periodically. The road surface is within the range of this zone, where the active part of the landslide is located. The landslide descends to the stream, where it has a height of approximately 5 m. The colluvium area is regularly drained by a surface stream flowing through the culvert under the road, and the stream is at the foot of the slope.

coming from surface water infiltration. The intensity of the filtration is largely dependent on the amount of precipitation. The retaining structure is located along the road, below its edge. It was built in the form of a 20 cm thick reinforced concrete slab. The slab is fixed to the subsoil with ground anchors 40/16. For computations purposes, it was assumed that the probable slip surface is located at a depth of about 7.0 m, while the anchoring was assumed to be in the layer of fine sandstone under the deepest slip surface, as specified by geological documentation. The length of these ground anchors were 15.0 m and 17.0 m. The anchors were spaced 2.0 m apart in both directions and were finished with a 4 m long concrete end. The rods were fixed in a reinforced concrete slab with steel plates measuring 20×20 cm. The retaining structure is divided by a 5 cm wide dilatation into separate segments. Along the road, due to the need to widen the shoulder, the upper edge of each section was finished with a vertical wall thickness of 20 cm. The wall height of 0.60-0.74 was adjusted to the slope of the longitudinal road. In a reinforced concrete slab, horizontally mounted filters Ø 10 cm were placed at a distance of 2 m in both directions. Figure 2 presents the land development within the landslide and road.

As part of the construction, a project to stabilize the landslide and the road was carried out on the 100.0 m long road. A reinforcement of the existing pavement structure, at a width of 7.00 m with both sides of the road paved with widths of 1.60 m and 1.85 m, was performed. The rainwater was drained, in a controlled manner, to two wells and further by the road to the roadside ditches. There is no continuous aquifer in the quaternary area formations; however, the occurrence of water flow within the sandstone clayey deposits was identified. The water is

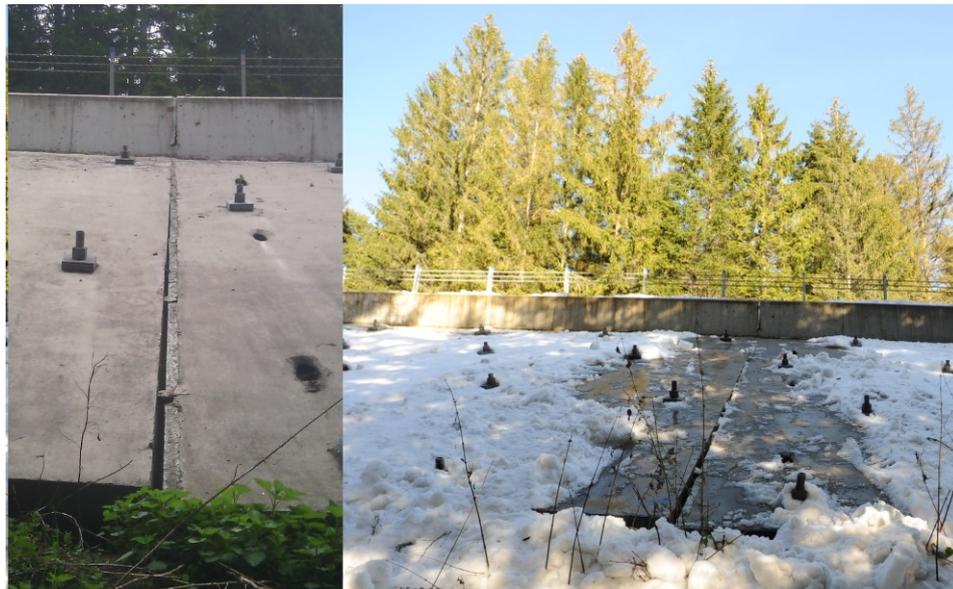
Fig. 3. Section of the failed slab of the anchored retaining structure

After a couple of years of intensive use of the road, considerable displacements were observed from the third, counting from the pass side, section of the retaining structure. The as-built inventory shows that the sections of the retaining structure have been visibly dislocated. The displacement is clearly visible in the upper part of the plate and measures 8 cm horizontally and 3 cm vertically. Figure 3 presents

a picture of the failed slab of the anchored retaining structure from different perspectives, taken during the summer and winter measurement periods on site.

The deformed part of the anchored retaining structure with the critical section is shown in Figure 9. A comparison to Figure 3 gives the reader awareness of the adequacy of the discrete model acquired.

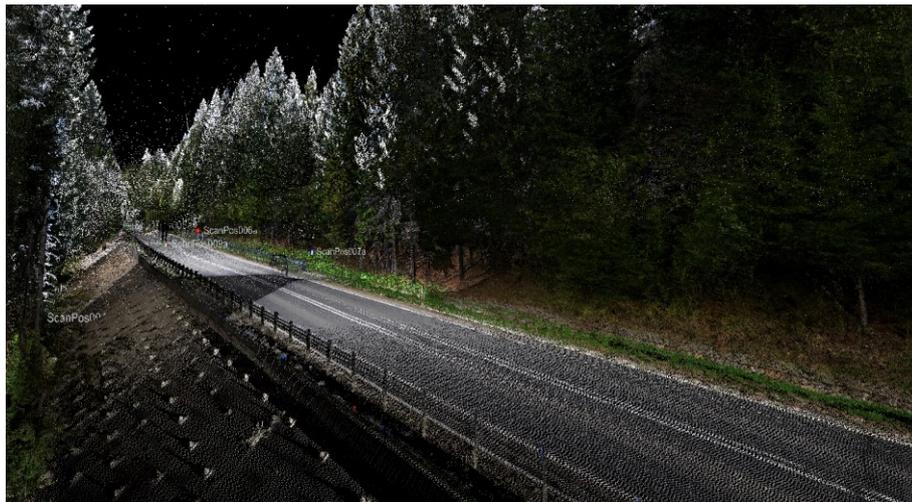
Fig. 4. Terrestrial laser scan within the analysed landslide

As part of the surveying work, a local situation and altitude map of the landslide was made using a Riegl Vz-400 terrestrial laser scanner. The scanner has high speed data acquisition with up to 500,000 measurements/sec, with a wide field of view 100° over 360°. It has a range of measurements up to 800 m, with 5 mm accuracy and precision of measurements about 3 mm. The ordinates were determined using the method of direct survey in the field in the local coordinate system. Figure 4 shows a terrestrial laser scan of the site. It displays an image of the road and the landslide developed using the Riscanpro software package on a stretch of 75 meters. The image obtained, in the form of a cloud of points, may be compared with subsequent scans in order to monitor landslide movements.

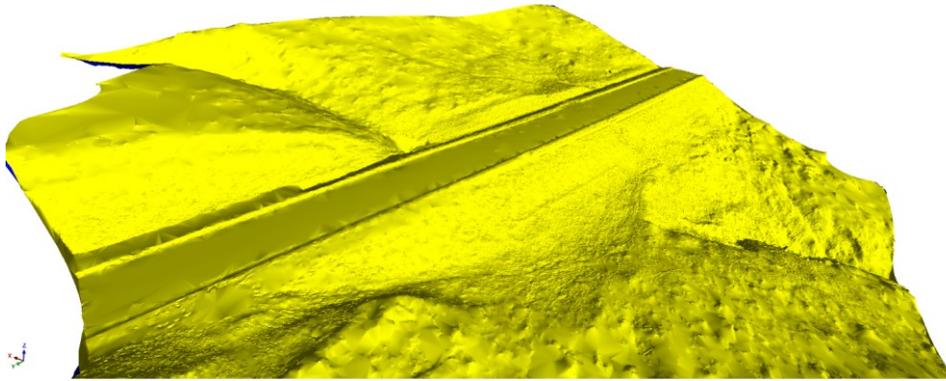
Fig. 5. Laser surface scan of the analysed landslide applied to the numerical model

A terrestrial laser scanner survey allowed us to apply the cloud map of the terrain to the numerical 3D model. Figure 5 presents the surface of the analysed slope with the road and the retaining structure extracted from the scan. The surface was then introduced into the FEA package [7]. It is commonly known that slope failure can occur if the internal shear stresses are greater than the shear strength of the slope soil. A slope stability analysis allowed us to calculate the safety of slope. There are various slope stability analysis methods, namely the Strength Reduction Method (SRM) and Stress Analysis Method (SAM).

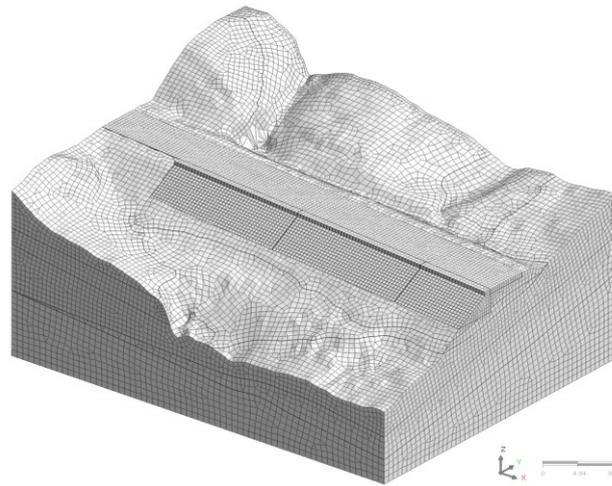
Fig. 6. Spatial FEM model mesh of the terrain with a retaining structure

The model utilized the data from the design documentation about the spatial variability of the subsoil and the soil effective parameters from the tests. The 3D model was built then and loaded with pointed forces corresponding to axles of several trucks, so that the rear axles were directly above the critical cross-section. Figure 6 presents the FEM model. The substrate was discretized by a finite element mesh. The ground anchors were added as pre-stressing cable elements, anchored to the concrete plates by one end and fixed into the substrate at the other. The number of nodes was equal to 120635, while the number of elements was equal to 238703. The number of degrees of freedom was 366813, and the number of equations solved was equal to 337964. Next, the calculations simulating the behaviour of the entire structure along with the ground were carried out by the SRM method in order to estimate the potential displacements and the slip surface. Two cases were considered. In the first case, the entire road was loaded with point loads corresponding to the truck's several axles, so that the rear axles were directly above the critical cross-section. The axle load was equal to 115 kN. Both

lanes were loaded. The SRM analysis was performed and the Factor of Safety was computed.

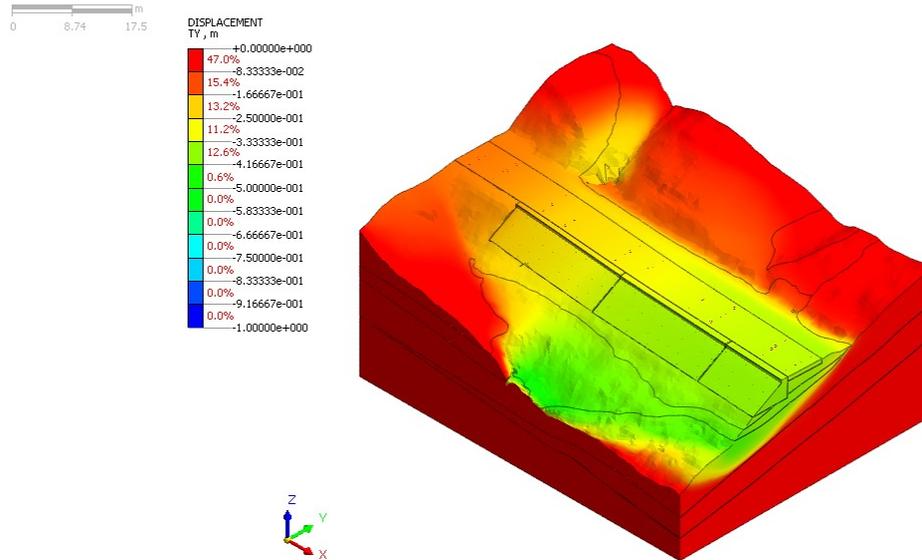
Fig. 7. Horizontal displacements of a numerical model for the Fos = 1.403 (case #1)

Figure 7 presents an exemplary map of the horizontal displacements in the direction perpendicular to the road axis. It corresponds to the Factor of Safety  $Fos = 1.403$ . The minimum Factor of Safety according to the instructions [9] and accepted by preexisting regulations [10] is equal to  $Fos = 1.5$ . Figure 7 also illustrates the potential slip surface of the landslide.

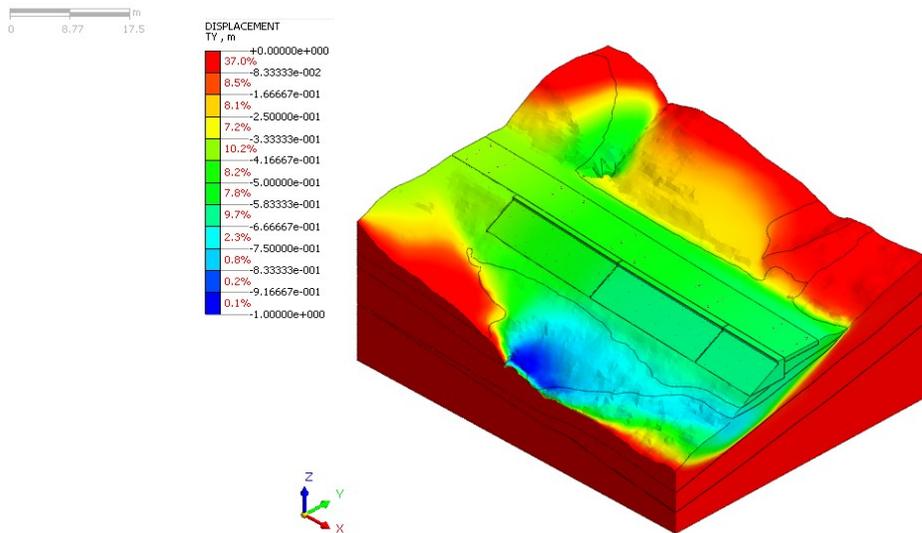
Fig. 8. Horizontal displacements of a numerical model for the Fos = 1.456 (case #2)

In the second case, the part of the road, which is above the critical section, was loaded with point loads corresponding to the truck's axles, on both lanes. The SRM analysis was performed and the Factor of Safety was computed again.

Figure 8 shows a map of the horizontal displacements in the direction perpendicular to the road axis with a corresponding Factor of Safety  $Fos = 1.456$ . Figure 8 also exhibits the potential slip surface, which is similar to the previous one.

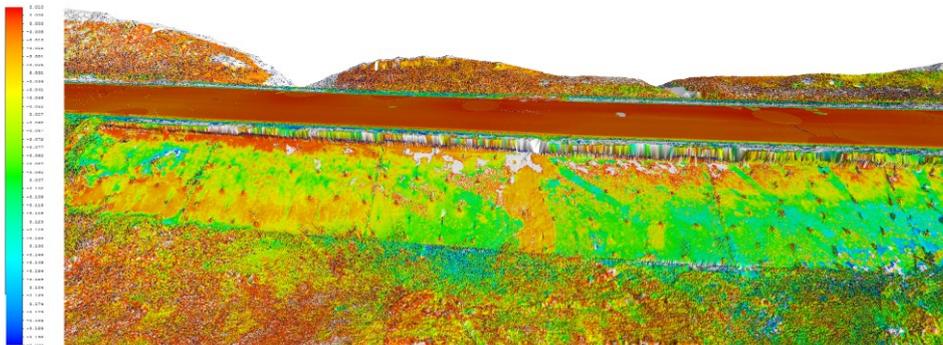
Fig. 10. Differential model of two consecutive laser scans of the road

The slope and the retaining structure are the subject of regular measurements. The terrestrial laser scans are used to make a differential model and observe further landslide behaviour. An example of such a model is presented in Figure 10. Unfortunately, the concrete sections scans in this model are contaminated by snow and verdure, so the only reference is the road surface. It is visible from the picture that the surface seems to be stable with vertical displacements not exceeding 1 cm. The retaining structure deformations do not threaten the stability of the road.
