## **BUILDING RESTORATION OF HISTORIC POOL IN BOLESŁAWIEC: ASSUMPTIONS, DESIGN, REALIZATION**

The present elaboration describes realization of project task, entitled: „Retrieving old function in historic swimming pool, at 52 Zgorzelecka street in Bolesławiec”, it has an influence with taking into consideration the most important problem on ultimate form of rebuilding, on base of present project done by the author of article, as being producer and planner at the same time. It emphasizes architectonic questions in text, concerning forming area, however, it omits solutions of numerous engineering problems (e. g. isolation and draining, etc.). Work project started at the end of 2010 and finished in February of year 2012. Object is in the course of final construction works.

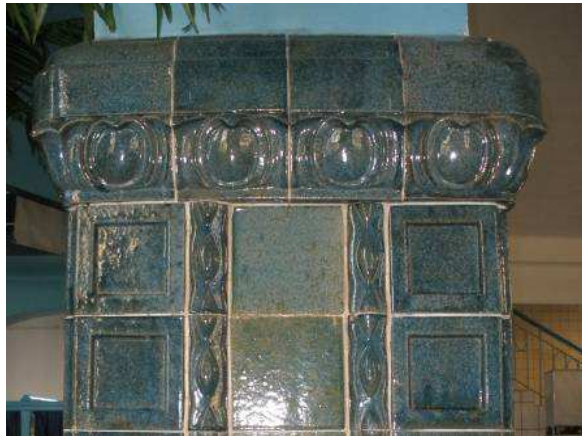
Fig. 4. Head of the pillar ceramic body of the ground floor arcade in the pool hall (*photo by the author*)
