INDICATING VERTICAL DEVIATION OF HISTORICAL BUILDINGS USING GEODETIC METHODS - CASE STUDY OF BRICK AND WOOD TOWER IN NOWE MIASTECZKO

Maria MRÓWCZYŃSKA¹, Sławomir GIBOWSKI²
University of Zielona Gora, Zielona Góra, Poland

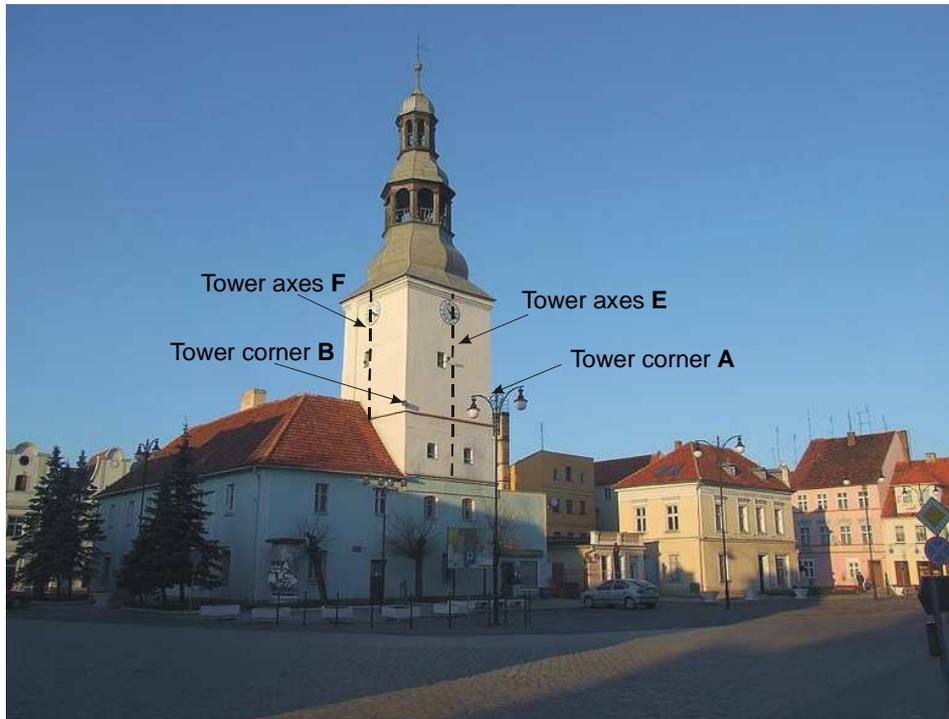
In order to determine the vertical deviation of the tower constituting a part of the Town Hall located on Rynek 2 St. in Nowe Miasteczka, two periodical measurements were taken: prior to the renovation of the tower (March 2010) and upon completing the remodeling works (September 2010). Due to the brick-wooden construction of the building structure, corners A and B located on the brick section of the tower and tower axes marked as E and F were selected for measurements (Fig. 1 and 2).

Fig. 1. Tower corners and axes subjected to measurements

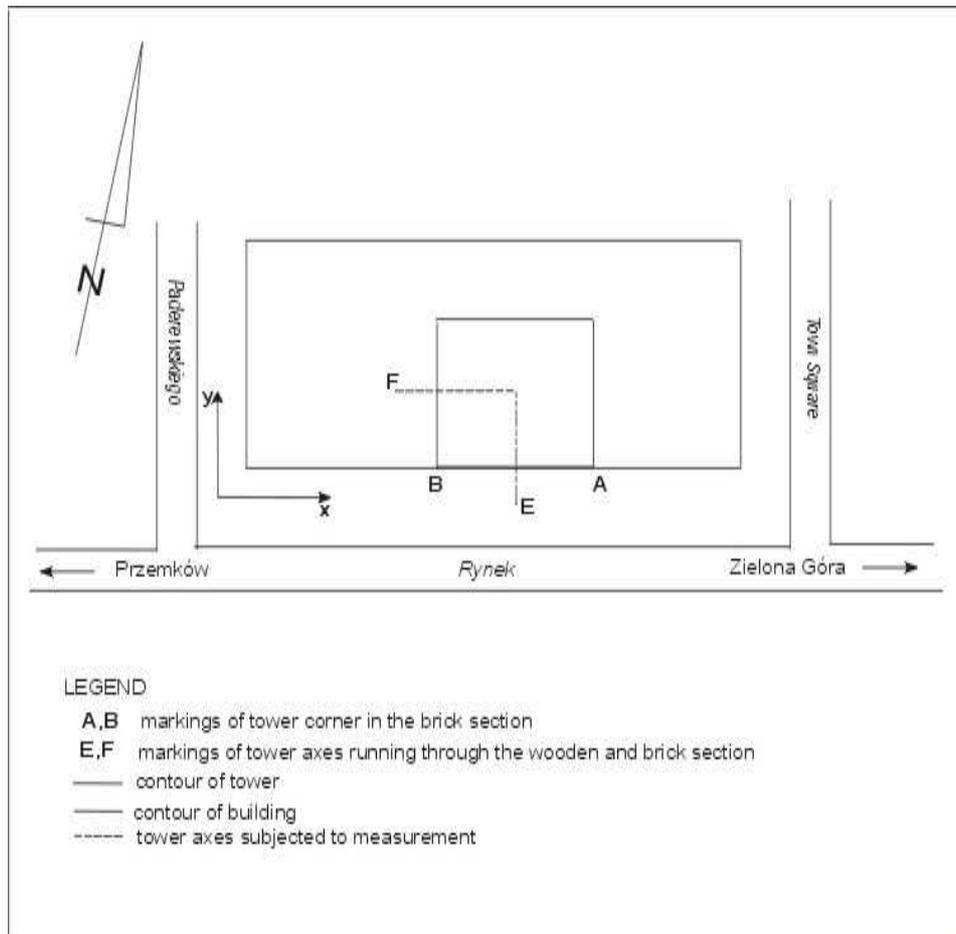
Fig. 2. Building location along with the arrangement of corners and axes

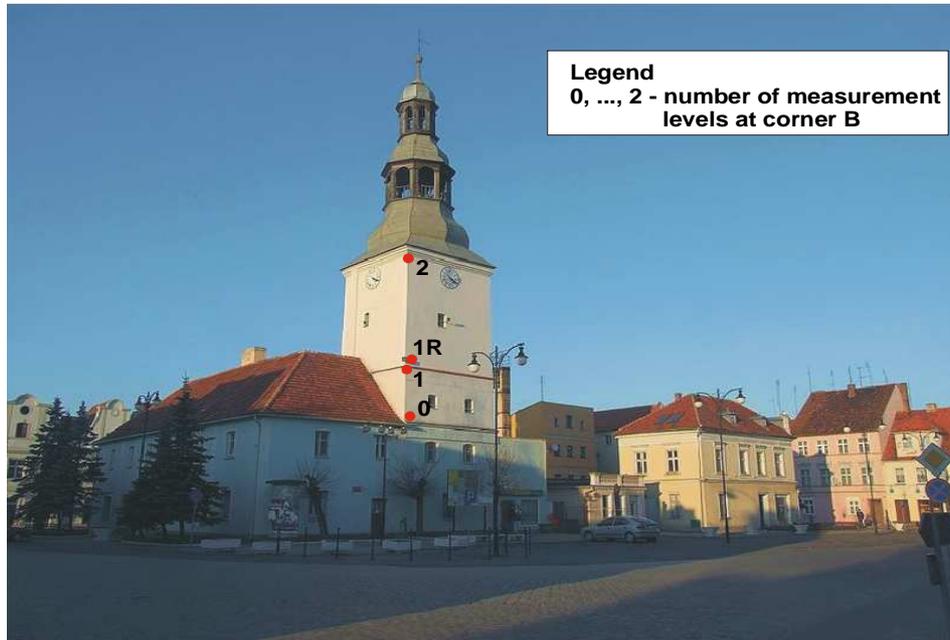
Measurement of vertical deviations by method of direct projection was carried out at 4 measurement points located at given levels of two corners (A and B) of the brick section - attention should be paid to the fact that one of the points (marked in Fig. 3 as 1R) was a reduction due to the change in the thickness of exterior walls, and at 4 measurement points located at given levels of two axes (E and F) running through the brick as well as wooden part of the tower (Fig. 4).

Fig. 3. Measurement levels on brick section of the tower

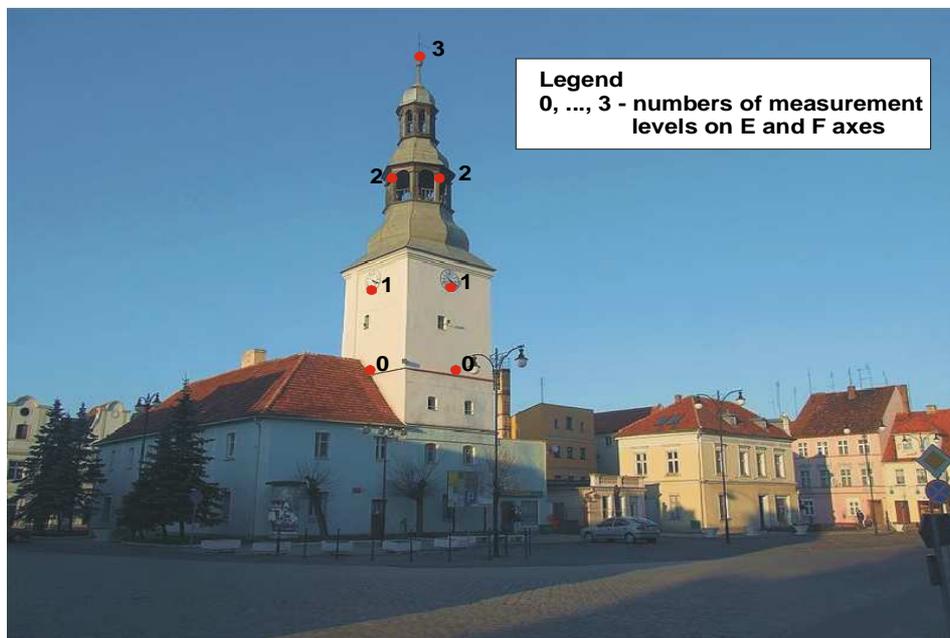
Fig. 4. Measurement levels on the axis of the wooden section of the tower

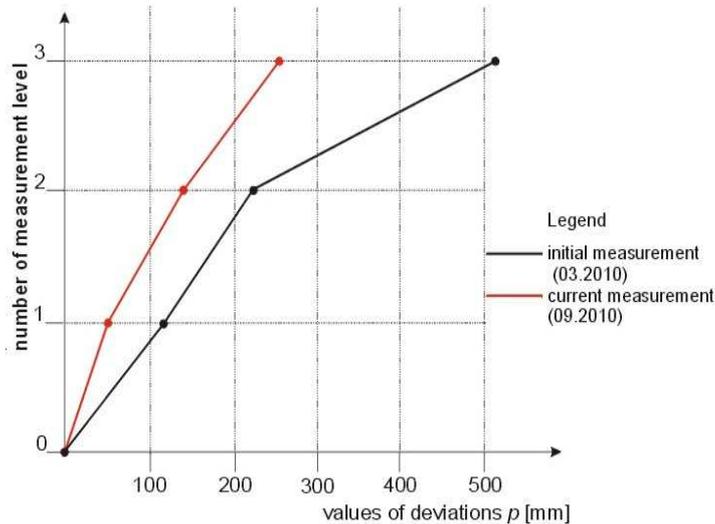
Maximum vertical deviations obtained from carrying out two periodical measurements have been presented in Table 1. Taking into consideration the measurement of vertical deviations taken for the tower axis, it was confirmed that the observed deviations are significantly larger than the deviations of the corner edges of the tower, and reach a maximum value of 511.7 mm before renovation and 265.2 after renovation at the last (4th) measurement level. Level 4 was located at a height of 34.09 m.

It ought to be pointed out that, in relation to the initial measurement carried out in March 2010, the values of deviation were reduced by -26.4 mm for corner A, -5.4 mm for corner B, and -246.5 mm for tower axes E and F. A compilation of changes in the vertical deviation at the individual levels from the initial measurement to the current one has been presented in Table 2. Deviations of the tower axis obtained at the initial measurement (prior to renovation) and the current measurement (following renovation) have also been presented graphically in Fig. 5.

Fig. 5. Deviation of tower axis in initial and current measurement
