CEER 2016; 21 (2): 121-130 DOI: 10.1515/ceer-2016-0027

Case Study Article

HISTORIC BUILDINGS OF THE WARSAW UNIVERSITY OF TECHNOLOGY - SELECTED ISSUES OF RENOVATION, MODERNISATION AND ADAPTATION

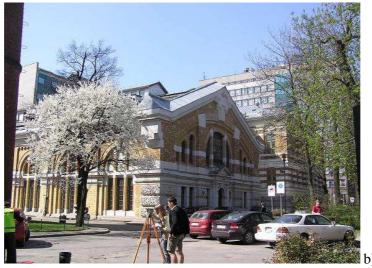
Fig. 1. The Old Boiler Room building: a) after the 1970s' 'renovation' b - Current condition. Photos: A. Wagner, 1994; 2012

The lack of respect for historic architectural substance, so typical of this period, was manifested in an extreme way in the devastation of the adjacent Old Boiler

Room, then home to the Repair and Utility department. During the 'repairs' conducted in the 1970s, its spatial layout and war-damaged elevations were partially changed, particularly the northern façade. Fortunately, the end of the 1970s brought a change in approach to historic architecture. A striking example of this new thinking was put in place twenty years later, from 1996-1997, when the damaged façade of the Old Boiler Room was cleaned (Fig. 1) and the interior modernized for the teaching purposes of the Faculties of Environmental Engineering and Electrical Engineering (design: Architect Hanna Czajkowska, 1995).

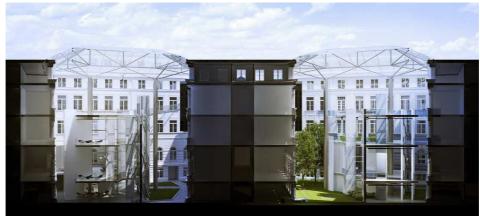
Fig. 3. Courtyard roofing designs for the Main Building, according to a concept by Prof. Lech Kłosiewicz

Czajkowska). Instead of the pre-war Szyller design, a modern architectural form was proposed, that would not disturb the overall historic character of the Main Building with its location between the two inner courtyards (Fig. 2). In 2012, the interior cloister courtyard was revitalised, exposing underlying layers of paint and decorative elements made of sandstone. The following year, a modern elevator was put into use, accessible from the internal level of the northern courtyard, which significantly increased access to the building, especially for the disabled. Renovation of the façade was then completed in summer 2014. Covering-over of the interior courtyards is also being considered, which would greatly increase the usable floor area of the building (Fig. 3).

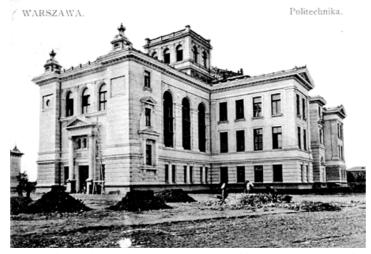
Fig. 4. The Physics and Electrical Engineering Pavilion at the Polytechnic Institute of Warsaw, Architect St. Szyller. Postcard from the collection of the Museum of the Polytechnic Institute of Warsaw

Completed at the beginning of the 20th century in the spirit of the architecture of late historicism, it combined new functional, spatial and technological thinking with a historicist's design (Fig. 4), but was seriously damaged during the war. The destroyed front wing with its large auditorium was replaced with a new part that has altered dimensions, a different room layout and a façade that is also different from the original. Its simple design and low level of detailing were the result mainly of the post-war conditions under which reconstruction of the university was carried out, highlighting the individuality of the new construction while also adapting it suit the historic character of the building (Fig. 5).
