HOW TO BRING A BUILDING BACK FROM RUINS

This paper is about the renovation of the baroque palace in Żagań. The journey starts at what was once a Medieval castle and finishes in the XIX century at the villa of Żagań Princes. Now the building is a XIX century villa maintained in a baroque style. The castle was built in the Middle Ages by Silesian Piasts and rebuilt three times, first by prince Wallenstein, then by prince Lobkovic, and finally, in the XVIII century, by princess Talleyrand. It remained the property of a French citizen until the 1960s, with its condition slowly decaying. In 1965, it was almost totally destroyed. Then the first renovation and revitalization works were initiated, lasting almost twenty years. The second renovation took place in the years 2007-2013, co-funded by the European Union. However, as a result of some cost cutting, the palace now requires a further, third approach to renovation.

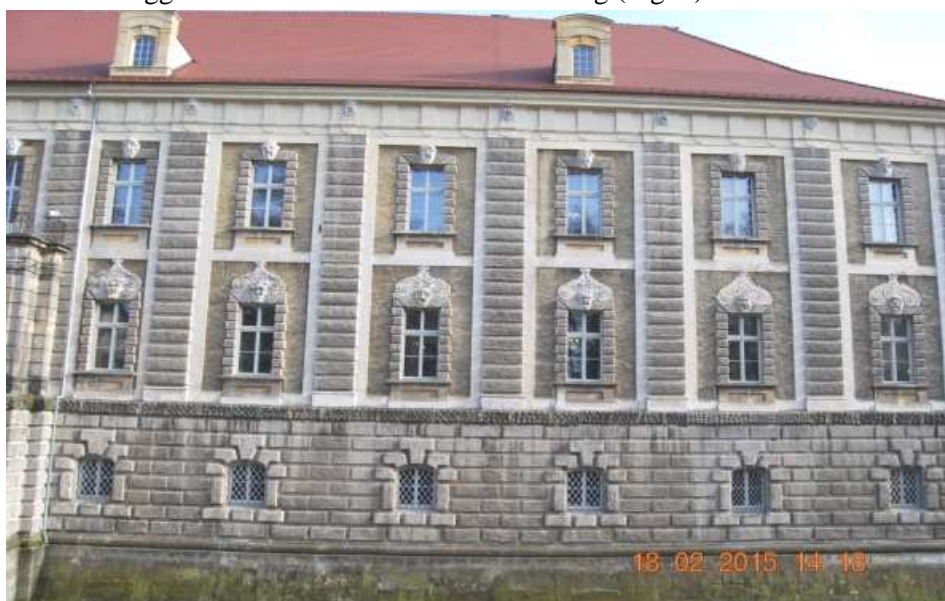
Fig. 4. Characteristic elements of the palace façade (fot. W. Sokołowski)

The elevation of the building is in a simple vertical form. It was based on vertical, rusticated selvedges and a pattern of window openings in rusticated frames; their horizontal counterweights are the cornices. The crowning of the decorations are the ornamental reliefs of faces composed into the keystones of the windows and the ornamentation of the crowning cornice. All of these elements suggest the fortress nature of the building (Fig. 4).

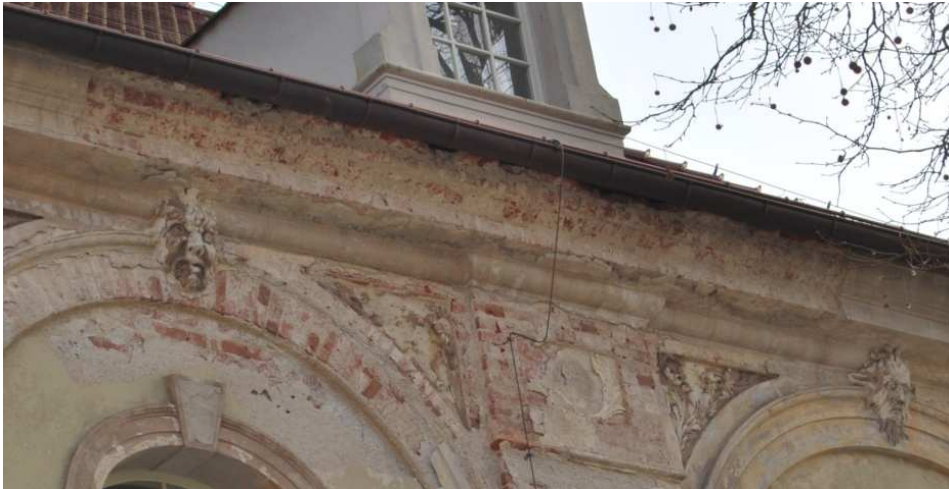
Fig. 10. Deteriorating east façade (fot. W. Sokołowski)

What is more, in the area of the courtyard, the system for draining water from the roof was implemented incorrectly, resulting in water damage to the newly redone facade (Fig. 10).

The many-year renovations carried out on the palace in Żagań have led to its heyday, saving it from the ruins that it had been 1965. However, some of the works were carried out incorrectly (roof drainage system), while failure to complete others (repair chimneys), has led to further deterioration. As a matter of fact, the title of the article ought to read "How to bring a building back from ruins and, once again, attempt to bring it to ruins". Not stopping the progressing deterioration of the facade by redesigning and repairing the system of roof drainage and failure to redo the chimneys can lead to such a situation very quickly. Another important element of the renovation works on this palace is installing a lighting system within the palace-park complex (preferably solar-powered), as well as assessing the effectiveness of the park drainage system and, if possible, bringing the fountains back into use.
