## **EXAMINATION OF DETERIOGENIC BIOFILMS ON BUILDING FACADES WITH SCANNING ELECTRON MICROSCOPY**

### Abstract

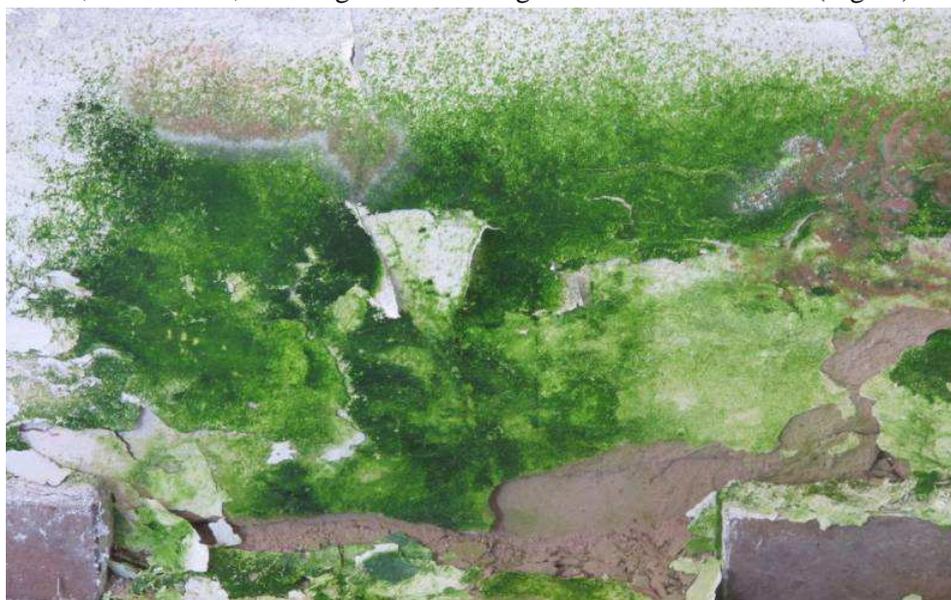
Fig. 1. Detail of the facade of the building with clearly visible biocorrosion

The term - deterioration involves a wide spectrum of phenomena causing weakening, loss of quality and destruction. All technical materials used on facades, are exposed to depositing of biological agents, and consequently susceptible to the development of biological corrosion. The technical state of a facade, its material properties and the environmental conditions are of great importance in the progression of the destruction [3, 5, 7, 8, 12, 16]. Biocorrosion refers to facades of both old and new buildings, facades with insulation and the ones with thin-layer plasters. This phenomenon leads to a weakening of the functional characteristics of the technical material such as: cracks, detachment, crushing and worsening of the visual aesthetics (Fig. 1).

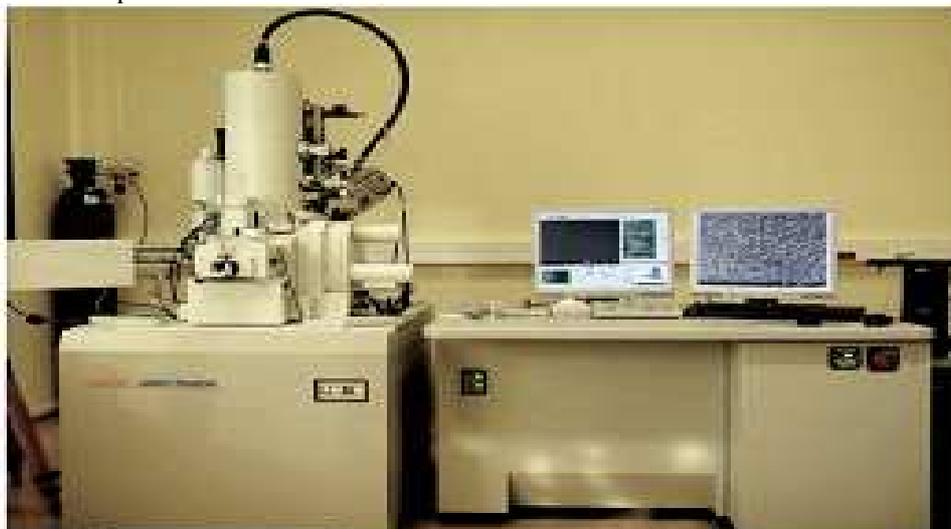
Fig. 2 . Scanning electron microscope JEOL JSM SEM-7600F at the Faculty of Mechanical Engineering, University of Zielona Góra

and identification of any defects or chemical composition. The essence of the scanning electron microscope is the use of the electron optical microscope for scanning of the tested sample with an electron beam formed by a system of magnetic lenses. The basis of the electromagnetic lens design is the solenoid which produces an electromagnetic field after electric current has flown through it. Electrons are very sensitive to magnetic fields, and thus can be controlled by changing the current flowing through the lens. An electron beam of high energy is concentrated in the area of the influence of electromagnetic lenses and reaches the sample, thereby generating signals on its surface. This results in the transmission of, inter alia, backscattered electrons, Auger electrons, secondary electrons, characteristic X-rays, cathodoluminescence and other photons of different energies. They are received by a detector, consisting of a photomultiplier and a scintillator. The main task of the scintillator is to transform signals emitted from the sample into electrical pulses which are next amplified by the photomultiplier. The signal from the detector reaches the electronic circuits that control the image on the computer screen [4, 9, 10].

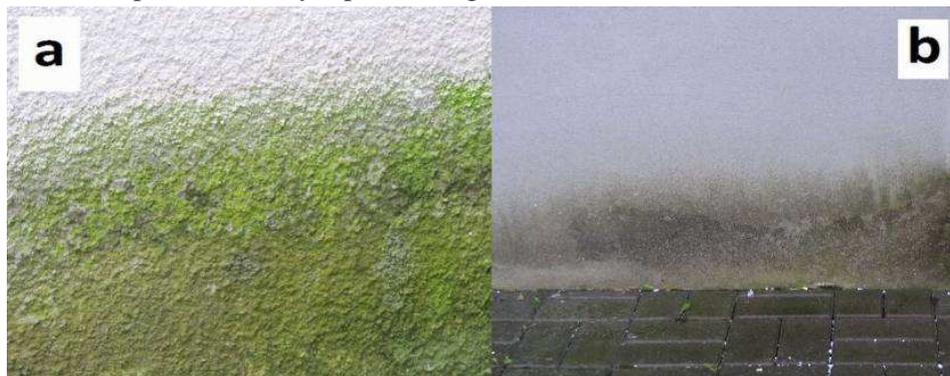
Fig. 3. Parts of the facade adjacent to the ground which the biological film for SEM observation was derived from, a - 30-year-old, non-insulated facade, very porous, b- 14-year-old facade insulated with styrofoam, covered with a thin-layer plaster

1. from an approx. 30-year-old, non-insulated building covered with a rough cement-lime plaster (Fig. 3a.)
2. from an approx. 14-year-old building insulated with styrofoam, covered with a porous thin-layer plaster (Fig. 3b.).
