## IMPACT OF BUILDING WALLS OF HISTORIC OBJECTS FROM HALF-TIMBERED WALL IN THEIR STATE OF THERMAL PROTECTION

Agnieszka SZYMANOWSKA-GWIŹDŹ<sup>1</sup>, Tomasz STEIDL<sup>2</sup>  
The Silesian University of Technology; Gliwice, Poland

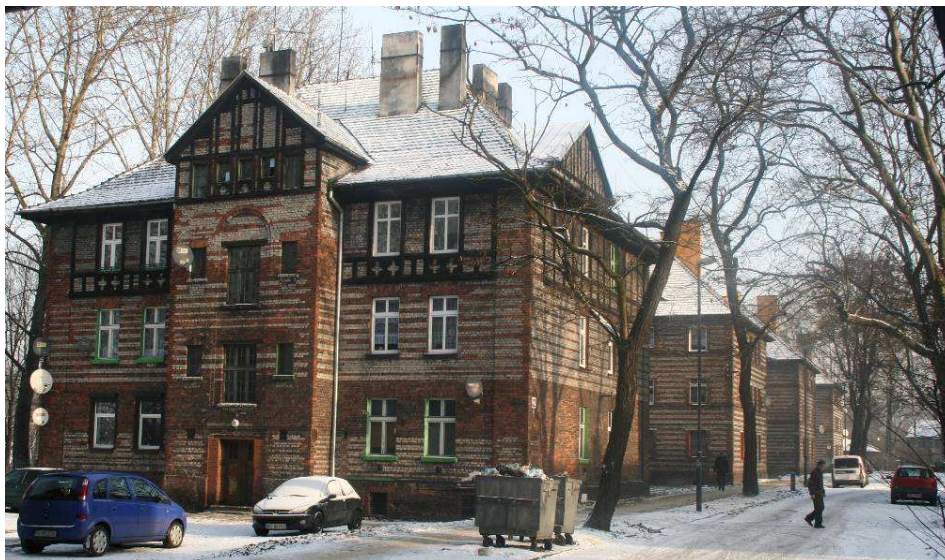
Fig. 1. Residential buildings in the settlement of Zandka in Zabrze

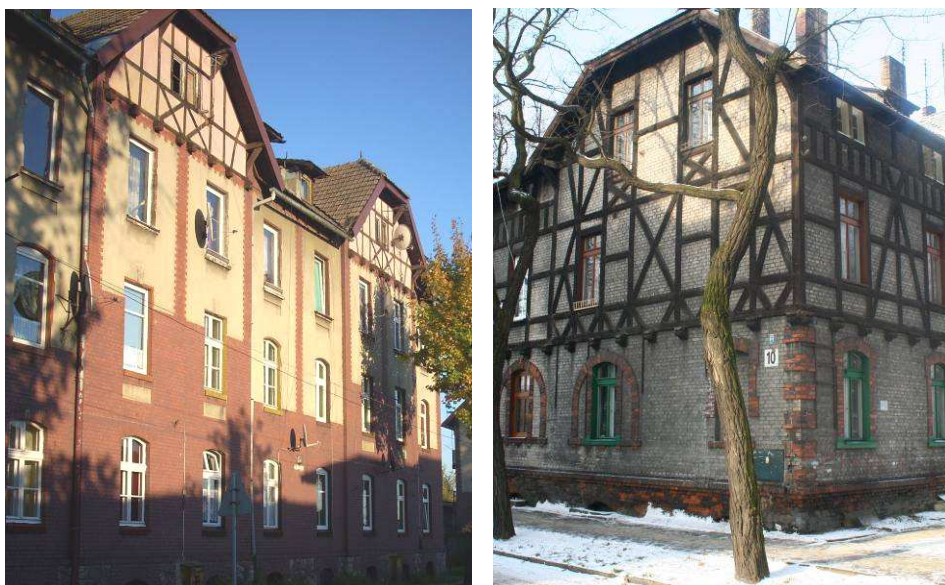
Fig. 2. Residential buildings in the railwaymen settlement in Pyskowice (left) and Zandka in Zabrze (right)

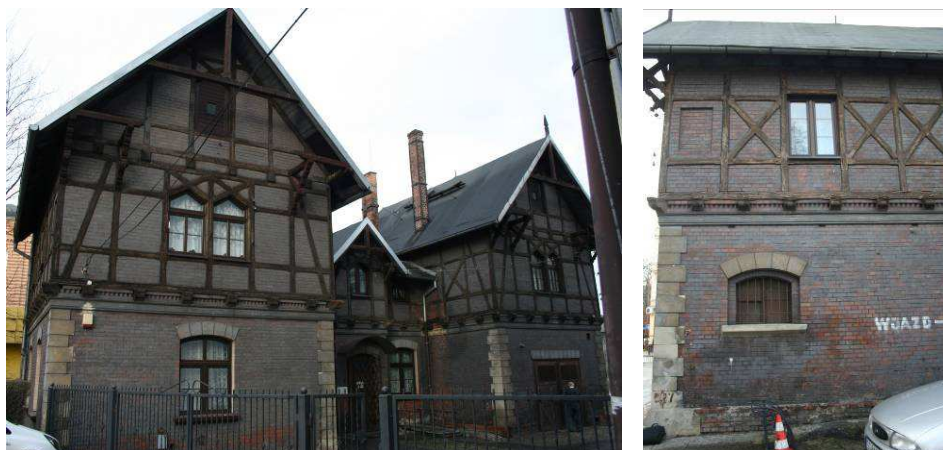
Fig. 3. Building of State Music School in Gliwice.

Gliwice's "pearl" of timbered houses is a building of the current State Music School, dating from the early twentieth century. The skeleton construction is found in the walls of the second floor, the ground floor is made entirely of a brick. Floor rooms are a library and music rooms for exercise.

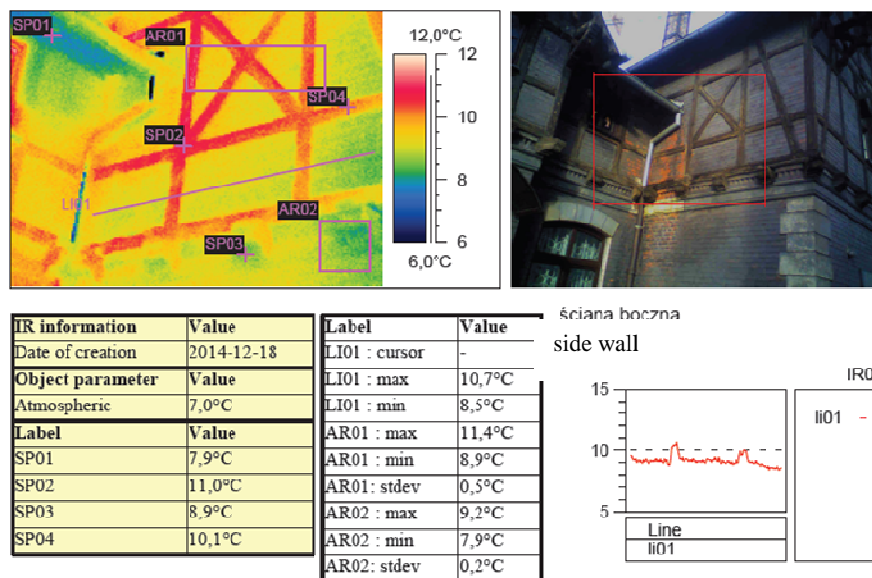
Fig. 5. Thermogram made on the outside of the building of State Music School in Gliwice

Thermographic survey was carried from the premises floors side, enclosed with frame construction, and from the facade of the building. As a result one obtained thermograms (Figure 4 and 5) showing the temperature at several selected points marked with a cross and the number (e. g. SP01, SP02) and areas (spaces) corresponding to the characteristic distributions of temperatures on tested barriers (e. g. AR01, AR02 ). For such marked areas, values of minimum and maximum temperatures were determined.
