DESIGN PROBLEMS WITH RENOVATING AND ADAPTING AN OLD MILL ON THE EXAMPLE OF THE EXECUTION OF AN ORIGINAL PROJECT

Aleksandra GRZONKA¹

Silesian University of Technology, Faculty of Architecture, Gliwice, Poland

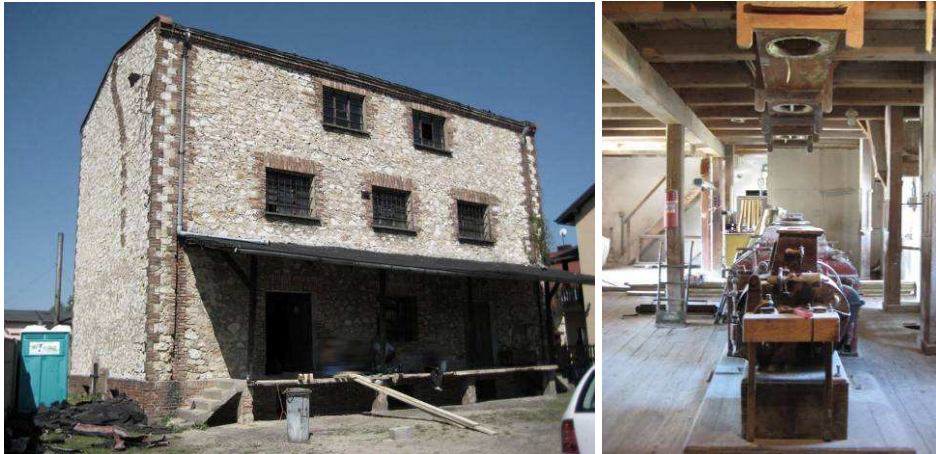
Photographs 1, 2. Młyn Zygmunt (Zygmunt Mill) Restaurant building prior to renovation, (photograph by A. Grzonka, 2011)

The old electric mill, which until recently served its initial purpose, is a four-storey building with a full basement in the form of a rectangle, covered with a gable roof.

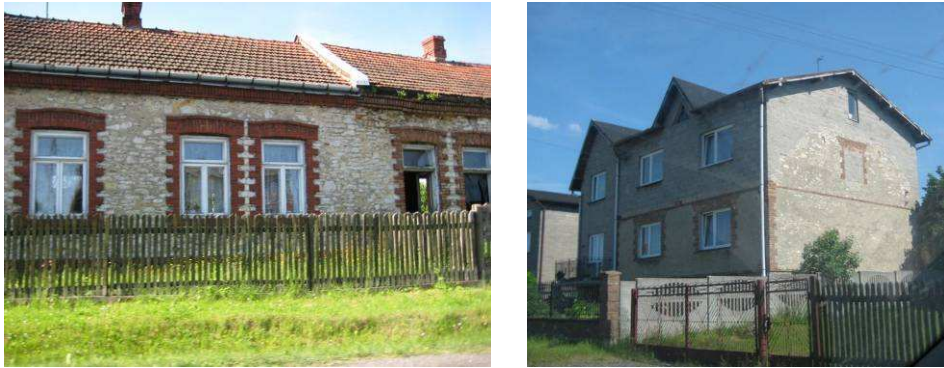
Photographs 3, 4. Existing buildings in the area of Łaziec,
(photograph by A. Grzonka 2011)

The building is located in Łaziec, in the gmina (municipality) of Konopiska near Częstochowa. This is an area where the Polish Jurassic Highland begins. A characteristic trait of the historical development found here are walls made of limestone, completed with brick elements. Bricks were used to construct the corners of the building and window openings, which resulted in the better bonding of the entire wall structures.

The limestone walls are strongly incorporated into the picturesque region of the Kraków-Częstochowa Upland, and unquestionably a positive feature of the landscape. Such technology continued to be used to construct the majority of structures up until the 1970's.

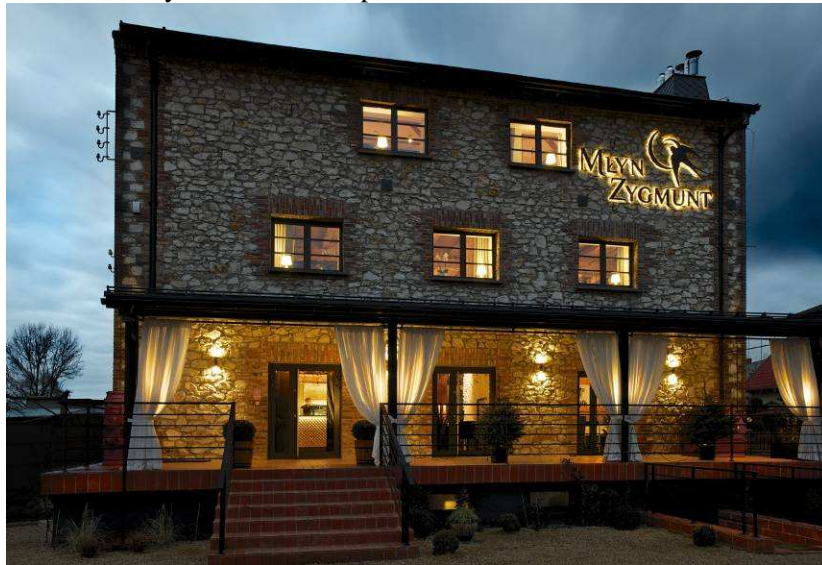
Photograph 5. Młyn Zygmunt Restaurant building following renovation,
(photograph by A. Nyk, 2014)

Such original technology strongly emphasizes the regionality of the place, thus influencing its cultural value. The natural stone wall became an inspiration for the architectural project of the restaurant "Młyn Zygmunt". However, turning this idea into reality was not so simple.

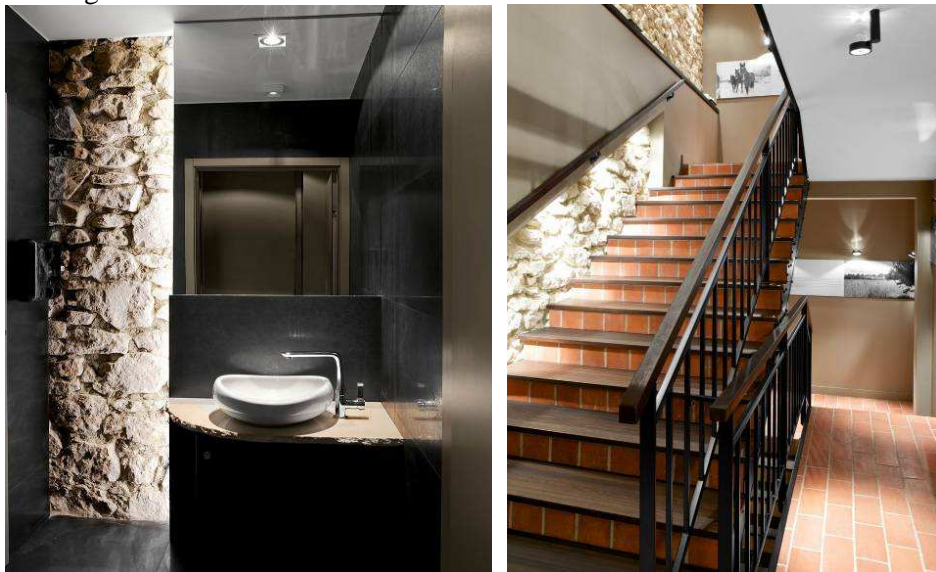
Photographs 6, 7. Młyn Zygmunt Restaurant following renovation,
(photograph by A. Nyk 2014)

The stone walls were subjected to renovation by replacing the mortar. The existing lime mortar had begun to crumble, which could have even led to the collapse of the building. In order to avoid such a situation, the decision was made to replace the existing mortar. This was no easy task. The works were carried out in phases on the entire building, including its interior. It was decided to use lime-cement mortar due to the beneficial qualities of lime. This substance has a positive effect on increasing the elasticity and adhesiveness of mortar to the surface. Along with the increase of lime in mortar, water vapor permeability increases, in addition to increased flexibility and the ability to self-heal minor damages. However, applying the new mortar posed the biggest problem. It could, on no account, be smoothed out, as this would have made the wall appear newly built.

In order to connect the exterior and interior of the building, a natural brick walls were exposed on the inside. By doing so, however, another problem arose - fulfilling the energy performance requirements of the building, which ought to be additionally carried out in order to obtain a building permit. This is why the surfaces of the exposed walls and their size are not random. Walls exposed on the inside were protected with a sealer to prevent the release of dust, and illuminated to emphasize their significance.

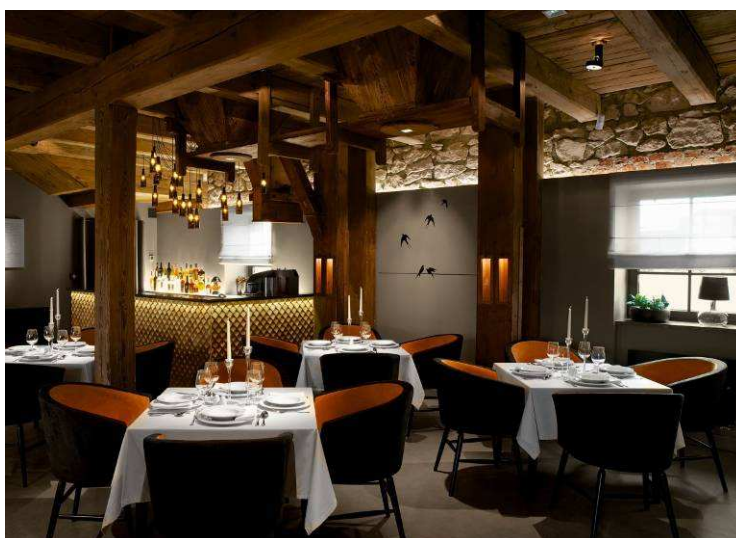
Photograph 8. Młyn Zygmunt Restaurant building following renovation,
(photograph by A. Nyk 2014)
