**METHODS OF TESTING AND ASSESSING
THE TECHNICAL CONDITION OF CHOSEN BUILDING
STRUCTURES LOCATED IN THE AREA
OF THE AUSCHWITZ-BIRKENAU NATIONAL MUSEUM
IN OŚWIĘCIM**

The results presented in this article consider the means of assessing the technical condition of two selected buildings, i.e. prisoner barracks number 123 and 124, located at the Auschwitz-Birkenau State Museum in Oświęcim. The work was carried out within the framework of a research project involving the development of methods for preserving, securing and strengthening the structure of buildings, along with their substrate and finishes. The aim of the project was to gain a knowledge base reflecting the actual state of the existing facilities and, on that basis, develop preservation methods and ways to protect the existing facilities against further damage, while maintaining the current character.

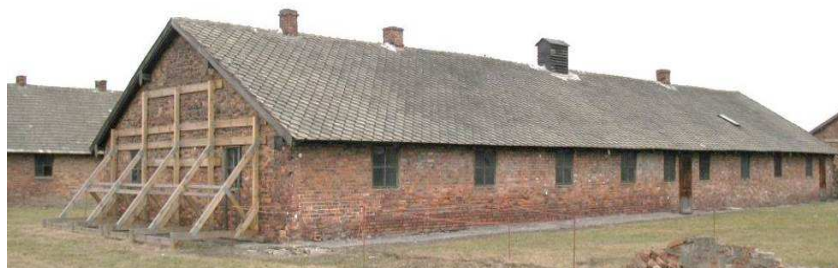
Fig 1. Prison barrack No. B-123

The accepted method of assessing the technical condition of buildings located in the area of the National Museum of Auschwitz-Birkenau in Oświęcim was presented on the basis of two prison barracks. Fig. 1 presents one of the analyzed prison barracks.

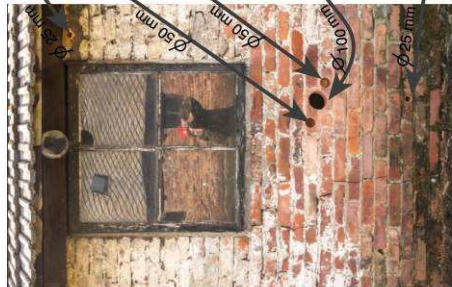
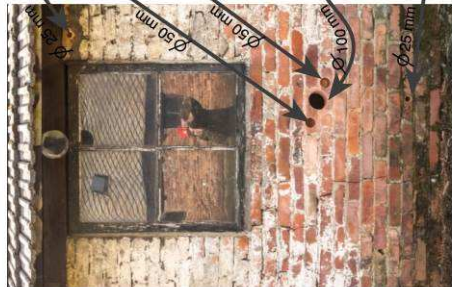
Table 1. Results of tests on mineral materials

Sample photographs of borehole samples taken from the building structures, their location, and results of conducted studies have been presented in Tab.1. The areas for collecting samples were chosen in such a way that enables the analysis of selected properties of materials in the wall height function.

0.15±3.39 n=8	Not determined	Not determined	7.4±8.6 n=8	0.23±0.39 n=8	0.01±0.02 n=8	0.0±0.02 n=8
		0.13±1.84 n=16	1633±1940 n=14	13.3±65.3 n=13	6.4±8.9 n=16	0.17±0.52 n=16	0.01±0.36 n=16	0.0±0.05 n=16

0.49±1.46 n=8	mortar: 1740±1935 n=14	wall: 2.9±12.2 n=6 mortar: 5.2±11.1 n=4	7.9±8.6 n=8	0.23±0.58 n=8	0.12±0.84 n=8	0.01±0.09 n=8
		0.70±2.86 n=8	Not determined	Not determined	7.2±8.9 n=8	0.18±0.52 n=8	0.01±0.02 n=8	0.0±0.01 n=8

Not determined	1915±2275 n=8	7.7±33.5 n=9	10.8±11.8 n=9	1.7±3.6 n=9	0.1±1.26 n=9	<0.01

The material assessment of the masonry walls covered determining the proportion of binding substance to aggregate in mortars. The ratio fell in the range of 1/2.2 - 1/3.1. The strength of mortar ranged from 5.2 to 11.1 MPa.

In assessing wall strength, the strength of ceramic brick, mortar and the wall fragment were all taken into account. The obtained values of wall strength differed significantly, ranging from 2.9 - 12.2 MPa. Attention ought to be drawn to the fact that strength was determined on the basis of samples taken from areas which were preserved in a state that made it possible to make boreholes. Thus, when assessing the load-bearing capacity, one ought to keep in mind that the analyzed buildings contain fragments of wall characterized by a lower strength than that mentioned above.
