## EXAMPLES OF UNUSUAL CONSTRUCTION SCAFFOLDINGS USED FOR RENOVATION WORKS OF HISTORIC BUILDINGS

Aleksander ROBAK<sup>1</sup>, Michał PIENKO, Ewa BŁAZIK-BOROWA  
Lublin University of Technology,  
Faculty of Civil Engineering and Architecture, Lublin, Poland

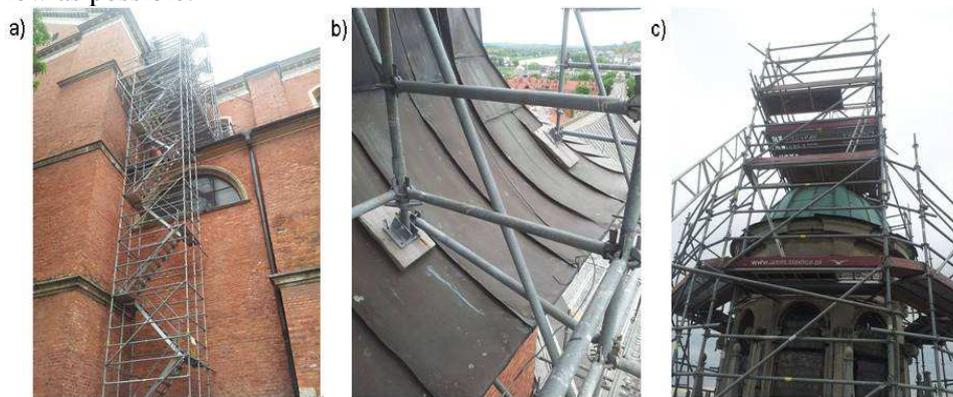
Fig. 1. Scaffolding at the church of Saints Peter and Paul in Kraków: a) circulation path, b) adjusting the tilt stand c) the crowning of the scaffolding

One example of unique scaffolding is a construction that has been set for the Church of Saints Peter and Paul in Kraków. Renovation work carried out in 2014 on this object relate to peak tower of building at the height of approx. 57m (Fig. 1c). In this structure there is no restriction to anchoring the scaffold and the possible support of scaffolding structure on the roof (Fig. 1b). Here the biggest problem turned out to be a very large angle of roof spread slope and the round shape of the structure. In addition to the scaffold, located right around the renovated tower, one made structure composed of several platforms and vertical walls, providing communication from ground level up to the cross located on the top of the tower. The first longest circulation path, shown in Fig 1a, was initially realized with a scaffold of dimensions 2.5 m x 0,73m and applying catwalks with transition flaps and aluminium ladders. Eventually this path was modified adding a second module with a width of 0,73m allowing replacing

temporary catwalks with stair courses significantly improving communication at this point. Above level 9 scaffold was based on church roof with tilt stands. Stands located in this manner, one needs to devote special attention and care in order to supply each of them with a tube fitting anchored to the wall. If this is not possible in the case of long-span roofs, as in the illustrated instance, stands should be combined with the scaffold structure using additional hardenings. One should take care of anchor or fixed hardening to be anchored to stand as low as possible.

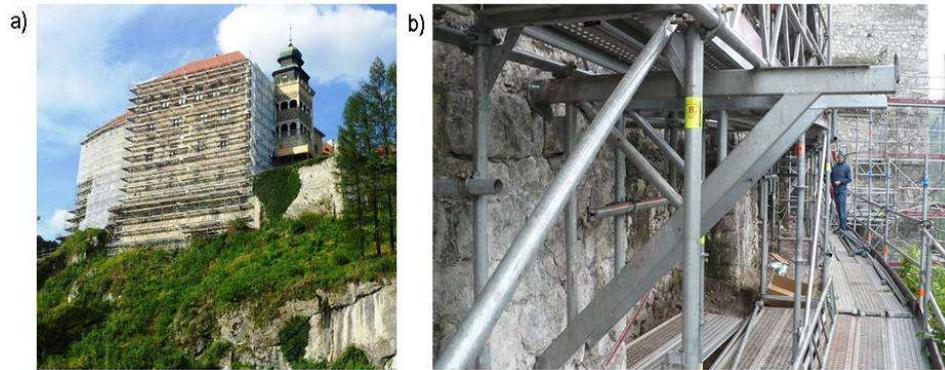
Fig. 2. Scaffolding on the facades of the castle in Pieskowa Skała: a) view of scaffolding, b) adjusting the scaffold on ancones

Another presented scaffolding is the design used at the castle in Pieskowa Skała in 2014 (Figure 2). Unlike in the previously illustrated example, at the castle in Pieskowa Skała renovations were carried out on external walls of the objects. In this case it was decided to use a framed scaffolding. The benefits of this assumption are the speed and ease of assembly, and above all, such scaffolding does not need to be further solidified in areas perpendicular to the facade. The first difficulty that appeared during the design of the scaffolding was the need to move the scaffolding horizontally up about one module in order to bring structure to the facade. This was achieved using a system supports, pillared with hardenings and the appropriate placement of anchoring fasteners in the area. The main problem was, however, the place of founding scaffolding, because it was very varied. In places the subsoil was flat and there was no obstacle to lean the scaffolding using the bases. Unfortunately, there were also areas with very high tilting starting directly from the walls of the castle. This situation forced the use of scaffolds suspension which was carried out by means of ancones and steel cranes. View of this mounting was shown in Fig. 3b.

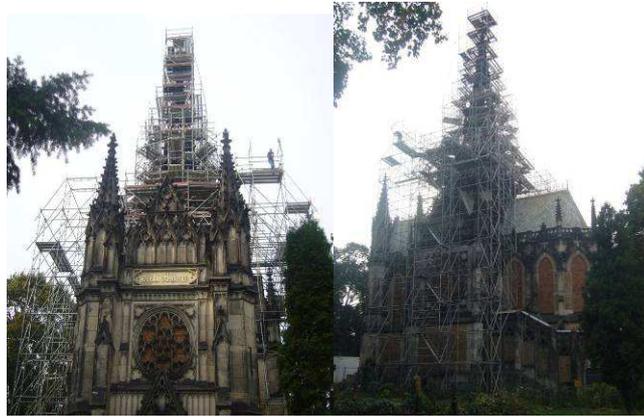
Fig. 3. Scaffolding around the Chapel of Scheibler

The chapel was built in 1888 cross plan with dimensions of 25 x 13.5m and is one of the greatest works of cemetery architecture in the world. The property has a slender body, topped with transparent stone tower. The total height of the building is 37m. In 2010 for the purpose of restoration works of the highest tower of the chapel along with the cross, placed at the top, one designed a scaffold with dimensions in a floor plan of an 11m x 18m and height of 38m which stands for 19 levels of scaffolding. Static analysis of scaffolding around the chapel, shown in Figure 3, is described in detail in a work of [1]. The biggest problem at the design stage and the implementation was the lack of a permit for anchoring to the walls of the chapel and the rest on the roof or ledges of the building. The result of these assumptions was to create a self-supporting structure which does not have any connection with the building, at which it was assembled. Scaffolding was based on subsoil through the wooden groundwork along the side walls of the chapel. The cross section of scaffolding at the ground level is shown in Fig. 4 and it was the same to the ninth scaffolding level of approx. 20m, where the two side walls of the scaffold were connected by means of ten pairs of steel girders, longitudinally connected with each other.

Such a large number of applied girders were necessary due to the fact that successive levels of scaffolding were based only on the girders that carried forces on the side walls of the scaffold. Above the ninth level of each next level was different from the lower and it resulted from need to adjust the scaffold to the shape of the restored tower. The last highest levels had dimensions of only 2,5m x 3,5m.

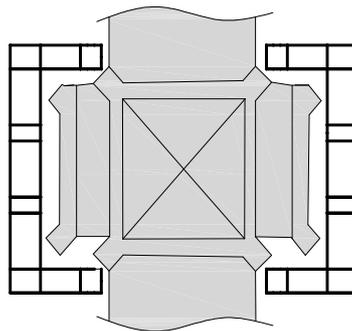
Fig. 4. Cross-section and location of scaffolding at ground level
