NOT IN-SERVICE RAILWAY ARCHED BRIDGES AND THEIR FUTURE

Artur JUSZCZYK¹, Marek DANKOWSKI², Adam WYSOKOWSKI³
University of Zielona Gora, Institute of Building Engineering, Poland

Abstract

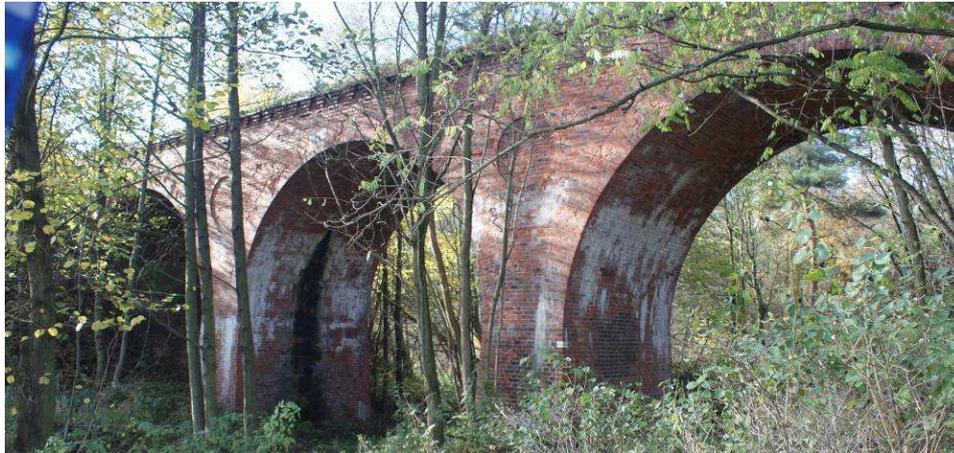
Fig. 2. General view of the bridge structure A

All arched bridges were made of full ceramic brick. The object marked with A is a viaduct, it composes of four arched spans up to approx. 8 m each (Fig. 2). Under the second span is a dirt road and under the third runs a small stream.

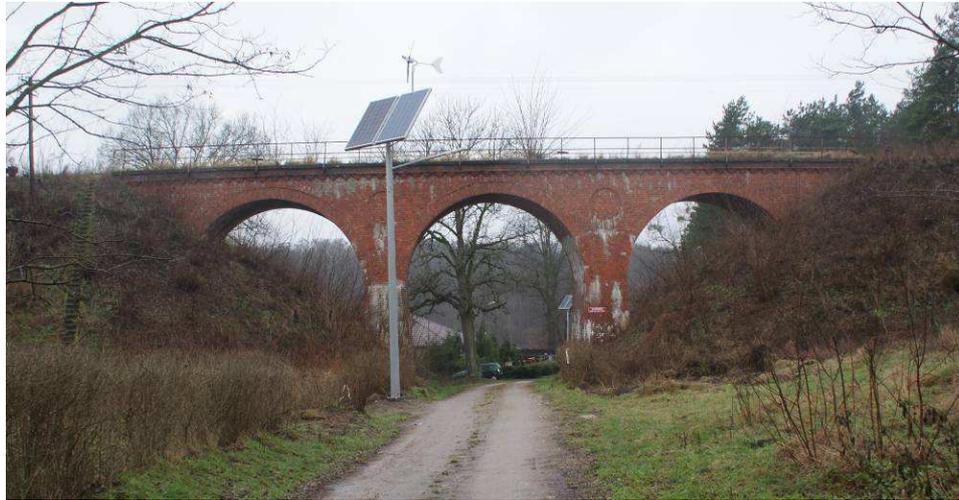
Rys. 3. General view of the viaduct B

The object marked B consists of three arched spans (fig. 3), whose basic dimensions were shown on the side view and a cross-sectional span (Fig. 4). Under the middle arch runs a paved road.

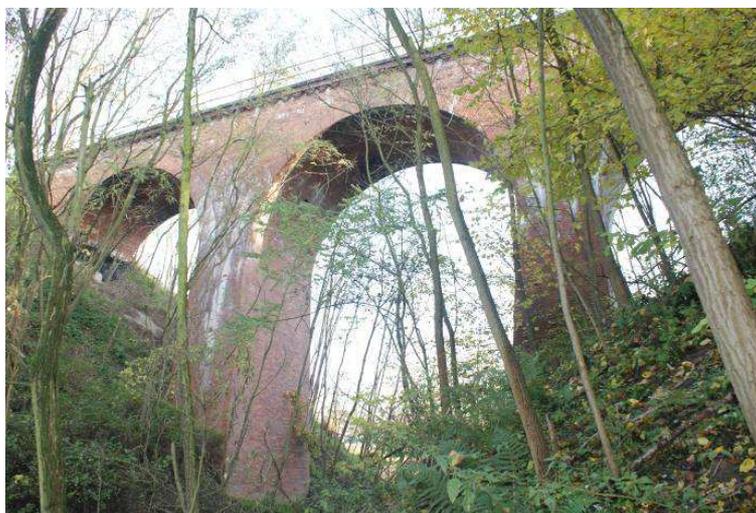
Fig. 4. General view of the bridge C

Object C, the highest of the described, is a bridge composed of three arched spans (Fig. 4). A few years ago, under the middle span flowed the small-sized watercourse - Oszczynica. Because on the west side one made the damming the stream, now the space between the pillars is completely filled with standing water. Due to the presence of water under the object and marshy areas on both sides of the bridge access is difficult.

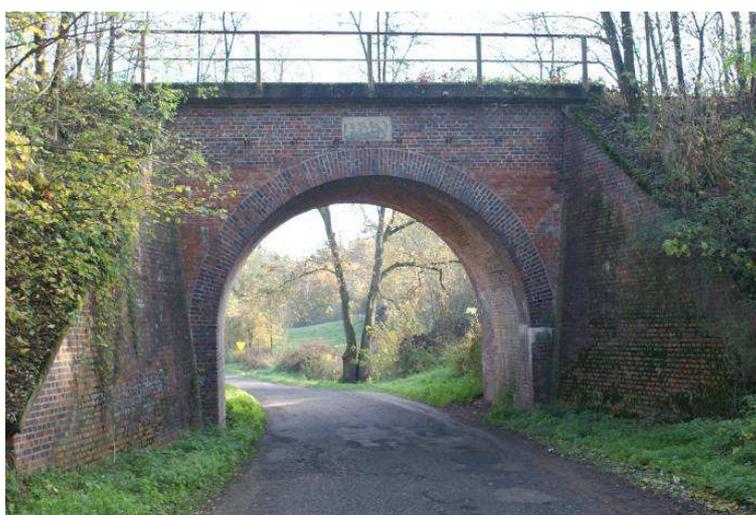
Fig. 5. General view of the bridge D

The object D is a one-span viaduct, the smallest of the described (Fig. 5). Under the object runs westwards the local paved road from the village of Nojewa to Kikowo. On both sides of the bridge, parallel to the road, on the length of more than 8 m, there are retaining walls restricting the ground scarps. In the early 60's building was undergoing a complete renovation during which fragments of vaultings, clinker bricks on the edges of the arches were renewed and one made a reinforced concrete bridging slab with a thickness of approx. 25 cm.
