RESTRICTIONS AND NEW POSSIBILITIES OF TECHNICAL AND CONSERVATION DIAGNOSTICS OF WOOD IN HERITAGE BUILDINGS

Joanna DROBIEC, Beata NOWOGOŃSKA¹,
University of Zielona Góra ¹

Abstract

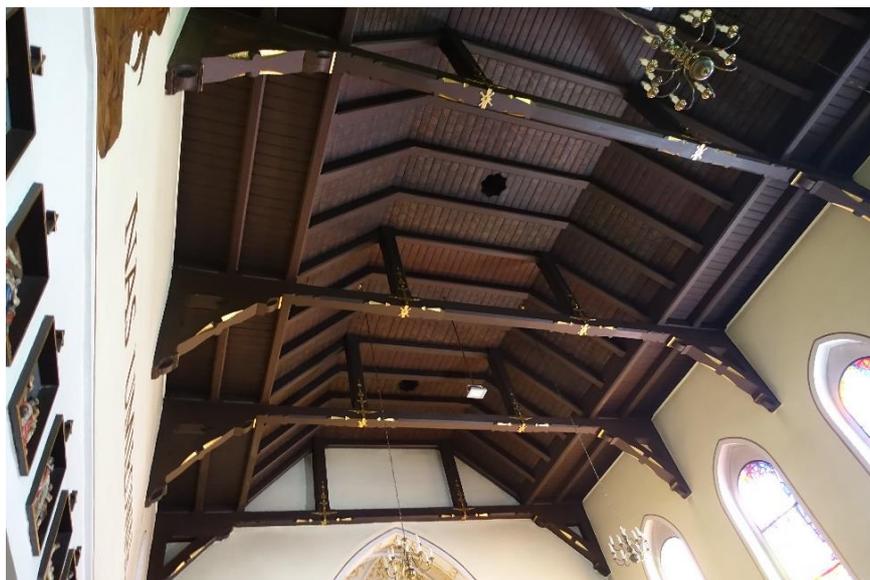
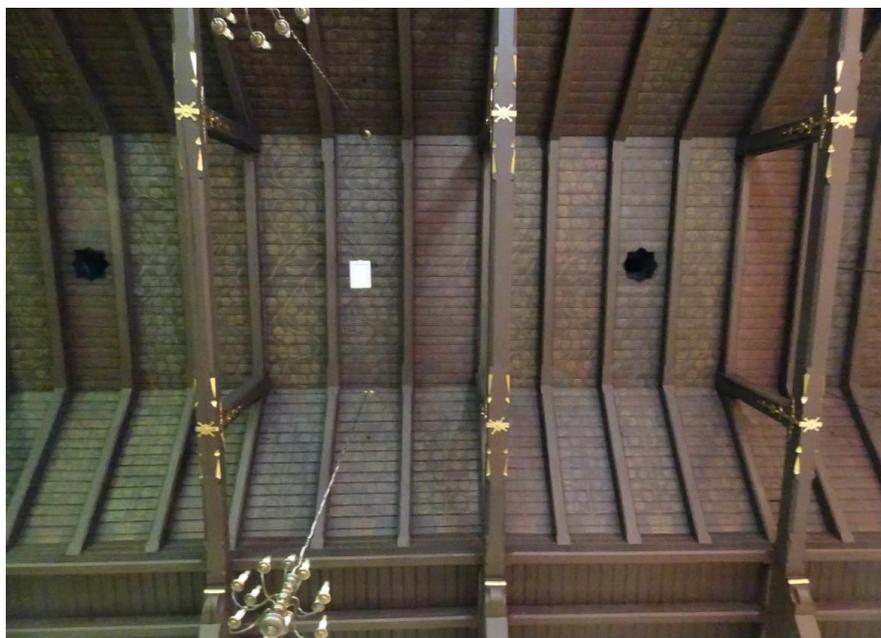
Fig. 2. Parts of the lower truss structure, view from the church side

Fig 3. Parts of the lower truss structure, view from the church side

The church building of the Sacred Heart of Jesus in Jastrzębie Zdrój dates to 1898. A view of the church is shown in Fig. 1. The roof truss, which is the subject of the study, was made as a purlin hanger double-hung truss. It is a partially open truss with a trapezoidal ceiling and horizontal overhanging [18, 19]. A view of the truss from the church side is shown in Figures 2 and 3, and from the side of the attic in Figure 4.

This construction of the truss has additional braces and struts, on which the ceiling was built in. Purlins were placed on the rafter hangers, and rafters were placed on them. The truss elements on the church side are additionally carved and painted. The ceiling was painted brown and decorated with plant ornaments.

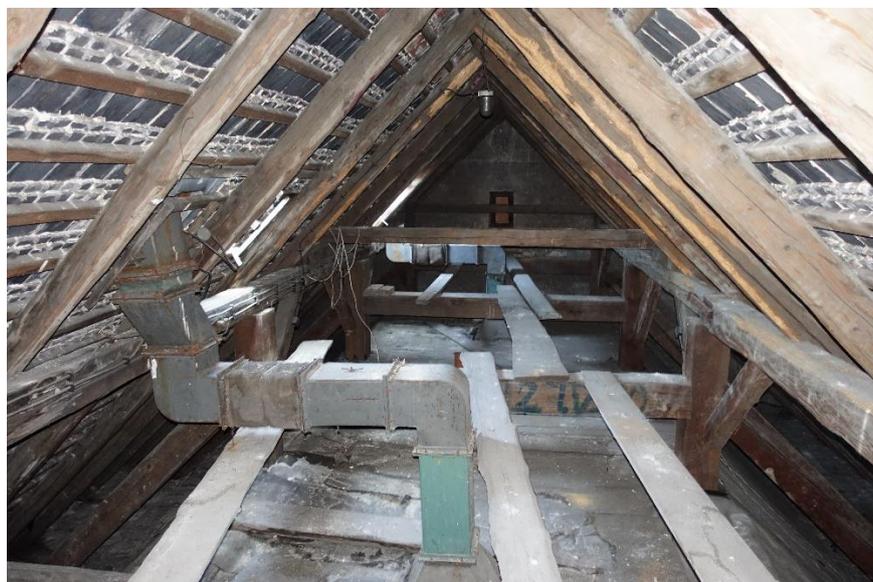
Fig. 4. Upper part of the truss structure, view from the attic side

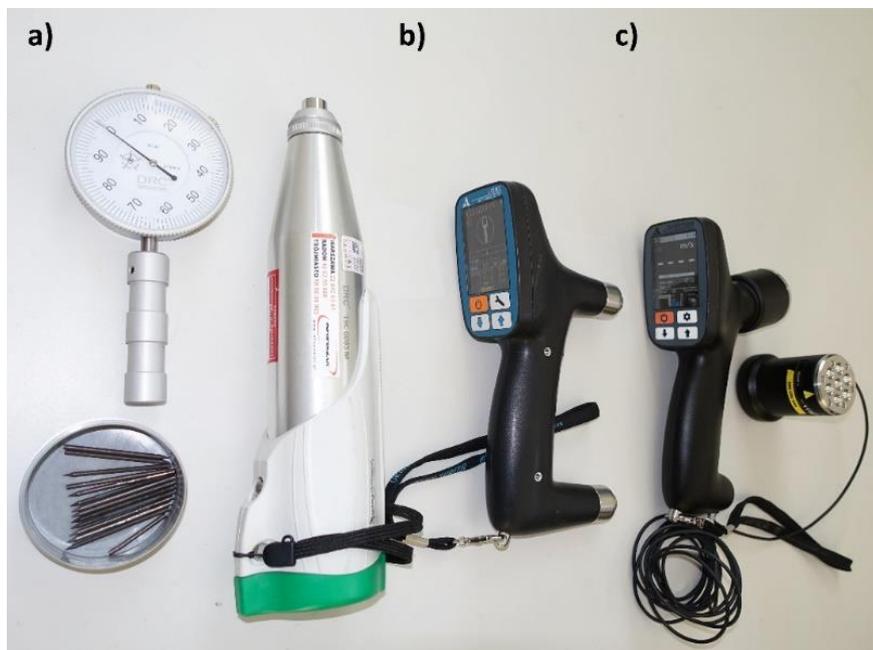
Fig. 5. Devices used in the study:
 a) Wood Peker DRC 19C0085M, b) UK 1401 SURFER, c) UK 1410 PULSAR

The roof truss was subjected to semi-destructive testing with a Wood Peker DRC 19C0085M wood hammer (Fig. 5a). In addition, ultrasonic tests were carried out using a UK 1401 SURFER device (Fig. 5b) measuring the velocity of the transverse wave along the fibers, and using a UK 1410 PULSAR device (Fig. 5c) measuring the velocity of the longitudinal ultrasonic wave across the fibers. In addition, the moisture content of the elements of the tested structure was also measured.

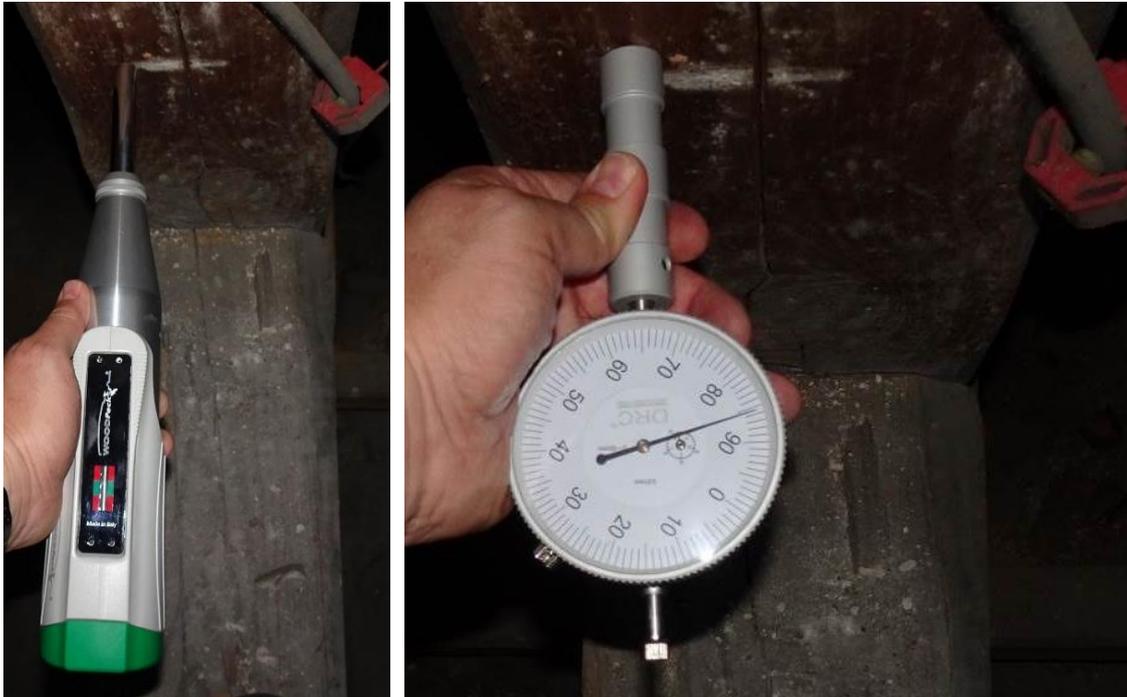
Fig. 6. Testing with a Schmidt wood hammer (hanger of hanger trusses)

The wood hammer test is based on driving a needle with a diameter of 2.5 mm, length of 50 mm, made of steel with a hardness of 60 HRC and ending in a cone with an angle of 35°. The impact energy is 2.207 Nm. After striking the hammer five times, the needle's cavity is measured using a dial indicator, and the strength parameters of the wood are determined on this basis from tables or formulas. An example view of the Schmidt wood hammer during testing is shown in Figure 6a, and an example of the needle measurement result is shown in Figure 6b.

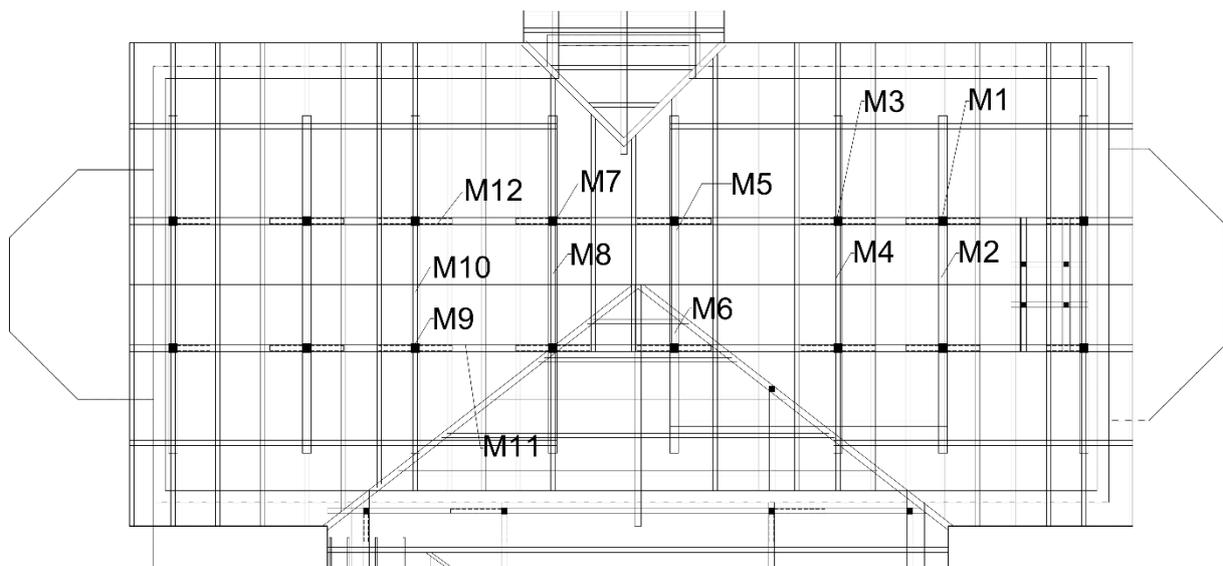
Fig. 7. Roof truss plan- Schmidt hammer test sites

Tests were conducted on selected 11 elements of the trusses, and the test sites were designated M1÷M11 (Fig.7). Tests were conducted on elements without biological corrosion and on elements showing damage. The results of the tests are shown in Table 1.

However, based on the results, a qualitative assessment of the wood can be made. In corroded elements, the needle penetrated deeper. In undamaged elements, the average depth of needle penetration was 23.7 mm, with a standard deviation of 1.75 mm (coefficient of variation of 7.4%), while in heavily damaged elements the average depth of needle penetration was 32.7 mm, with a standard deviation of 2.64 mm (coefficient of variation of 8.1%).

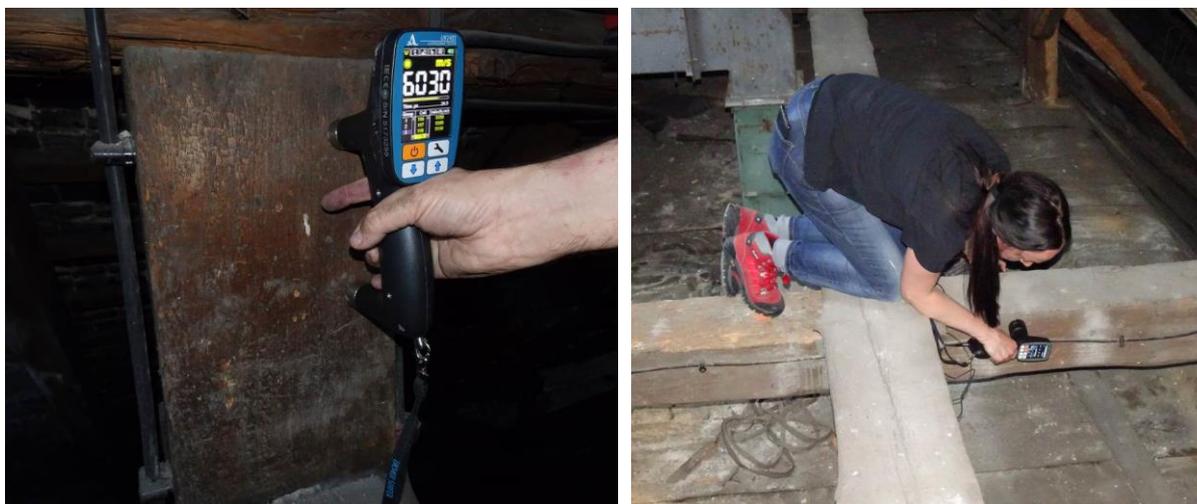
Fig. 8. Test locations with devices: a) UK1401 Surfer, b) UK1410 Pulsar

Non-destructive ultrasonic testing of truss members was carried out. The test involves measuring the time of passage of the ultrasonic wave through the wood. The devices record the time of passage of the ultrasonic wave and automatically calculate the speed of the ultrasonic wave based on the distance between the transmitting and receiving heads. The UK1401 Surfer uses an ultrasonic transverse wave, and the test itself is conducted along the wood fibers of the test piece. The UK1410 Pulsar uses a longitudinal ultrasonic wave, and the test is performed across the fibers. Both devices are equipped with ultrasonic exposure (spot) heads, which do not require additional acoustic coupling. The UK1401 Surfer has two heads built in at a fixed spacing of 15 cm, while the UK1410 Pulsar has 2x 7 heads each. The devices use heads on springs, adjusting to the plane of the test piece. In both devices it is possible to perform tests through wood defects (e.g. knots). A view of the devices during testing is shown in Figure 8.

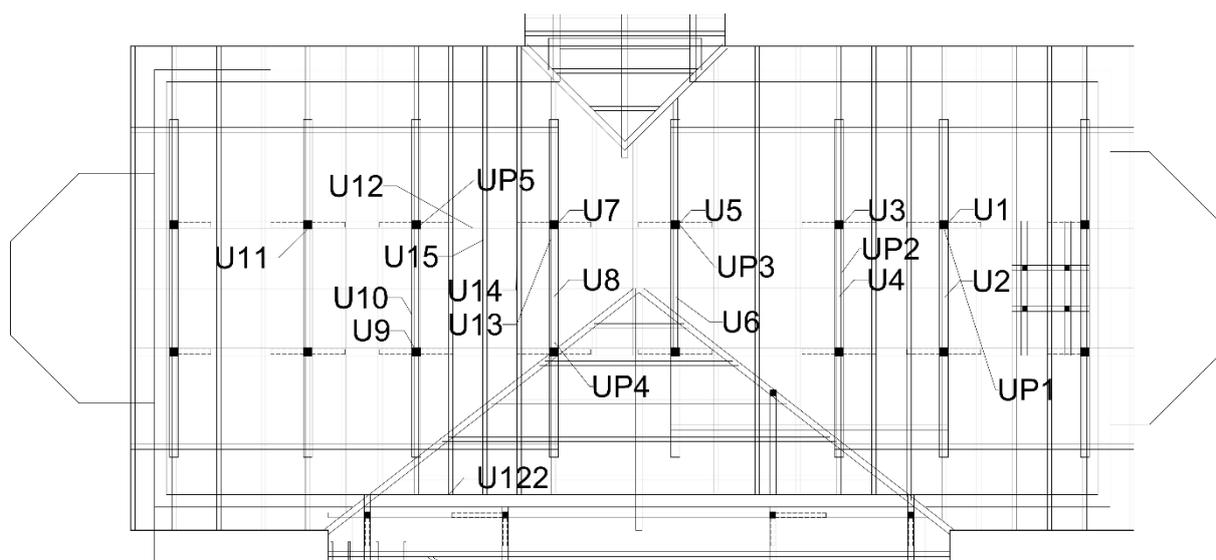
Fig. 9. Test sites with devices: a) UK1401 Surfer (marked U), b) UK1410 Pulsar (marked UP)

Tests were performed at selected 20 locations of the roof truss, which are shown in Figure 9. Tests conducted with the UK1401 Surfer device were marked with the symbol U, while tests conducted with the UK1410 Pulsar device were marked with the symbol UP. As in the case of the wood hammer tests, tests were conducted in undamaged areas and in areas showing biological corrosion. In addition, the speed of ultrasonic flow through wood defects (knots) was tested with the UK1401 Surfer device. The results of the tests are given in Table 2.

However, a qualitative analysis can be made on the basis of the tests performed. In the case of testing with the UK1401 Surfer device (ultrasonic transverse wave), an average ultrasonic velocity of 5469 m/s was obtained in undamaged elements, with a standard deviation of 222 m/s (coefficient of variation of 4.1%). In elements with biological corrosion, an average ultrasonic velocity of 4922 m/s was obtained, with a standard deviation of 160 m/s (coefficient of variation of 3.3%). The UK1401 Surfer device was further used to study defects (knots). Two defect sites were investigated by placing the device's heads

on both sides of the knot. An average ultrasonic velocity of 4185 m/s was obtained. Thus, it can be clearly seen that the ultrasonic velocity in the vicinity of the defect decreases by 25%, as the flow path of the ultrasonic wave lengthens (the wave bypasses the defect).

In the case of tests performed with the UK1410 Pulsar (ultrasonic longitudinal wave) device, an average ultrasonic velocity of 1930 m/s was obtained in undamaged parts, while in damaged parts the velocity was 70% lower at 1363 m/s.

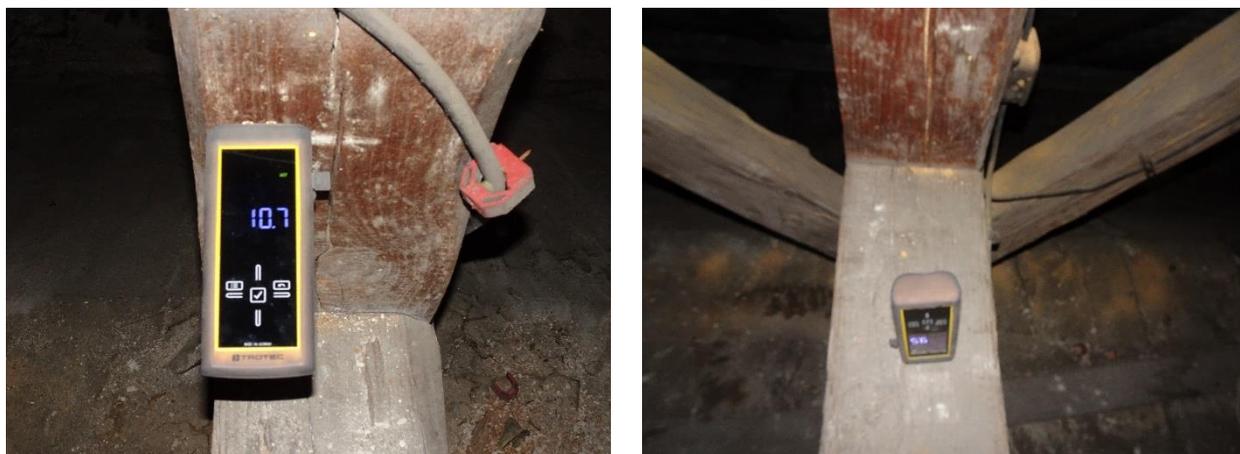
Fig. 10. Measurement results of the T510 moisture meter: a) hanger - moisture content of 10.7%, b) strut - moisture content of 9.5%

Tests of wood moisture content were conducted at selected locations on roof truss members. During the tests, the temperature in the interior was 18 degrees Celsius, the relative humidity was 55 %. Example test results are shown in Figure 10.

In the paper [20], it is stated that wooden elements located in unheated indoor spaces should have an equilibrium moisture content of $12\% \pm 3\%$. Such a result was obtained in the tested elements of the truss in question. According to [20], the equilibrium moisture content for structures exposed to the weather is $18\% \pm 6\%$. The literature [20] further states that at a moisture content of $<20\%$ there is no wood fungus. The moisture content $<20\%$ (12.8% at most) was always obtained in the tests, and no traces of mold or the characteristic musty smell were found during the inspection.
