INFLUENCE OF TEMPERATURE SENSOR (PT100) ACCURACY ON THE INTERPRETATION OF EXPERIMENTAL RESULTS OF MEASURING TEMPERATURE ON THE SURFACE

Maria Teresa MAŁEK¹, Halina KOCZYK

Poznan University of Technology, Faculty of Environmental Engineering and Energy, Institute of Environmental Engineering and Building Installations, Poland

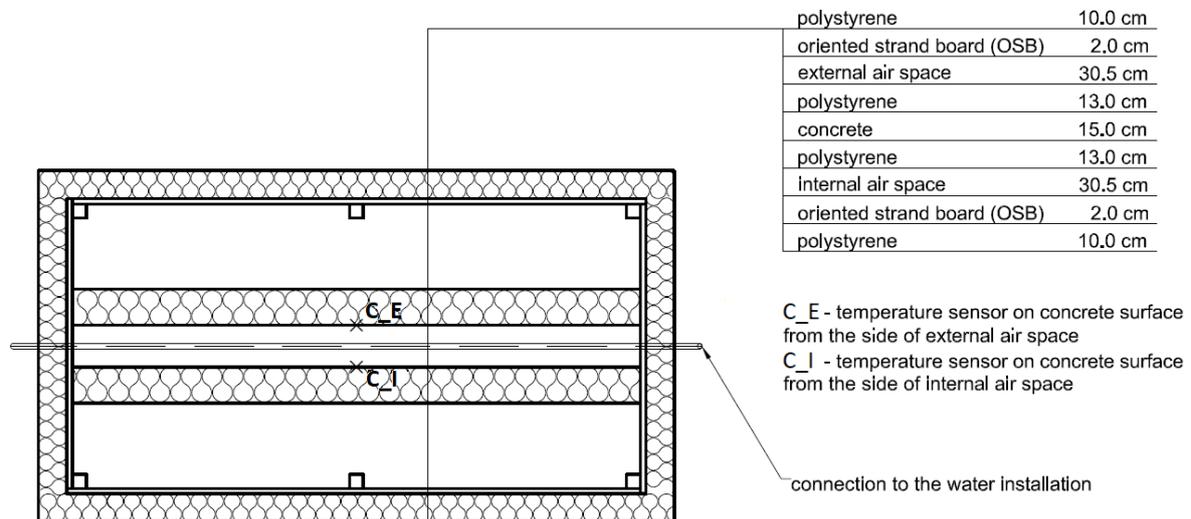
Fig. 1. Diagram of the experimental stand

The experimental stand consists, as already mentioned, of a concrete wall 15 cm thick and 202 cm high, insulated on both sides with 13 cm thick polystyrene. Inside the partition, in its axis of

symmetry, a loop of 20x2mm thermoplastic pipes is embedded, arranged in the shape of a meander form with a spacing of 10 cm and connected to an cooling bath thermostat with the possibility of controlling water supply temperature and water flow. The wall structure is covered with oriented strand board (OSB), creating a 30.5 cm wide air space between it and the concrete wall. The experimental stand was also separated from the environment in such a way that it was raised 10 cm above the floor of the laboratory hall, and this space was filled with XPS extruded polystyrene and the entire OSB casing was insulated with 10 cm thick polystyrene. The parameters of building materials: concrete and polystyrene are presented in Table 1. Figure 1 shows a diagram of the test stand, while in the photo, see Fig. 2, its view is shown.

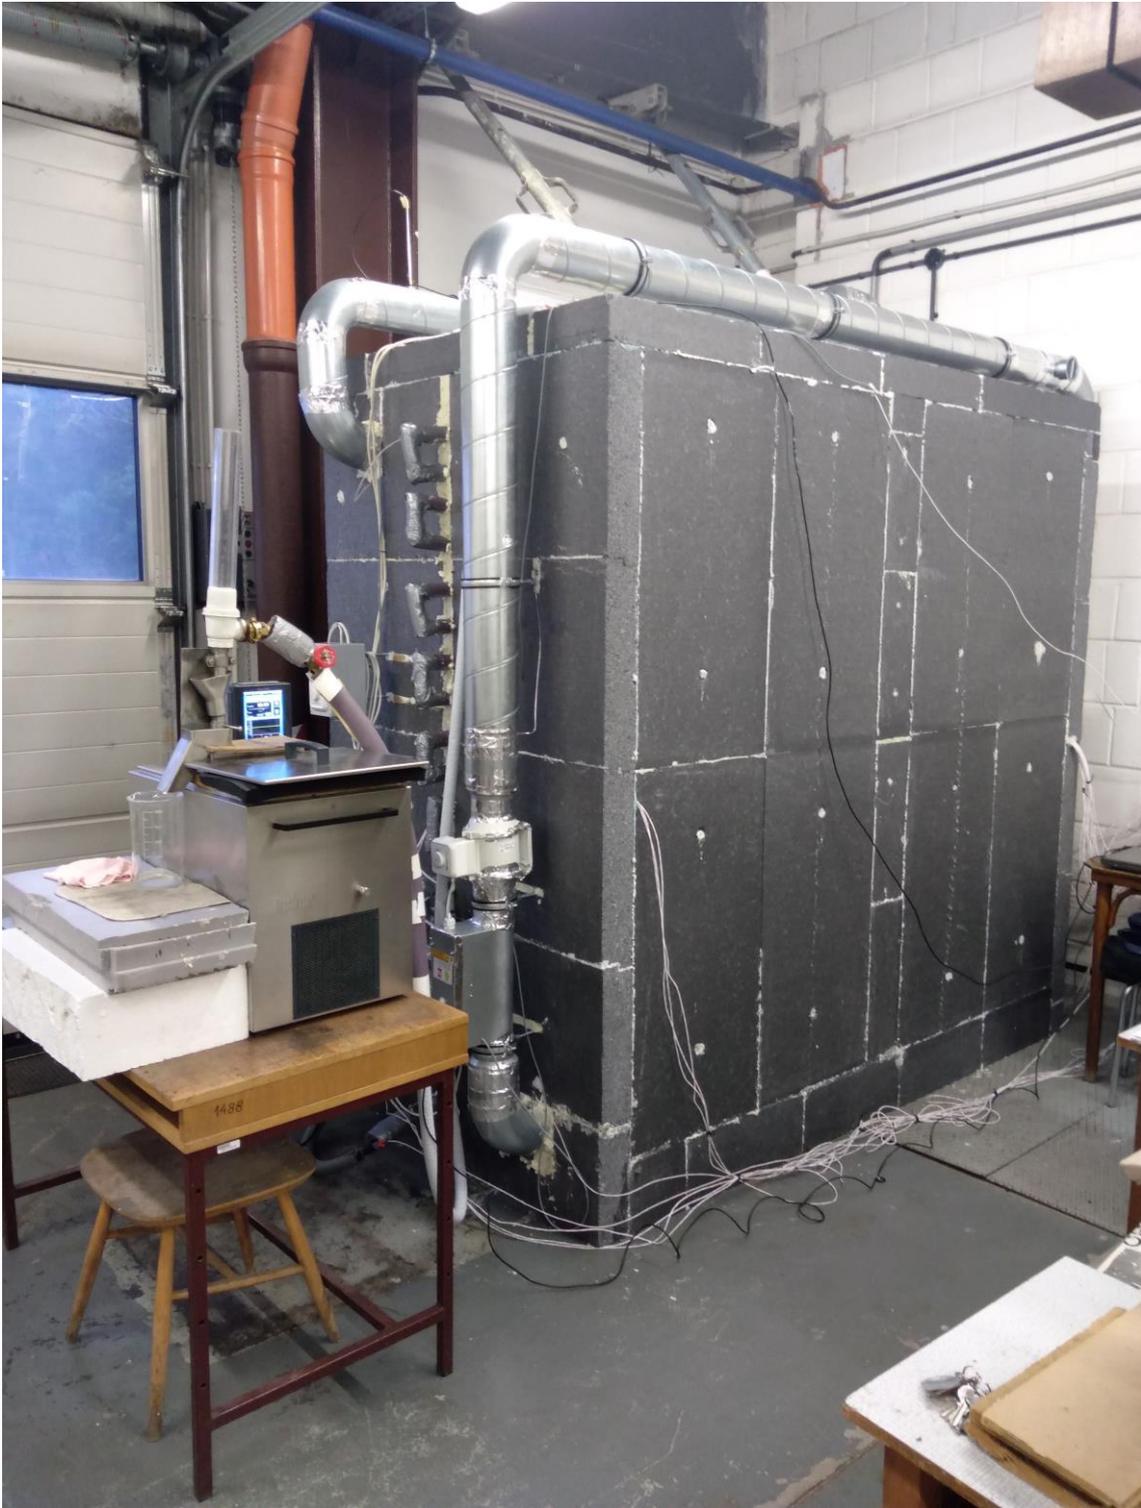
Fig. 2. View of the experimental stand

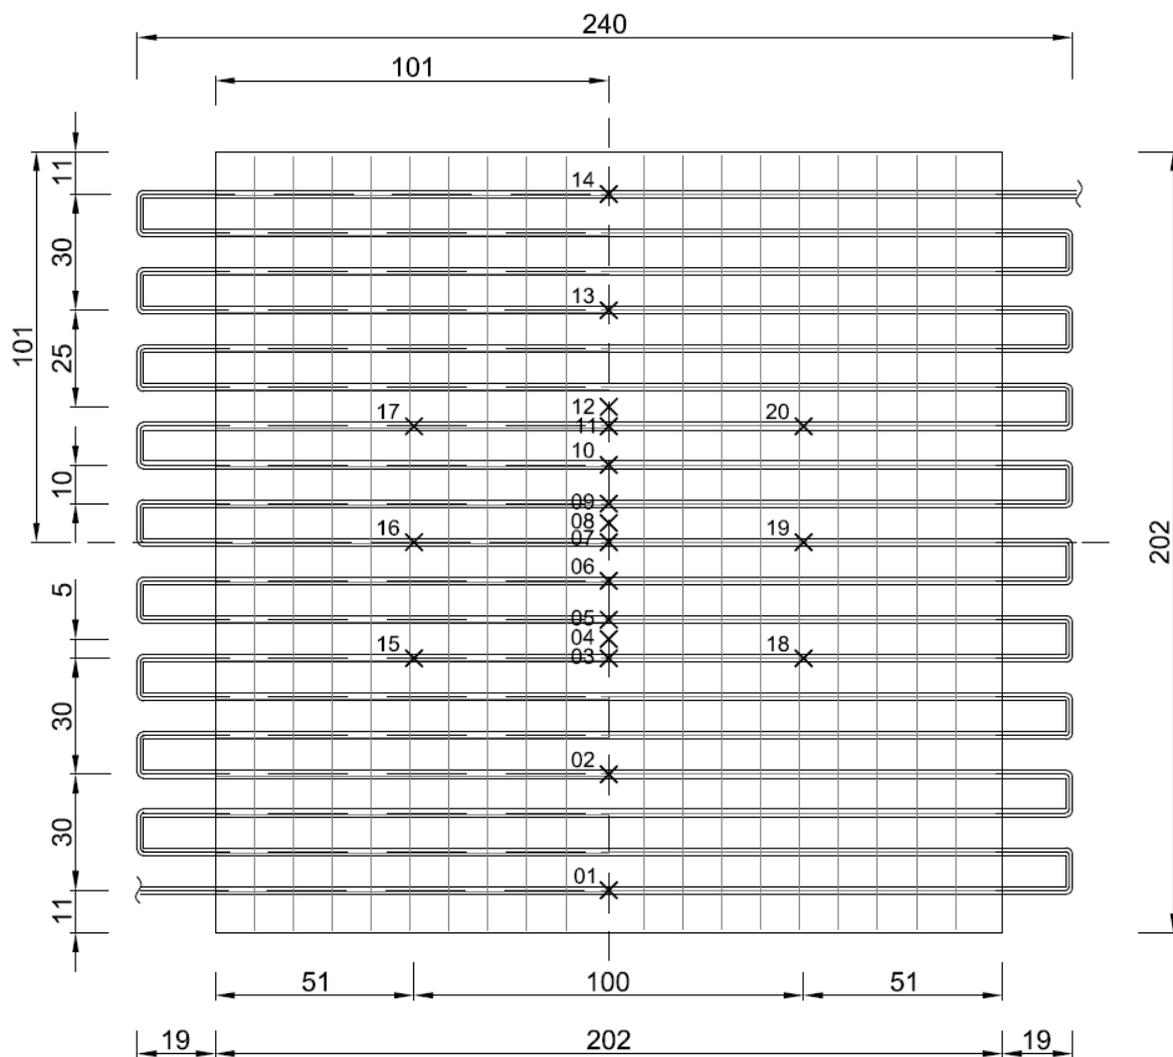
Fig. 3. Location of measurement points on the surface of the partition

A total of 40 Pt100 resistance temperature sensors with accuracy class according to manufacturer's data equal to 1/3 B for the range of positive temperatures were placed on the concrete surface under the polystyrene layer (20 sensors on each side of the partition). The location of individual measurement points on the partition surface is shown in Fig. 1 and Fig. 3. Symbol C denotes the location on concrete surface, markings: I and E refers to the location on surface adjacent to a specific air space i.e. I - the internal, E - the external (Fig. 1). The numbers denote a specific location on the wall surface (Fig. 3), the dimensions are given in centimeters.

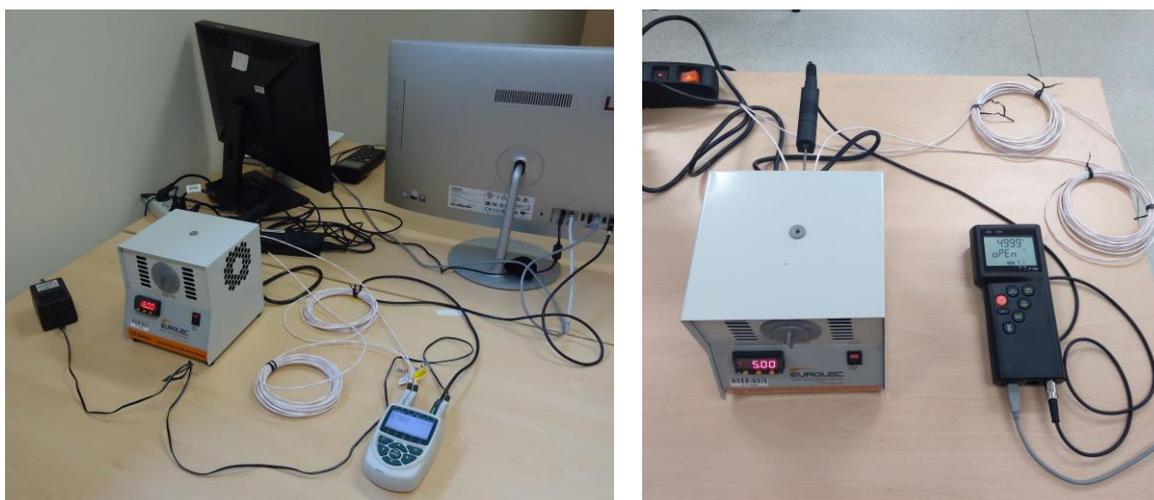
Fig. 4. The deviation measurement for temperature sensors

For temperature sensors, the deviation measurement was made with CS175 calibrator by EUROLEC INSTRUMENTATION Ltd. of accuracy of $\pm 0.05^{\circ}\text{C}$ and a resolution of 0.01°C , the ALMEMO data logger by AHLBORN with a resolution of 0.01°C and an electronic thermometer P795 by company DOSTMANN electronic with a Pt100 sensor with accuracy of $\pm 0.015^{\circ}\text{C}$ and a resolution of 0.001°C with a calibration certificate (Fig. 4). According to the data provided by the sensors' manufacturer on the absolute error at 100°C , the maximum value of 0.15°C occurs for sensor C_E_16, whereas minimum value for 4 sensors: C_I_07, C_I_13, C_E_11 and C_E_19 is in the order of 0.02°C . According to the IEC 60751: 2022 [16] standard, the permissible deviation for platinum resistors at 100°C should be $\pm 0.27^{\circ}\text{C}$, therefore the values from the technical data are within the expected range and are more accurate. Unfortunately, due to the temperature range up to $+85^{\circ}\text{C}$ of the calibrator, no measurements were made for 100°C . The tests carried out on it were in the settings of: 5°C , 10°C , 15°C , 20°C and 25°C , i.e. the conditions in which the partition can operate.

The procedure involved placing 2 surface sensors in the calibration chamber, at least 1 hour after the operating temperature of the calibrator was set. According the calibrator's operating instructions, the manufacturer allows waiting only 30 minutes, before taking any readings. The readings were extended twice, in order to be sure of the results obtained and due to the impossibility of repeating the deviations values tests after the experiment, i.e. after sensors were placed on the concrete wall, the beneath its insulation layer. For the same reason, the readings from the data logger for temperature sensors were taken after approximately 40 minutes. In the next step the results obtained for surface sensors were compared with the values indicated by the electronic thermometer, which was placed also in the calibration chamber. And the electronic thermometer is a standard instrument. Discrepancy results obtained for temperature readings are presented in chapter 3. In the same chapter was included the results of the main part of the experiment consisting in the assessment of influence of previously determined deviation on the interpretation of experimental results, i.e. temperature measurement on the concrete surface.

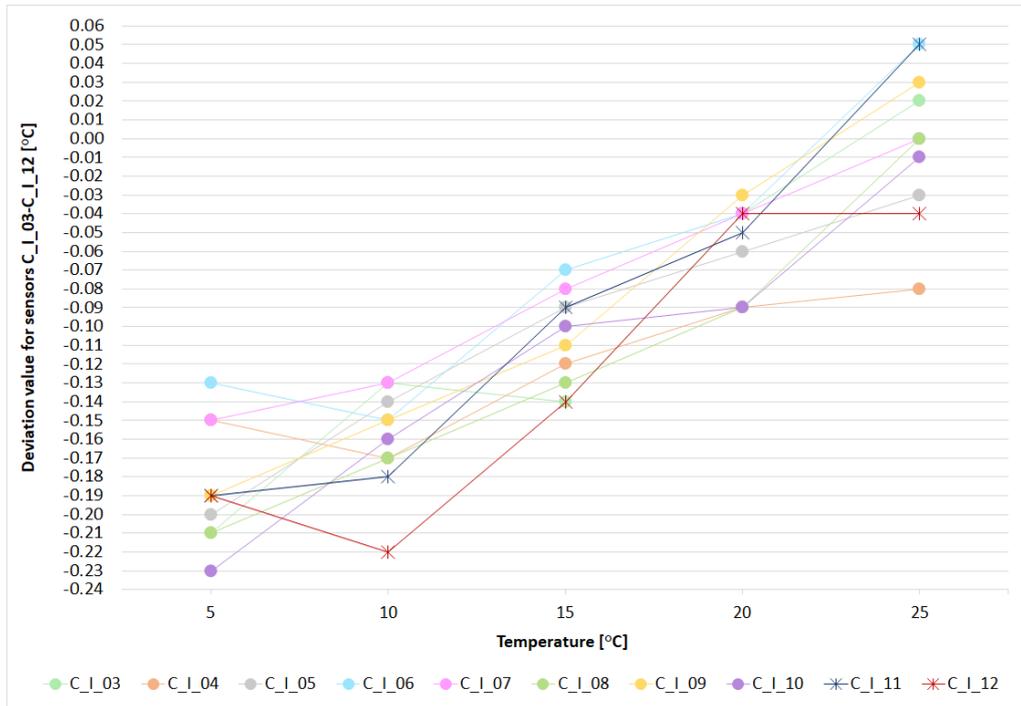
Fig. 5. Deviation values for sensors been mounted on the concrete internal surface under the polystyrene layer for C_I_03 - C_I_12

The graphs below (Fig. 5 - Fig. 8) show deviation curves of Pt100 sensors for the given temperature settings set in the calibrator. An upward trend is noticeable, not exceeding $\pm 0.1^\circ\text{C}$ for the temperature of 25°C ; however, only for one C_I_02 sensor (Fig. 6), the measurement at this temperature is exposed to absolute error of -0.12°C . For several sensors, a deviation of 0.01°C is achieved, which value is also the resolution of the measuring instrument. Referring to the conclusions of other researchers, certain similarities can be noticed. In the publication Jovanović and Denić indicate advantages and disadvantages of platinum resistance temperature sensors [17]. These sensors are characterized by: high accuracy and wide temperature range, but they have lower sensitivity and longer response time. The authors: Piechowski et al. [18] indicate that the group of the most accurate temperature sensors includes Pt100 sensors and mention their use also in industry around high voltage equipment. Another application is described by Echarri et al. [19]. In this publication Pt100 sensors were used to monitor the actual behaviour of building enclosure.

Returning to deviation measurement, the obtained results were crucial in deciding about assigning a given sensor to a place on the wall. The sensors with the lowest range of deviation values in temperature range of supply medium of partition (most often temperature range $16^\circ\text{C} - 22^\circ\text{C}$) were located in central location on surface concrete layer. So for sensors on the locations points from 3 to 12 deviation values were within range: $-0.14^\circ\text{C} - 0.01^\circ\text{C}$ for temperatures $15^\circ\text{C} - 20^\circ\text{C}$ (Fig. 5 and Fig. 7). Only 1 sensor reached value below -0.10°C for 20°C and it was C_E_09 with deviation value equal to -0.12°C (Fig. 7). For the sensors located on the rest part of surface of concrete layer (points from 1 to 2 and from 13 to 20) deviation values were within range: $-0.19^\circ\text{C} - 0.00^\circ\text{C}$ for temperatures $15^\circ\text{C} - 20^\circ\text{C}$ (Fig. 6 and Fig. 8). And 8 sensors reached value below -0.10°C for 20°C : C_I_01 (-0.14°C), C_I_02 (-0.14°C), C_I_14 (-0.13°C), C_I_15 (-0.12°C), C_I_17 (-0.12°C), C_I_20 (-0.12°C) in Fig. 6 and C_E_14 (-0.13°C), C_E_17 (-0.11°C) in Fig. 8.

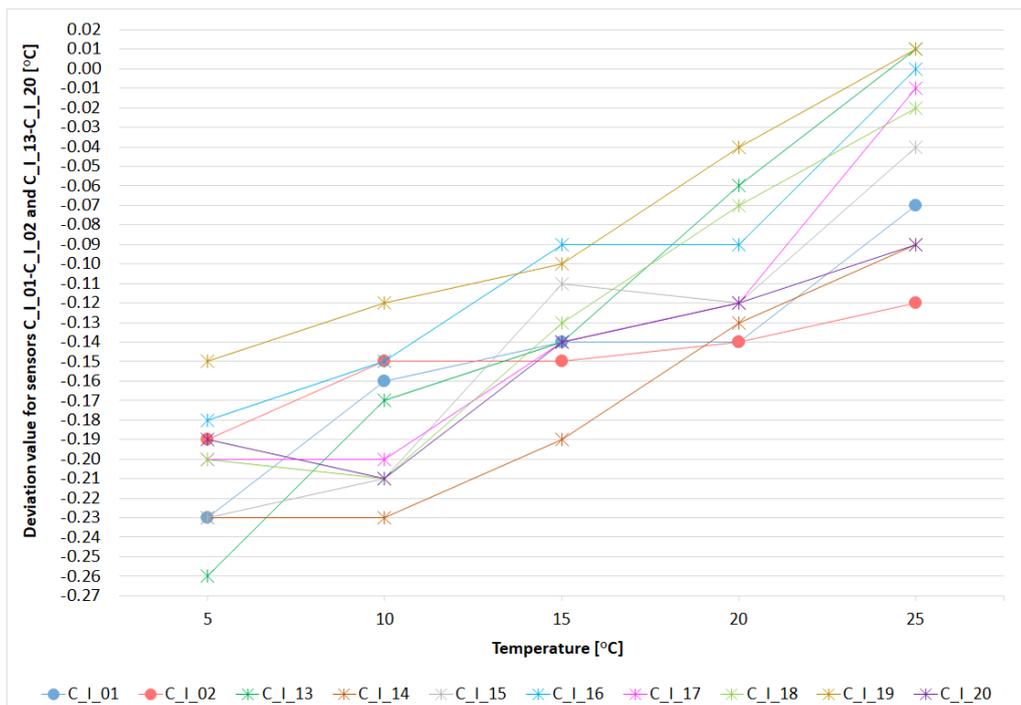
Fig. 6. Deviation values for sensors been mounted on the concrete internal surface under the polystyrene layer for C_I_01 - C_I_02 and C_I_13 - C_I_20

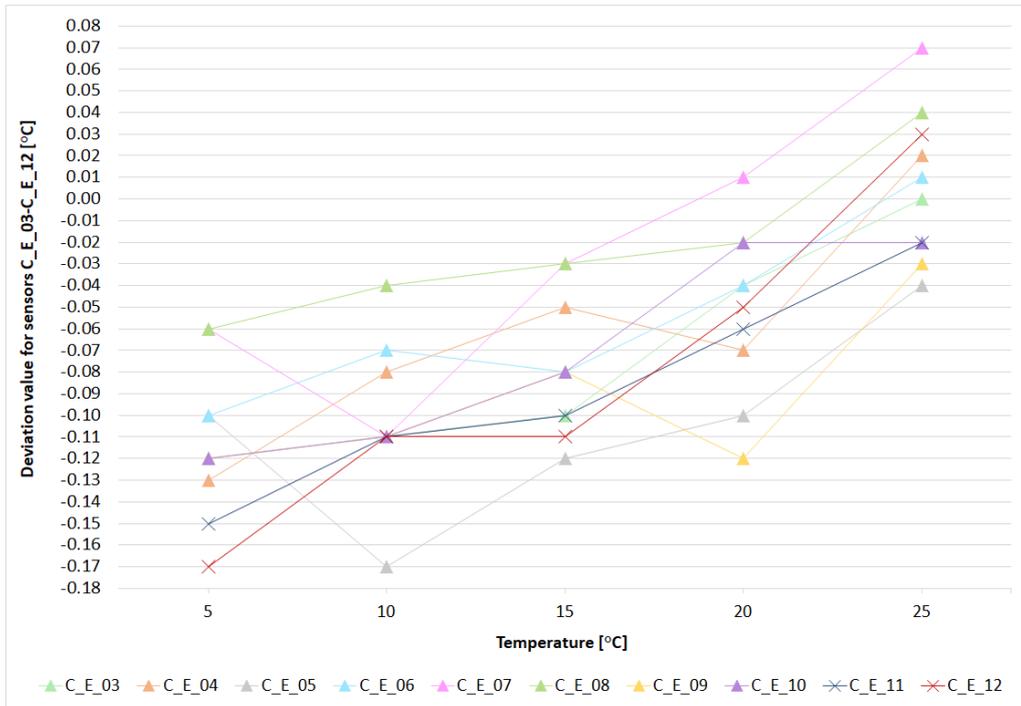
Fig. 7. Deviation values for sensors been mounted on the concrete external surface under the polystyrene layer for C_E_03 - C_E_12

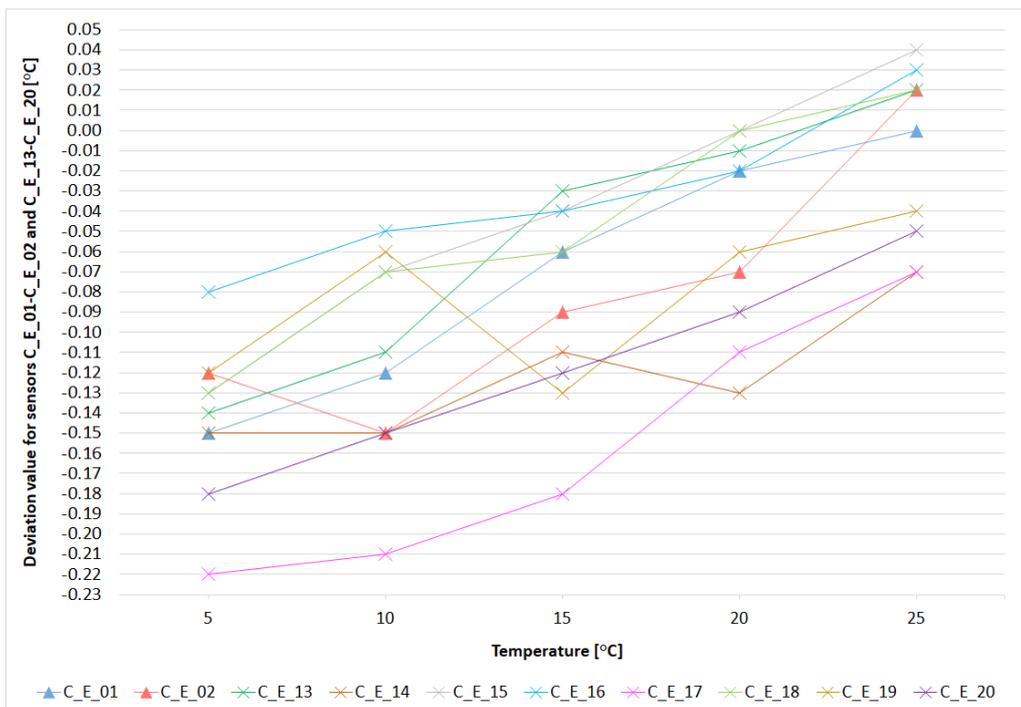
Fig. 8. Deviation values for sensors been mounted on the concrete external surface under the polystyrene layer for C_E_01 - C_E_02 and C_E_13 - C_E_20

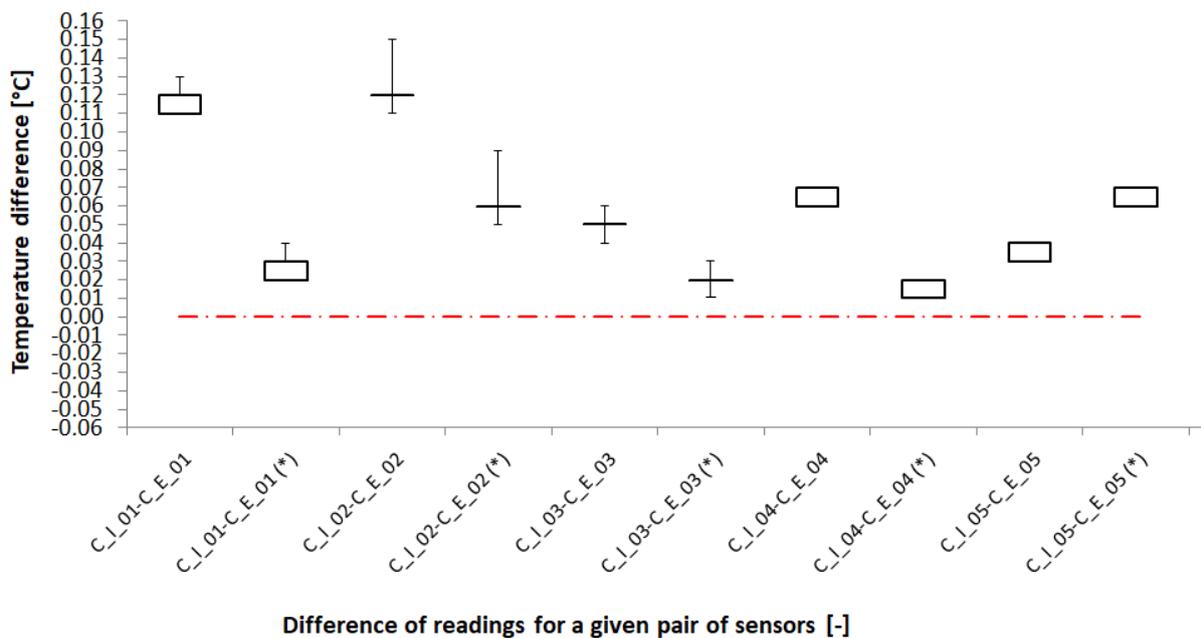
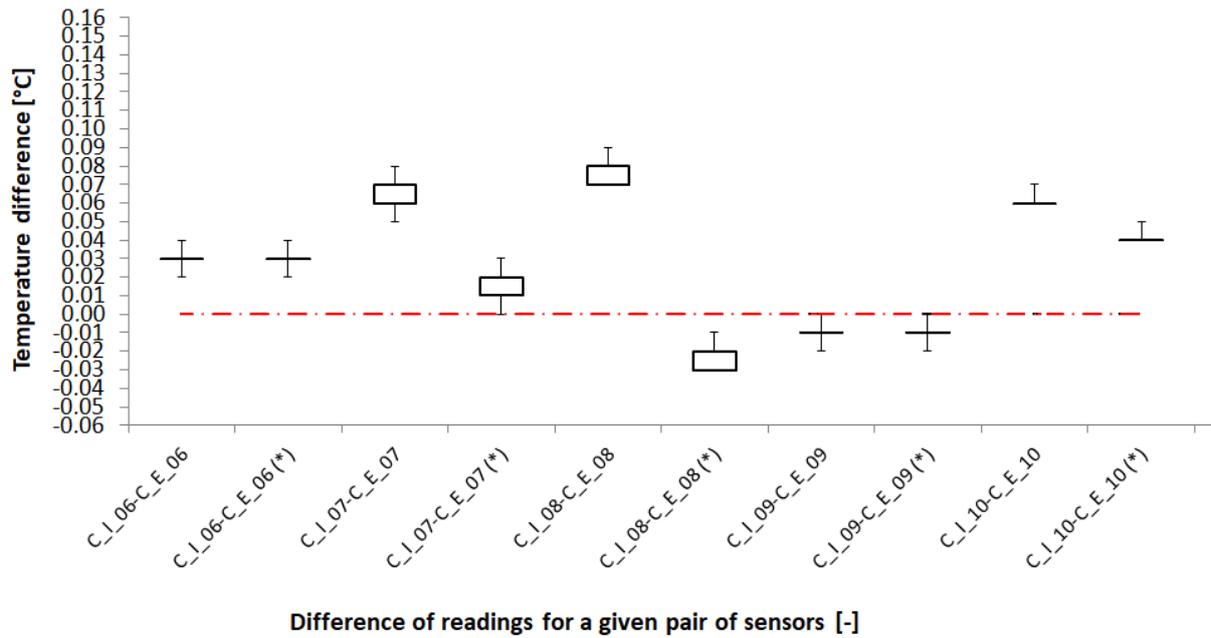
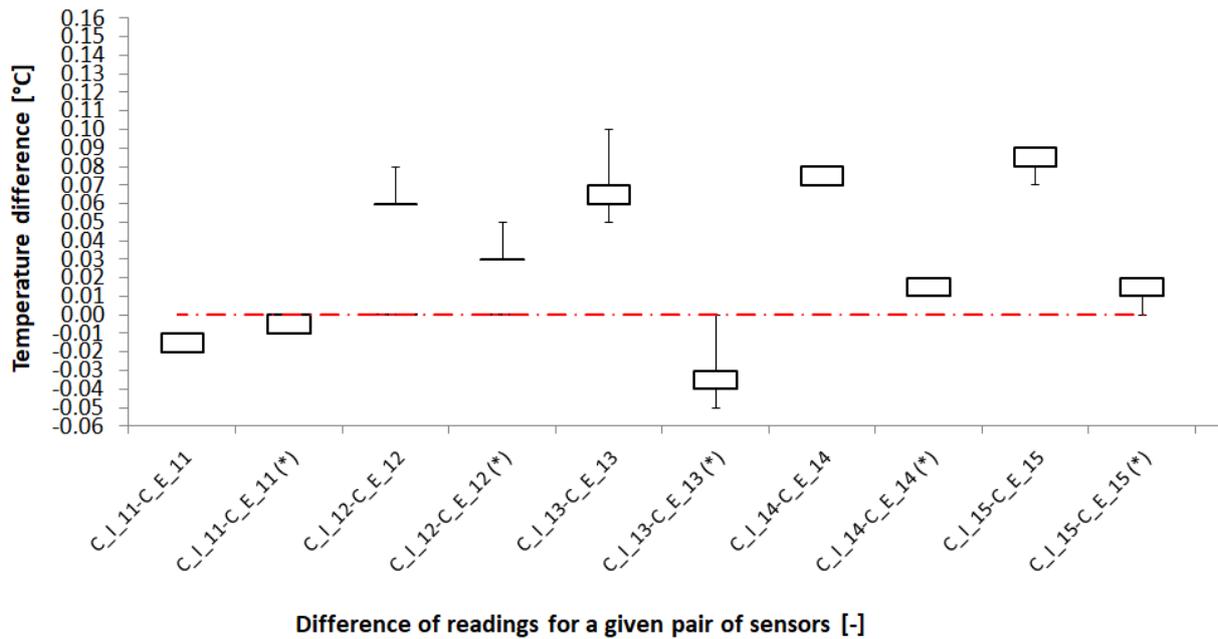
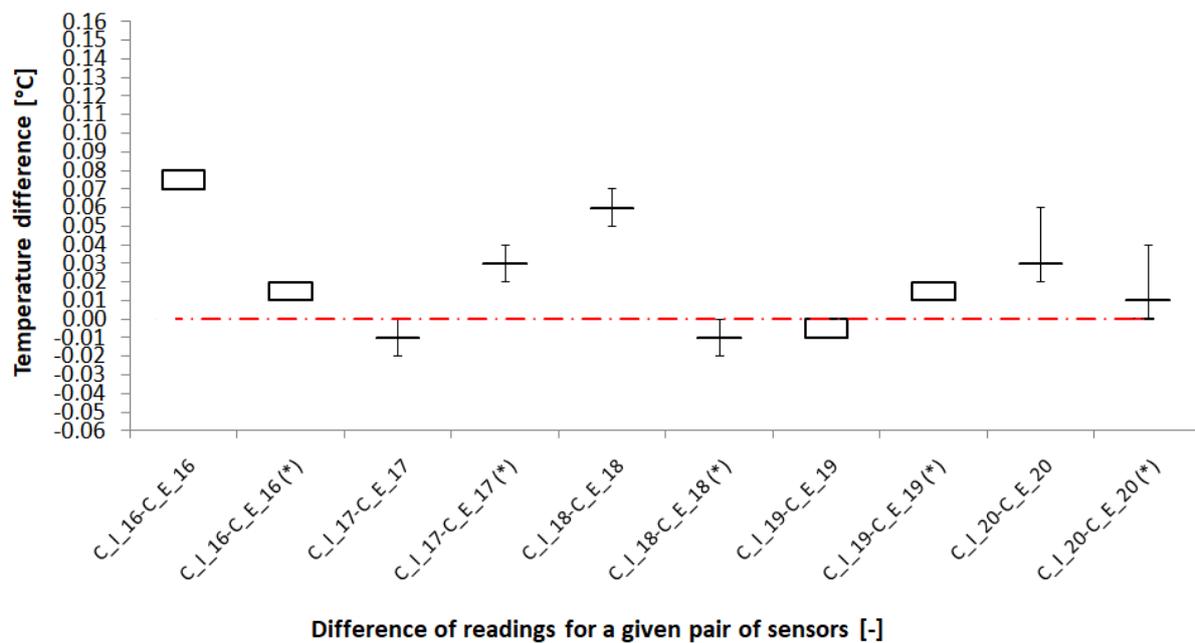
Fig. 9. Box and whisker plot for a setting of 16°C for sensors pairs 1 to 5

Fig. 10. Box and whisker plot for a setting of 16°C for sensors pairs 6 to 10

Fig. 11. Box and whisker plot for a setting of 16°C for sensors pairs 11 to 15

Fig. 12. Box and whisker plot for a setting of 16°C for sensors pairs 16 to 20

The tests were carried out for 4 supply temperatures of the loop in the wall: 16°C, 18°C, 20°C and 22°C. These values of temperature were different from the calibration's temperatures settings (5°C, 10°C, 15°C, 20°C and 25°C), because it was wanted to obtain universal deviation values for all temperature sensors mounted in the experimental stand. The total of 50 surface sensors were mounted: 40 on the concrete surface under insulation layer, and 5 on the insulation (polystyrene) surface on each side adjacent to air space. For sensors located on the polystyrene layer, the temperature readings were in wider ranges, because it was depending on the stage of research. However, this article presents results for 40 sensors on the concrete surface under insulation layer and without air flow into the air space, because in order to have no doubts as to the final results obtained i.e. the difference in temperature sensor readings in identical locations on both sides of the partition, should reach a value close to 0. A type of this partition i.e. pipe-embedded wall with insulation, should be supplied by low-temperature medium, earlier mentioned, most often, e.g. 16°C, 18°C, 20°C and 22°C. Measurements were recorded every 5 seconds, and the graphs were prepared (Fig. 9 - Fig. 24), the period for the temperature stabilization inside the partition was used. The number of measurements used to make box plots (box and whisker plots) was 1,805 measurements for respective temperature settings in the cooling bath thermostat at 16°C, 18°C, 20°C and 22°C. The asterisk (*) denotes differences in the readings of the sensors for whose deviation was taken into account. The red dash-dot line marks temperature difference of 0.00.

For differences in temperature readings between both sides of the partition, the third quartile was determined, which is interpreted in such a way that 75% of the observations are located below it. The greatest number of such cases, 32 out of 40 possible, occurred for the loop supply temperature in the concrete wall of 22°C (Fig. 21 - Fig. 24). Additionally, for some sensors maximum and minimum values were recorded for the differences, e.g. for sensors C_I_07 and C_E_07 for both supply temperatures of 16°C (Fig. 10) and 22°C (Fig. 22), in the other two settings, the distribution of differences was the same, i.e. throughout the analyzed period the sensors showed the same values whose differences were identical (Fig. 14 and Fig. 18). A similar situation was observed for sensors C_I_13 and C_E_13, but for the 22°C setting only the maximum value was registered (Fig. 23). For the pair of sensors C_I_14 and C_E_14, the distribution was always within the temperature range between which the difference was 0.01°C, regardless of the temperature setting (Fig. 11, Fig. 15 and Fig. 19); however, for the 22°C setting, maximum and minimum values were also observed (Fig. 23). The loop supply temperature in the partition for which the most situations with an even distribution of differences occurred was 18°C, then 34 such cases out of 40 were recorded (Fig. 13 - Fig. 16). For sensors C_I_12 and C_E_12, the distribution of differences was the same regardless of the temperature setting in the cooling bath thermostat; nevertheless, there were individual situations when it was possible to record extreme values (minimum - for 20°C in Fig. 19, maximum - for 16°C in Fig. 11 or both - for 22°C in Fig. 23).

Taking absolute error of the sensors into account in the measurements made the differences in the temperature indications closer to the expected level, i.e. the value of 0. For some sensors it was possible to achieve this: C_I_07 and C_E_07 (for the settings: 16°C in Fig. 10, 20°C in Fig. 18), C_I_08 and C_E_08 (for the setting: 20°C in Fig. 18), C_I_09 and C_E_09 (for the settings: 16°C in Fig. 10, 18°C in Fig. 14), C_I_10 and C_E_10 (for the setting: 18°C in Fig. 14), C_I_11 and C_E_11 (for the settings: 16°C in Fig. 11, 22°C in Fig. 23), C_I_13 and C_E_13 (for the settings: 16°C in Fig. 11, 20°C in Fig. 19), C_I_14 and C_E_14 (for the setting: 20°C in Fig. 19), C_I_15 and C_E_15 (for the setting: 16°C

in Fig. 11), C_I_16 and C_E_16 (for the settings: 18°C in Fig. 16, 20°C in Fig. 20), C_I_17 and C_E_17 (for the setting: 18°C in Fig. 16), C_I_18 and C_E_18 (for the setting: 16°C in Fig. 12), C_I_19 and C_E_19 (for the settings: 18°C in Fig. 16, 20°C in Fig. 20) and C_I_20 and C_E_20 (for the settings: 16°C in Fig. 12, 18°C in Fig. 16).

In 5 cases for sensors: C_I_01 and C_E_01 (for the setting: 20°C - Fig. 17), C_I_05 and C_E_05 (for the all settings: 16°C - Fig. 9, 18°C - Fig. 13, 20°C - Fig. 17 and 22°C - Fig. 21), C_I_09 and C_E_09 (for the setting: 22°C - Fig. 22), C_I_17 and C_E_17 (for the settings: 16°C - Fig. 12, 22°C - Fig. 24.), C_I_19 and C_E_19 (for the settings: 16°C - Fig. 12, 22°C - Fig. 24) the effect was opposite, but the differences still remained small, i.e. not exceeding 0.09°C.

For certain sensors, introducing the deviation did not change anything in the value of the temperature difference on both sides of the partition. This happened for the following sensors: C_I_06 and C_E_06 (for the settings: 16°C - Fig. 10, 18°C - Fig. 14, 20°C - Fig. 18), C_I_09 and C_E_09 (for the setting: 16°C - Fig. 10), C_I_12 and C_E_12 (for the settings: 20°C - Fig. 19, 22°C - Fig. 23), C_I_14 and C_E_14 (for the setting: 20°C - Fig. 19) and C_I_17 and C_E_17 (for the setting: 20°C - Fig. 20). In this chapter 3 should also mentioned about potential limitations of the experimental setup. During the deviation measurement the sensors were placed in calibration chamber, but during the experiment the sensors were located on the surface of concrete layer. The uniformity of the concrete layer may also important. To make readings it is necessary connected sensors to data logger by connectors. Potential limitation can resulted of measurement's equipment, for example accuracy, resolution and operating range.

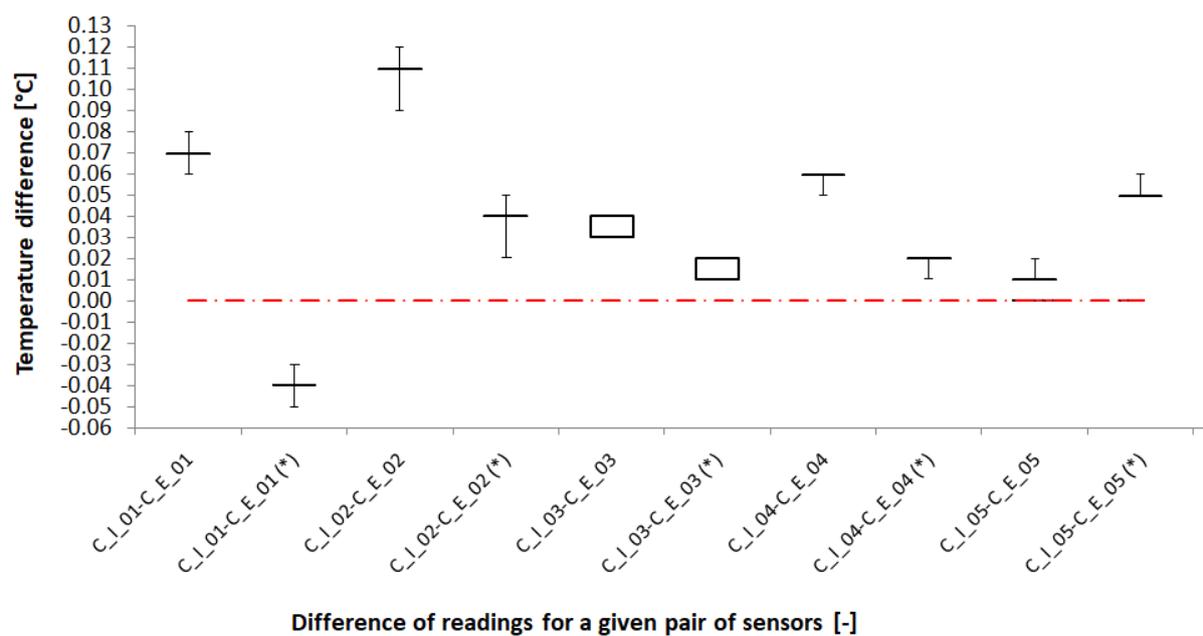
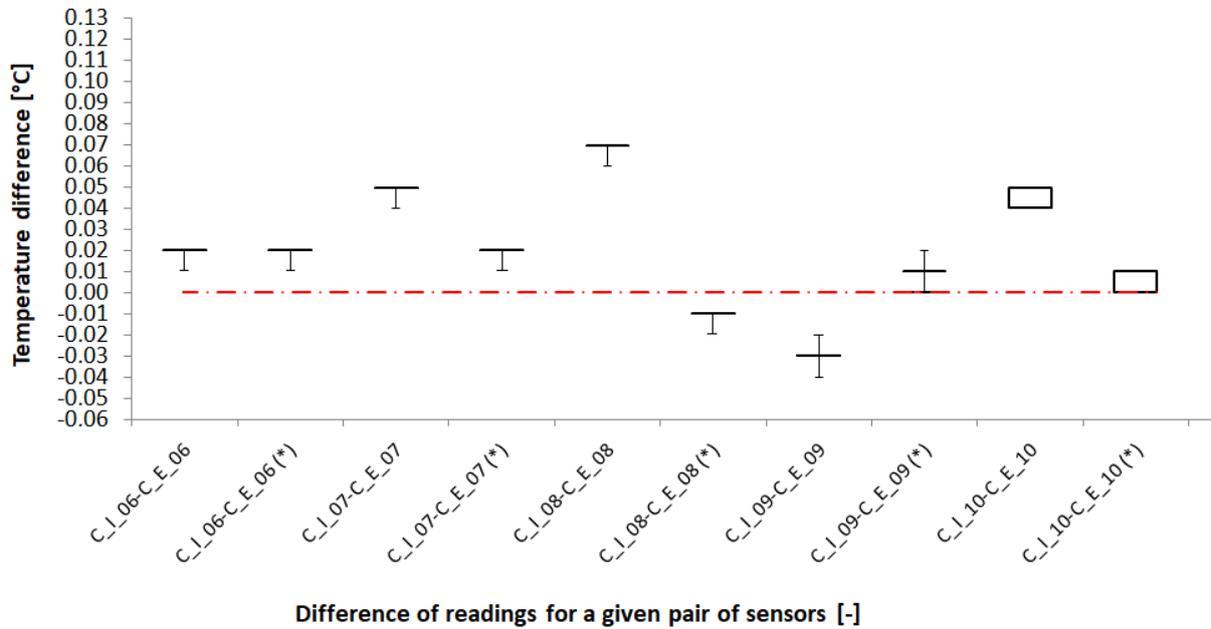
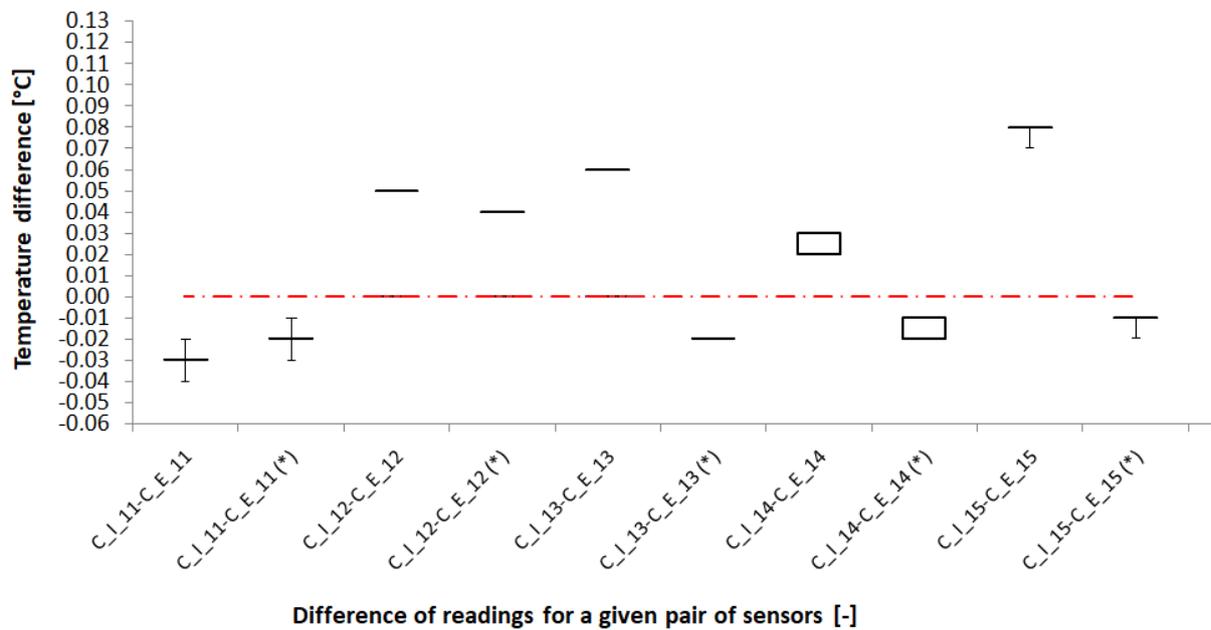
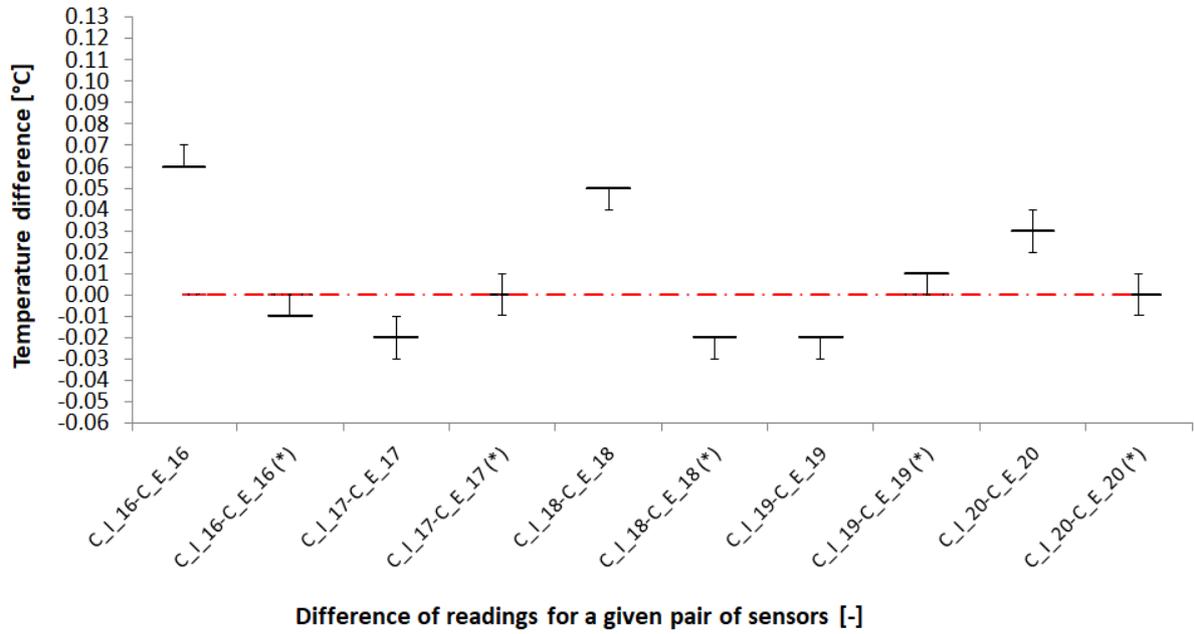
Fig. 13. Box and whisker plot for a setting of 18°C for sensors pairs 1 to 5

Fig. 14. Box and whisker plot for a setting of 18°C for sensors pairs 6 to 10

Fig. 15. Box and whisker plot for a setting of 18°C for sensors pairs 11 to 15

Fig. 16. Box and whisker plot for a setting of 18°C for sensors pairs 16 to 20

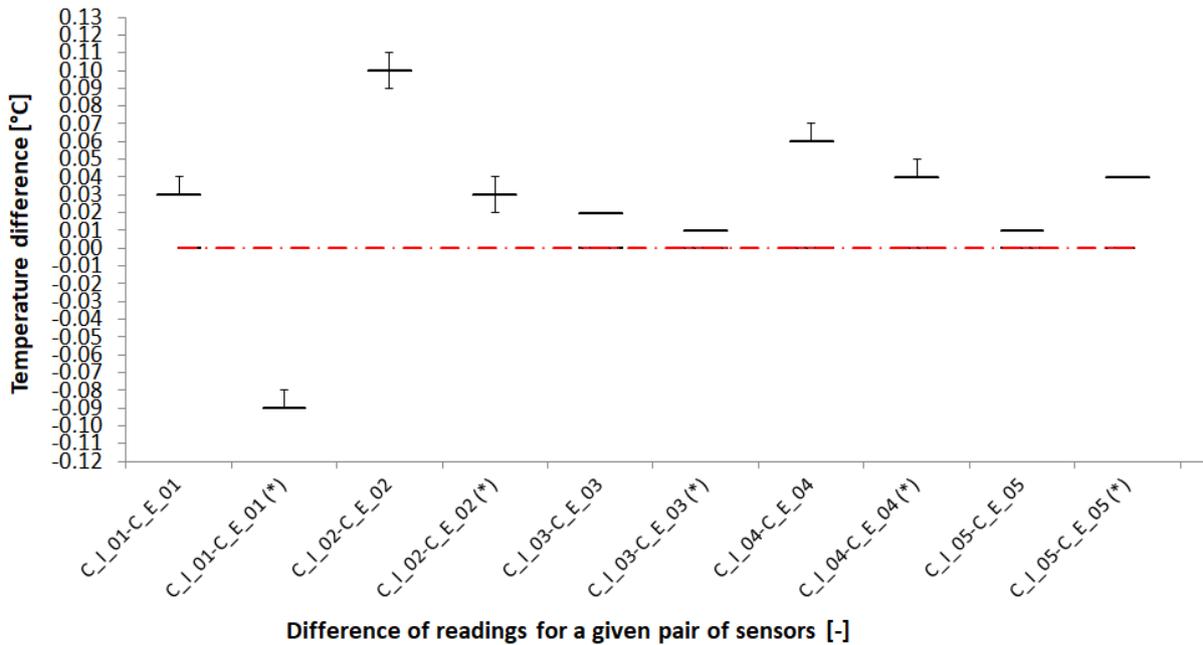
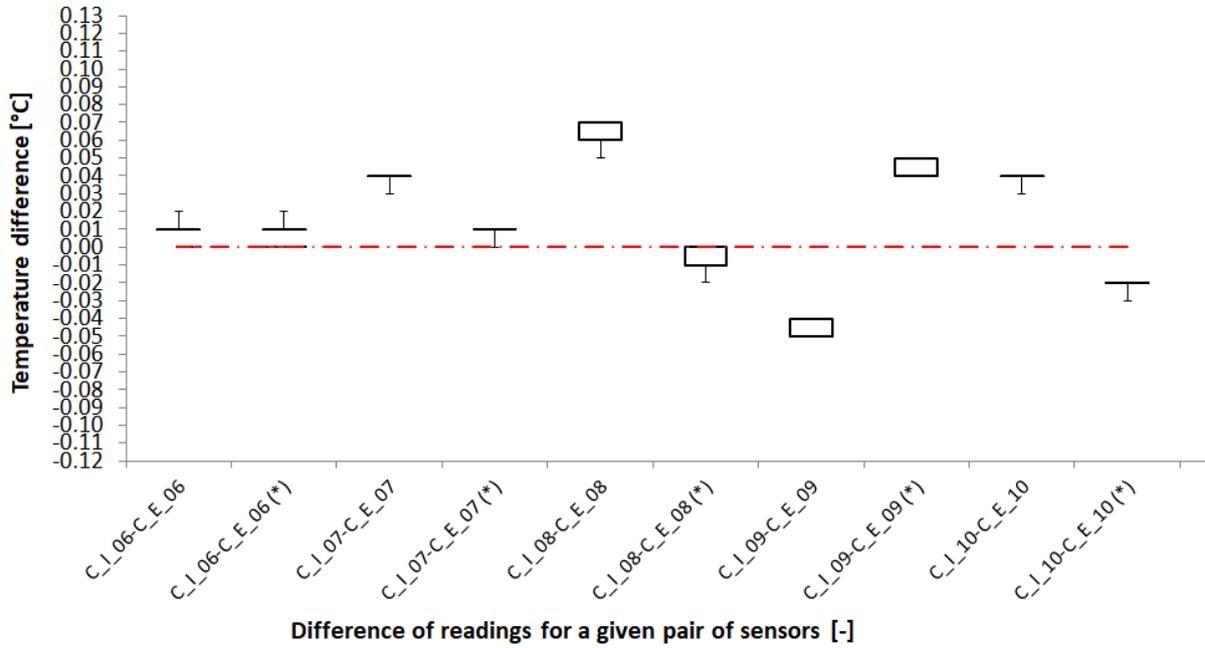
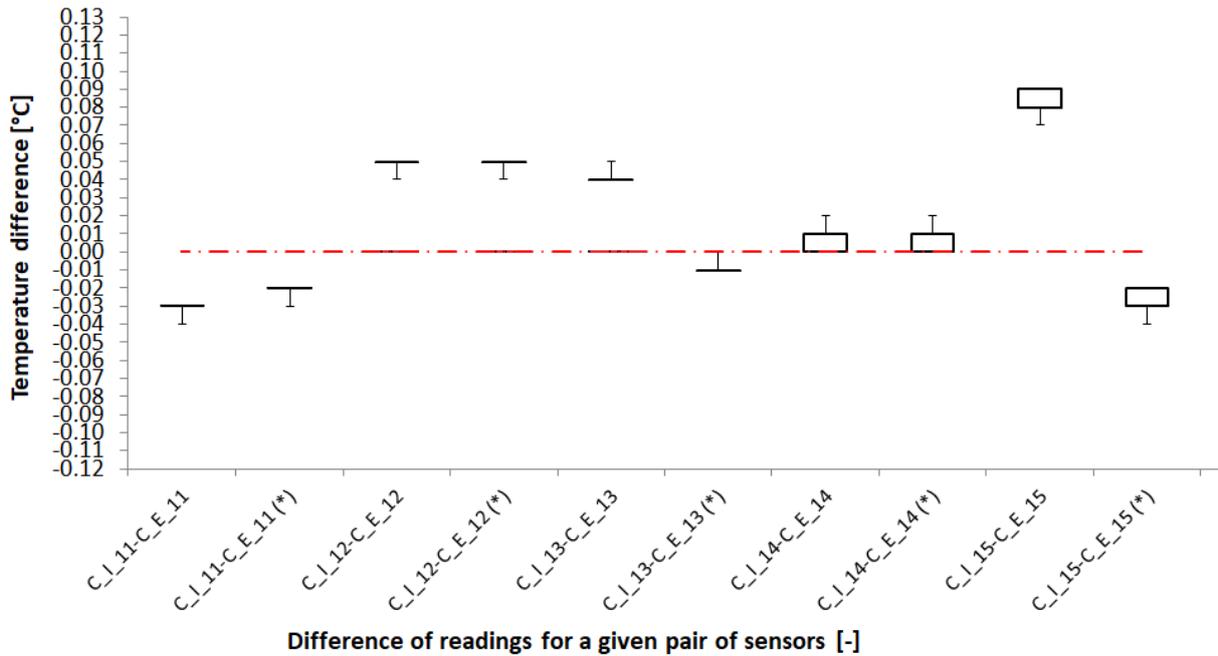
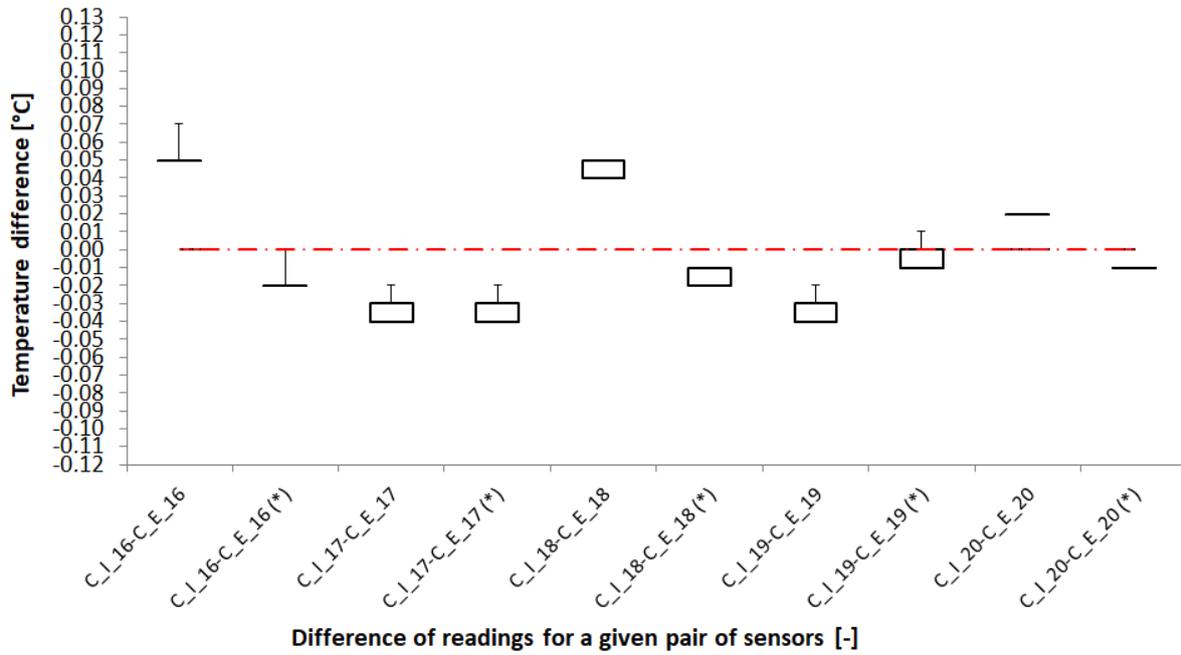
Fig. 17. Box and whisker plot for a setting of 20°C for sensors pairs 1 to 5

Fig. 18. Box and whisker plot for a setting of 20°C for sensors pairs 6 to 10

Fig. 19. Box and whisker plot for a setting of 20°C for sensors pairs 11 to 15

Fig. 20. Box and whisker plot for a setting of 20°C for sensors pairs 16 to 20
