INFLUENCE OF TEMPERATURE SENSOR (PT100) ACCURACY ON THE INTERPRETATION OF EXPERIMENTAL RESULTS OF MEASURING TEMPERATURE ON THE SURFACE

Maria Teresa MAŁEK¹, Halina KOCZYK

Poznan University of Technology, Faculty of Environmental Engineering and Energy, Institute of Environmental Engineering and Building Installations, Poland

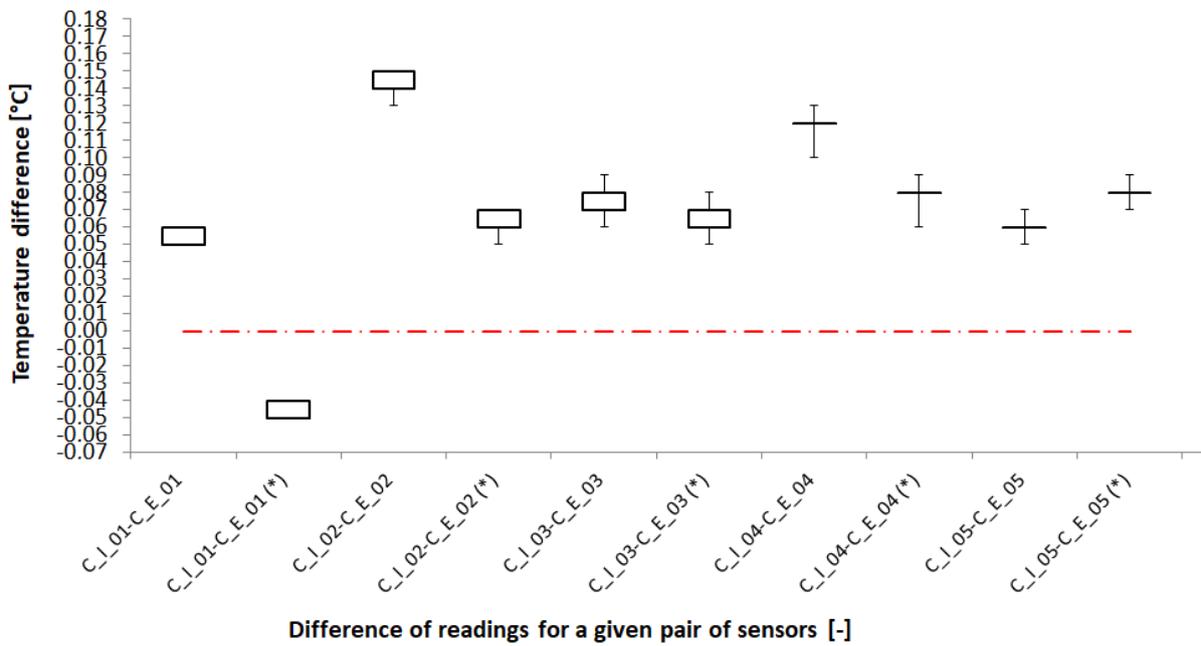
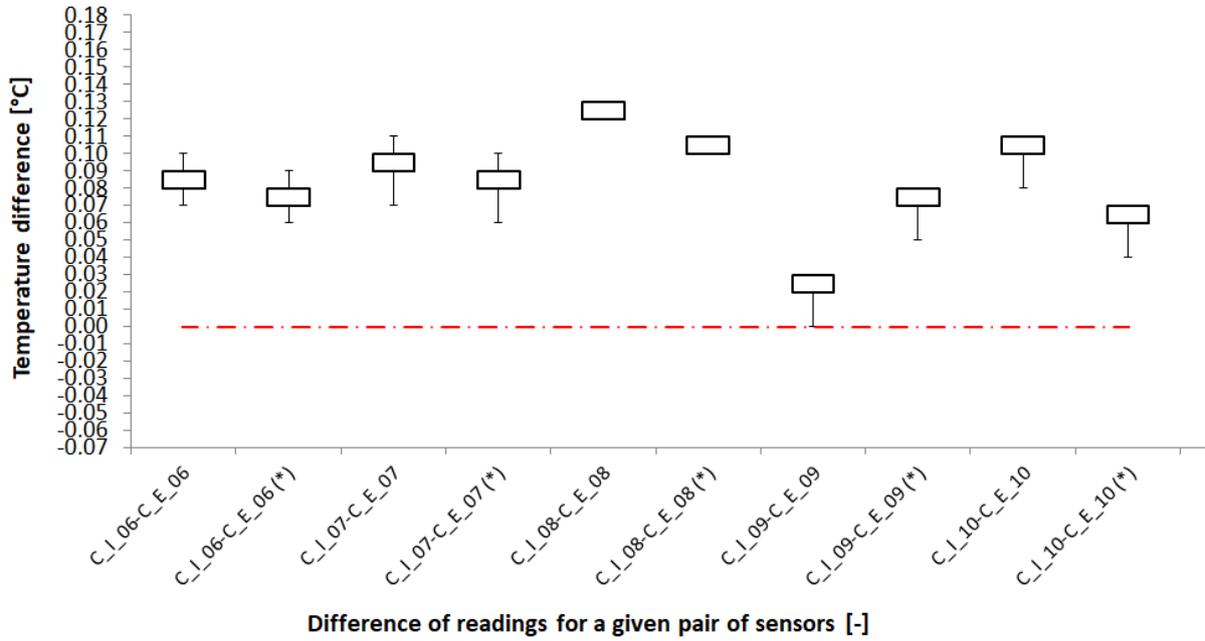
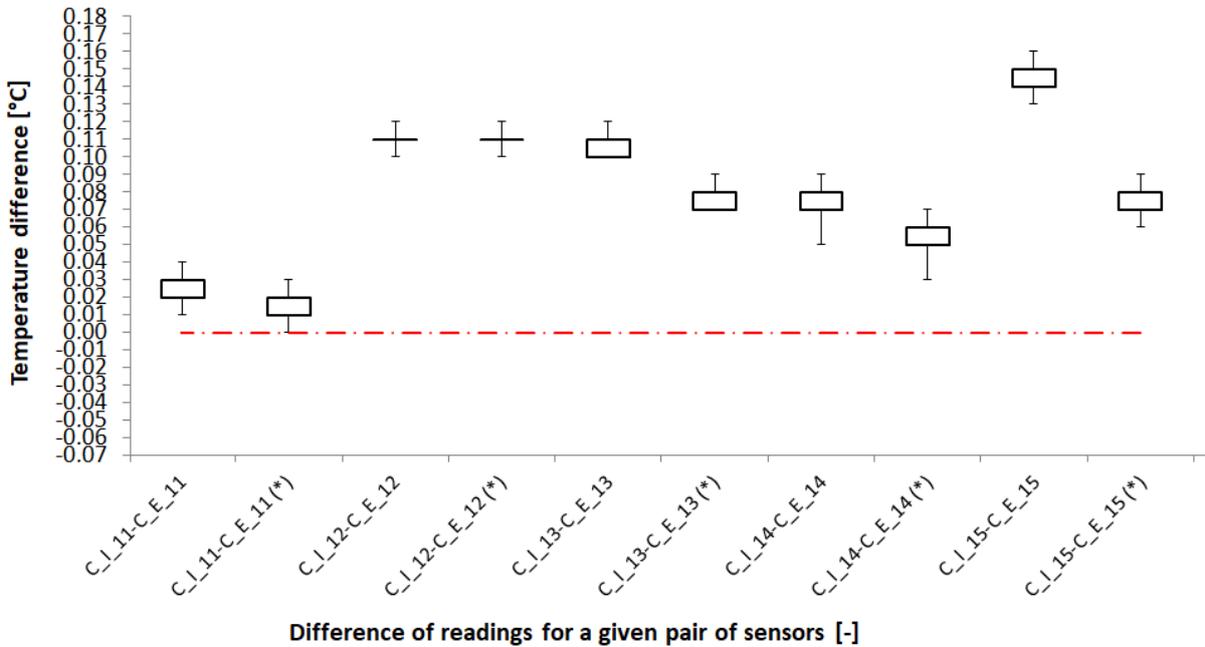
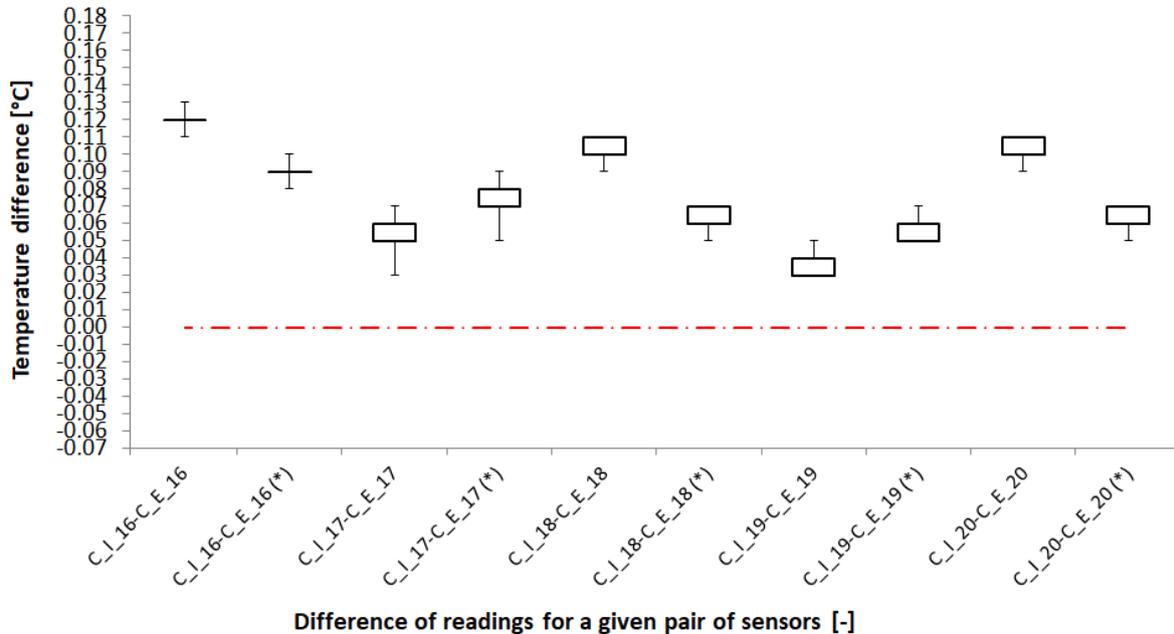
Fig. 21. Box and whisker plot for a setting of 22°C for sensors pairs 1 to 5

Fig. 22. Box and whisker plot for a setting of 22°C for sensors pairs 6 to 10

Fig. 23. Box and whisker plot for a setting of 22°C for sensors pairs 11 to 15

Fig. 24. Box and whisker plot for a setting of 22°C for sensors pairs 16 to 20

The tests were carried out for 4 supply temperatures of the loop in the wall: 16°C, 18°C, 20°C and 22°C. These values of temperature were different from the calibration's temperatures settings (5°C, 10°C, 15°C, 20°C and 25°C), because it was wanted to obtain universal deviation values for all temperature sensors mounted in the experimental stand. The total of 50 surface sensors were mounted: 40 on the concrete surface under insulation layer, and 5 on the insulation (polystyrene) surface on each side adjacent to air space. For sensors located on the polystyrene layer, the temperature readings were in wider ranges, because it was depending on the stage of research. However, this article presents results for 40 sensors on the concrete surface under insulation layer and without air flow into the air space, because in order to have no doubts as to the final results obtained i.e. the difference in temperature sensor readings in identical locations on both sides of the partition, should reach a value close to 0. A type of this partition i.e. pipe-embedded wall with insulation, should be supplied by low-temperature medium, earlier mentioned, most often, e.g. 16°C, 18°C, 20°C and 22°C. Measurements were recorded every 5 seconds, and the graphs were prepared (Fig. 9 - Fig. 24), the period for the temperature stabilization inside the partition was used. The number of measurements used to make box plots (box and whisker plots) was 1,805 measurements for respective temperature settings in the cooling bath thermostat at 16°C, 18°C, 20°C and 22°C. The asterisk (*) denotes differences in the readings of the sensors for whose deviation was taken into account. The red dash-dot line marks temperature difference of 0.00.

For differences in temperature readings between both sides of the partition, the third quartile was determined, which is interpreted in such a way that 75% of the observations are located below it. The greatest number of such cases, 32 out of 40 possible, occurred for the loop supply temperature in the concrete wall of 22°C (Fig. 21 - Fig. 24). Additionally, for some sensors maximum and minimum values were recorded for the differences, e.g. for sensors C_I_07 and C_E_07 for both supply temperatures of 16°C (Fig. 10) and 22°C (Fig. 22), in the other two settings, the distribution of differences was the same, i.e. throughout the analyzed period the sensors showed the same values whose differences were identical (Fig. 14 and Fig. 18). A similar situation was observed for sensors C_I_13 and C_E_13, but for the 22°C setting only the maximum value was registered (Fig. 23). For the pair of sensors C_I_14 and C_E_14, the distribution was always within the temperature range between which the difference was 0.01°C, regardless of the temperature setting (Fig. 11, Fig. 15 and Fig. 19); however, for the 22°C setting, maximum and minimum values were also observed (Fig. 23). The loop supply temperature in the partition for which the most situations with an even distribution of differences occurred was 18°C, then 34 such cases out of 40 were recorded (Fig. 13 - Fig. 16). For sensors C_I_12 and C_E_12, the distribution of differences was the same regardless of the temperature setting in the cooling bath thermostat; nevertheless, there were individual situations when it was possible to record extreme values (minimum - for 20°C in Fig. 19, maximum - for 16°C in Fig. 11 or both - for 22°C in Fig. 23).

Taking absolute error of the sensors into account in the measurements made the differences in the temperature indications closer to the expected level, i.e. the value of 0. For some sensors it was possible to achieve this: C_I_07 and C_E_07 (for the settings: 16°C in Fig. 10, 20°C in Fig. 18), C_I_08 and C_E_08 (for the setting: 20°C in Fig. 18), C_I_09 and C_E_09 (for the settings: 16°C in Fig. 10, 18°C in Fig. 14), C_I_10 and C_E_10 (for the setting: 18°C in Fig. 14), C_I_11 and C_E_11 (for the settings: 16°C in Fig. 11, 22°C in Fig. 23), C_I_13 and C_E_13 (for the settings: 16°C in Fig. 11, 20°C in Fig. 19), C_I_14 and C_E_14 (for the setting: 20°C in Fig. 19), C_I_15 and C_E_15 (for the setting: 16°C

in Fig. 11), C_I_16 and C_E_16 (for the settings: 18°C in Fig. 16, 20°C in Fig. 20), C_I_17 and C_E_17 (for the setting: 18°C in Fig. 16), C_I_18 and C_E_18 (for the setting: 16°C in Fig. 12), C_I_19 and C_E_19 (for the settings: 18°C in Fig. 16, 20°C in Fig. 20) and C_I_20 and C_E_20 (for the settings: 16°C in Fig. 12, 18°C in Fig. 16).

In 5 cases for sensors: C_I_01 and C_E_01 (for the setting: 20°C - Fig. 17), C_I_05 and C_E_05 (for the all settings: 16°C - Fig. 9, 18°C - Fig. 13, 20°C - Fig. 17 and 22°C - Fig. 21), C_I_09 and C_E_09 (for the setting: 22°C - Fig. 22), C_I_17 and C_E_17 (for the settings: 16°C - Fig. 12, 22°C - Fig. 24.), C_I_19 and C_E_19 (for the settings: 16°C - Fig. 12, 22°C - Fig. 24) the effect was opposite, but the differences still remained small, i.e. not exceeding 0.09°C.

For certain sensors, introducing the deviation did not change anything in the value of the temperature difference on both sides of the partition. This happened for the following sensors: C_I_06 and C_E_06 (for the settings: 16°C - Fig. 10, 18°C - Fig. 14, 20°C - Fig. 18), C_I_09 and C_E_09 (for the setting: 16°C - Fig. 10), C_I_12 and C_E_12 (for the settings: 20°C - Fig. 19, 22°C - Fig. 23), C_I_14 and C_E_14 (for the setting: 20°C - Fig. 19) and C_I_17 and C_E_17 (for the setting: 20°C - Fig. 20). In this chapter 3 should also mentioned about potential limitations of the experimental setup. During the deviation measurement the sensors were placed in calibration chamber, but during the experiment the sensors were located on the surface of concrete layer. The uniformity of the concrete layer may also important. To make readings it is necessary connected sensors to data logger by connectors. Potential limitation can resulted of measurement's equipment, for example accuracy, resolution and operating range.
