## RENOVATION OF THE LAPIDARIUM IN KOZUCHÓW

Bartosz MICHALAK<sup>1</sup>

University of Zielona Góra, Institute of Civil Engineering, Poland

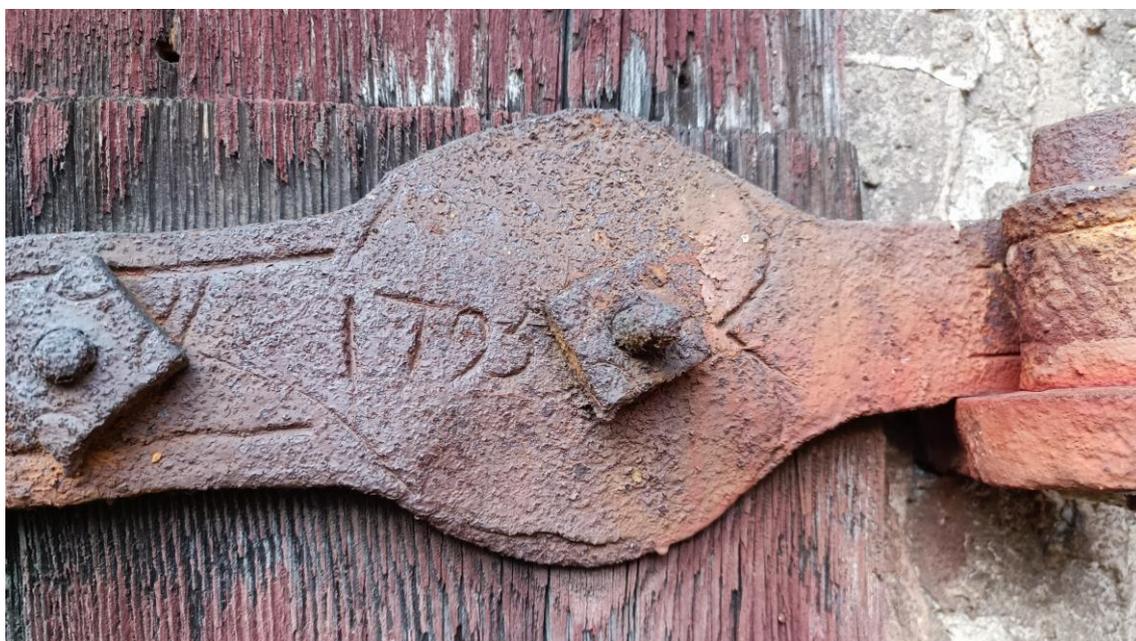
Fig. 3. Date of manufacture in cemetery gates (Autor)

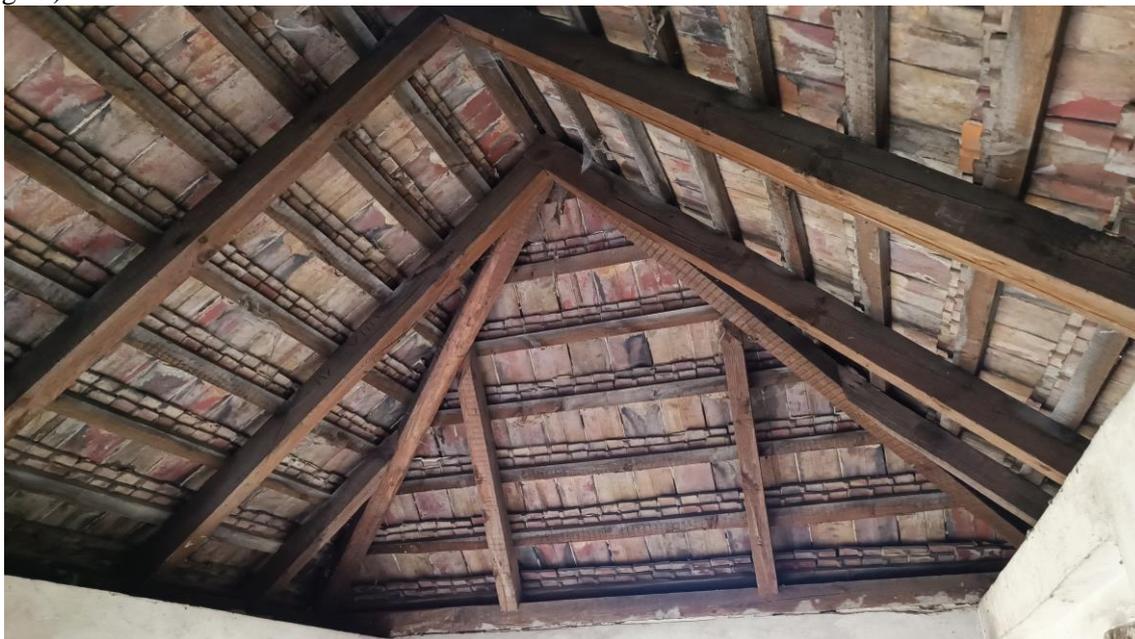
Fig. 4. Construction of the roof in the chappel (Autor)

- Replacement of the roofs of the chapels - manual dismantling of roofs, sorting, cleaning and hydrophobization of the removed tiles for reuse; dismantling of the wooden trusses of the chapels; construction of new wooden rafters made of treated wood, covering with ceramic plain tile in scales; copper roofing flashings; use of a clear agent against biological corrosion (Fig. 4.)

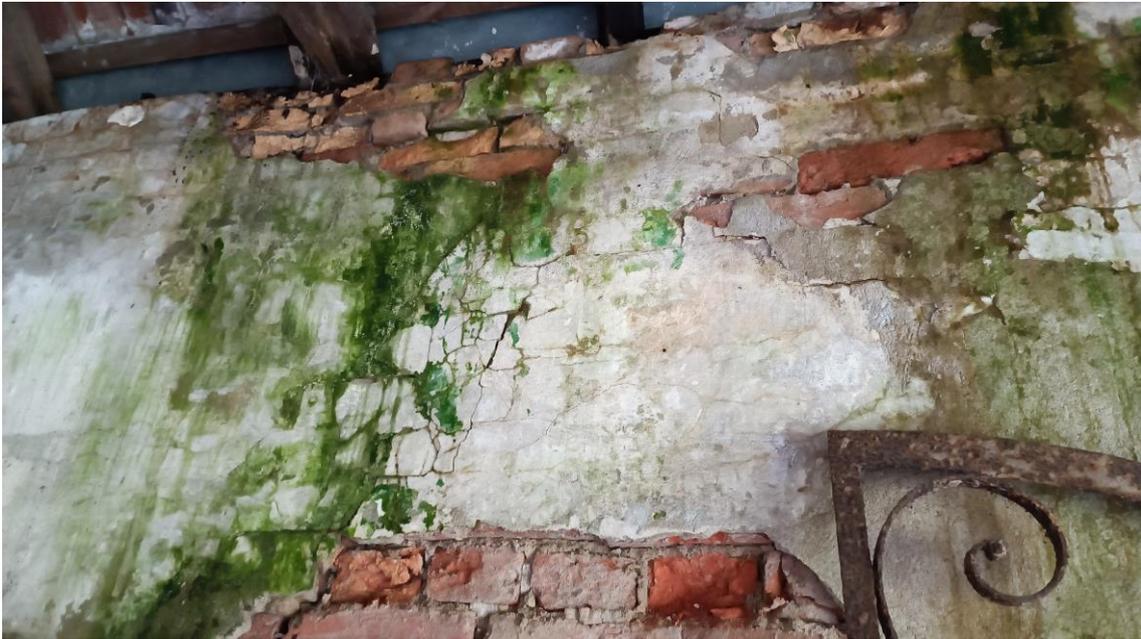
Fig. 5. View of masonry before repair: chipped plaster, salinity and biological corrosion (Autor)

Prior to the restoration work, a diagnostic was carried out for moisture in the masonry - the masonry was determined to be wet, the level of water saturation (by weight) was above 20% in most of the sites examined. Re-plastering with restoration plaster in accordance with WTA 2-9-04/D in the lower part of the wall; whitewashing the walls from the outside. Lime mortar with white cement was used for the work. The use of renovation plasters, is primarily walls and walls, which for years deprived of moisture insulation corroded and covered with salt efflorescence. Using this kind of plasters results in protection from further water soaking (mechanically by undercutting and replenishing insulation or chemically) from the very beginning.

- Renovation and replenishment of stucco detailing of the exterior walls of the chapels - Scuffing off chipped cement-lime plaster from the exterior face of the chapels; replenishing brick and mortar defects,

The next step was the scraping off of all salt-laden, crumpled and loose layers, followed by the application of a cementitious dressing that acts as a grafting bridge for the next layers - after which comes, perhaps the most important moment in the entire process, the application of a leveling restoration plaster.

Thanks to its high air pore content, it is designed to trap salts that will continue to migrate outward from the wall for some time to come. These salts increase in volume during crystallization or hydration, forming structures that destroy traditional plasters.

The renovation work began with site preparation. These consisted of: exposing the face of the masonry, making an inventory of the exposed joints, edges of the masonry, battlements, niches and possible stonework details, conducting a chronological stratification of the masonry with a description of the materials and technology used, and making descriptive, drawing and photographic documentation. Conservation studies were carried out on the walls of the chapels, including: studies of the arrangement of historical layers and color, analysis of historical relics, recognition of the materials used and their properties [9, 10] (Fig. 5-7.)

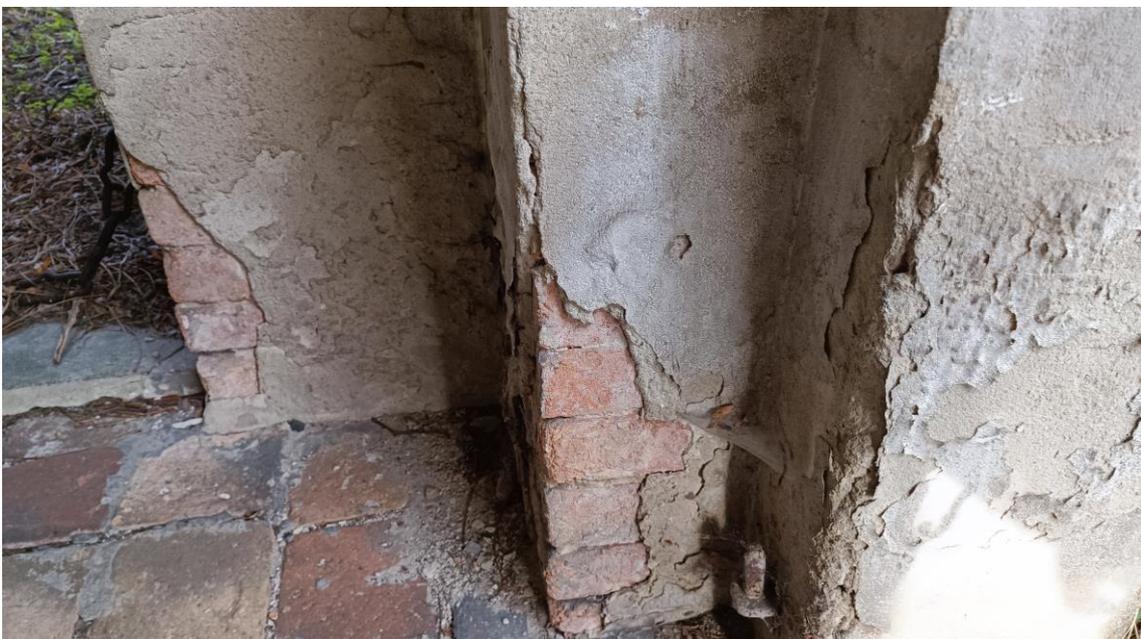
Fig. 6. Interior wall of the chapel: chipped plaster, salinity (Autor)

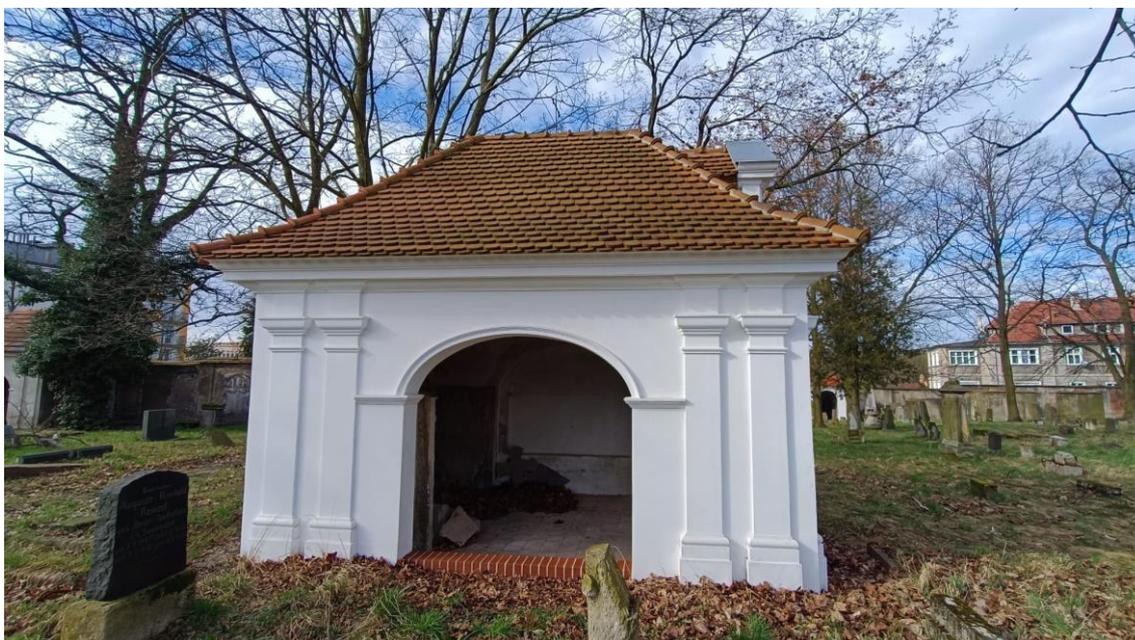
Fig. 7. One of the chapels after renovation works (Autor)

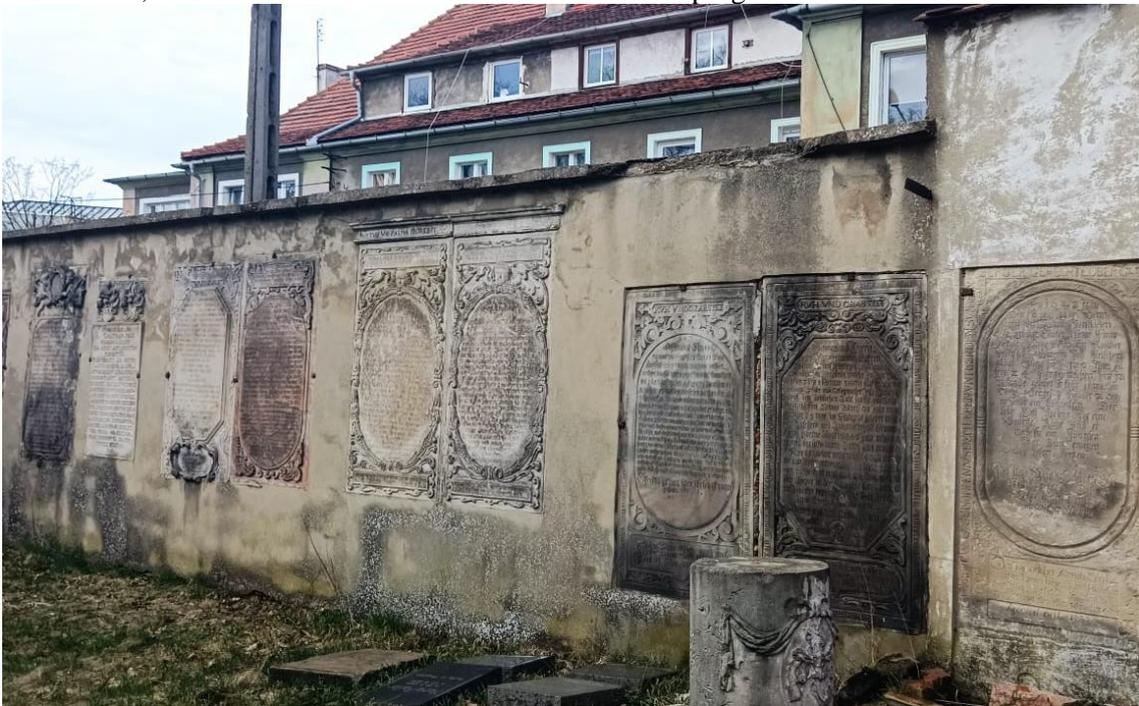
Fig. 8. Cemetery fence wall with display of epitaphs to be renovated next (Autor)

- Securing the crown of the outer wall - re-bricking of crumpled brick and laying of Ceramic plain tiles in scales with the development of a slope to the outside (Fig. 8.)
- Construction of reinforced concrete buttresses on the exterior side, connected to the wall with steel anchors and a crown on the crown of the wall
- Plastering the masonry with lime plaster with white cement, in the lower part used renovation plaster [10].

However, work on the outer wall is still at a low state of progress and will continue in 2024-2025.
