DIAGNOSIS OF THE PLINTH ZONE IN BUILDINGS UNDER CONSERVATION PROTECTION

Abstract

The results of thermographic research make it possible to model the actual operating conditions of selected parts of building structures. The article presents diagnostic analyses using thermographic tests of plinth zones in historic buildings. The results of the research form the basis for making decisions on thermo-renovation projects, and in historic buildings these decisions are additionally conditioned by the need to meet conservation requirements. The analysis carried out in this article shows that information about the temperature range in different parts of a building can be obtained using thermal imaging research, but not every result from research carried out with a thermal imaging camera can be used for further analysis. Thermal studies carried out only in accordance with the guidelines given in the standard allow for the acquisition of data that are necessary to carry out accurate simulations of the partition's operation over time and to select the most appropriate thermal insulation model.

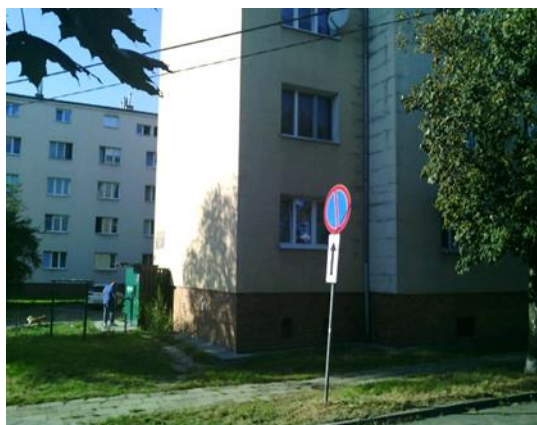
Fig. 3. Building without plinth insulation
(photo: B. Ksit)

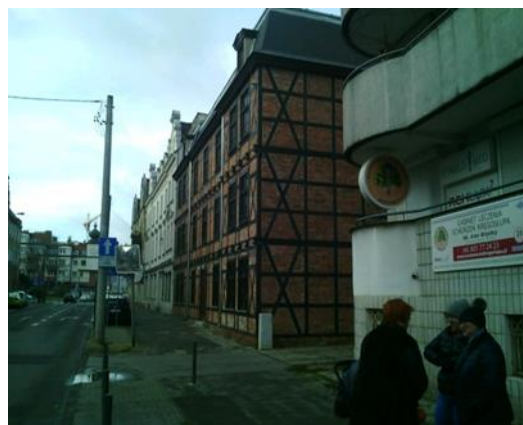
Fig. 4. Building with insulation on the inside
(photo: B. Ksit)
