TECHNICAL ASPECTS OF RENOVATION OF THE 16TH-CENTURY ROOF TRUSS

Beata NOWOGOŃSKA¹

University of Zielona Góra, Zielona Góra, Poland

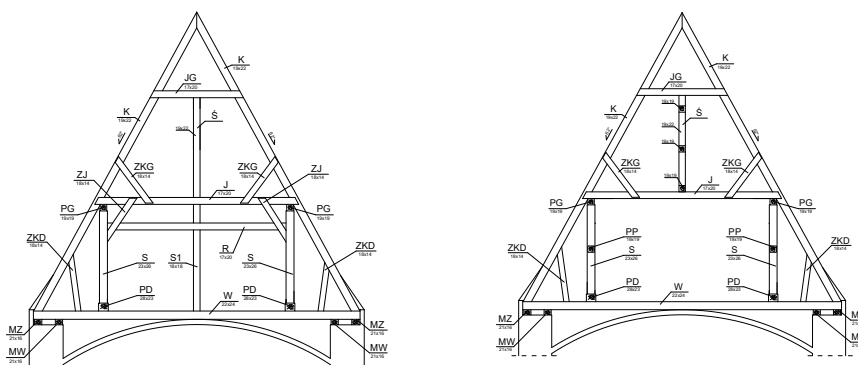
Fig. 1. Truss cross-section - full truss W1 Fig. 2. Truss cross-section - empty truss W1a

Truss structure is of collar beams with two supporting walls reinforced with transoms. Full trusses are additionally reinforced with a spreader beam. Between the full trusses in the longitudinal direction braces stiffening the structure. The cannula is additionally supported with braces.

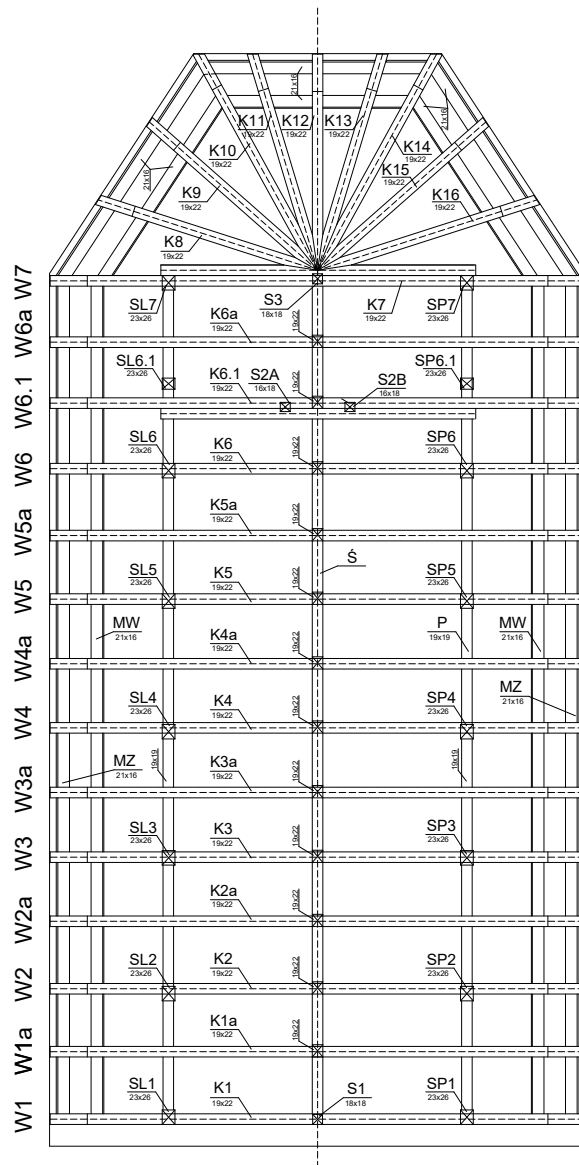
Fig. 3. Roof truss projection

In the upper part of the roof, a wooden mullion-transom frame is supported on the yards, additionally stiffened with braces running in one direction. The frame supports the tabs on the upper level. The truss is based on truss beams laid on two platforms.
