## **RECONSTRUCTION OF WAR DAMAGED BUILDINGS - A PROBLEM THAT STILL STANDS. THE CASE OF THE NATIONAL ECONOMY BANK IN WARSAW RESTORED DURING THE SECOND WORLD WAR**

Sławomir ŁOTYSZ<sup>1</sup>

Polish Academy of Sciences, Warszawa, Poland

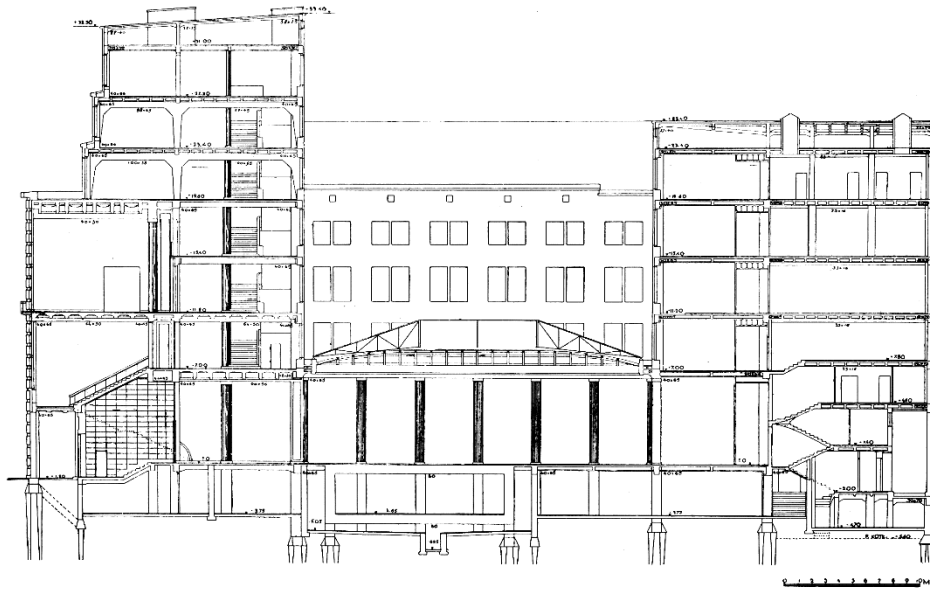
Fig. 1. Cross-section of the BGK building. On the left, the reinforced concrete framework of the main wing along Jerozolimskie Avenue is shown [7]
