## RENOVATION OF SHAFT MINING BUILDING NO. 2 IN KŁODAWA SALT MINE

### Abstract

## 2. DESCRIPTION OF SHAFT TOP BUILDING NO. 2

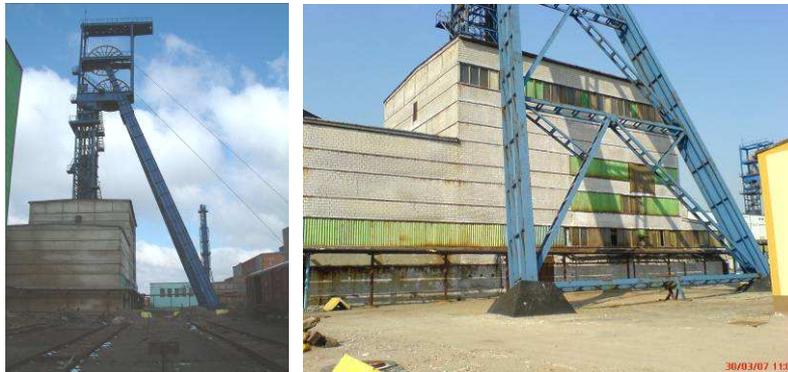
Fig. 1. View of Barbara mining shaft and shaft top building No. 2

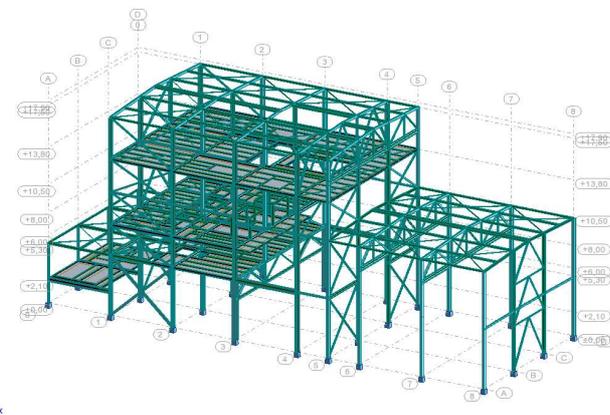
Fig. 2. Calculation model of the structural model of shaft top building No. 2

stress level of the individual beams of the building accounting for the actual cross-section parameters (Robot software model shown in Fig. 2), the floors on the level of +13.80 m between axes 1 and 2 at the location of dust extractors, inside columns of the high part between axes 1 and 5, the load-bearing lattice beneath the level of +5.30 m in axis 3, floor and load-bearing beams in the area of sieves at the level of +8.00 m in axes 1 and 3, load bearing beams of the silo at the level of +8.00 m and +13.80 m, between axes 2 and 4, main beams running through the floors and joints, inside column in the wall of axis B - 5, lattice in axis 4, roofing slabs in the outhouse - axis 0 to 1, inside and outside walls made of Silka 12 cm in thickness.
