DAMAGE TO THE FORTRESS IN DANKÓW AND RESTORATION OF KRZEPICKA GATE

Abstract

This paper describes conditions of the fortress walls in Danków. Locally they were found to be in very poor condition based on site inspections and non-destructive tests. The previous main gateway to the fortress, that is, the Krzepicka Gate was in the worst condition. Hence, the restoration for the Gate and the plan for its adjustment to become the preserved ruin were prepared. The structure was restored in the years 2021-2023.

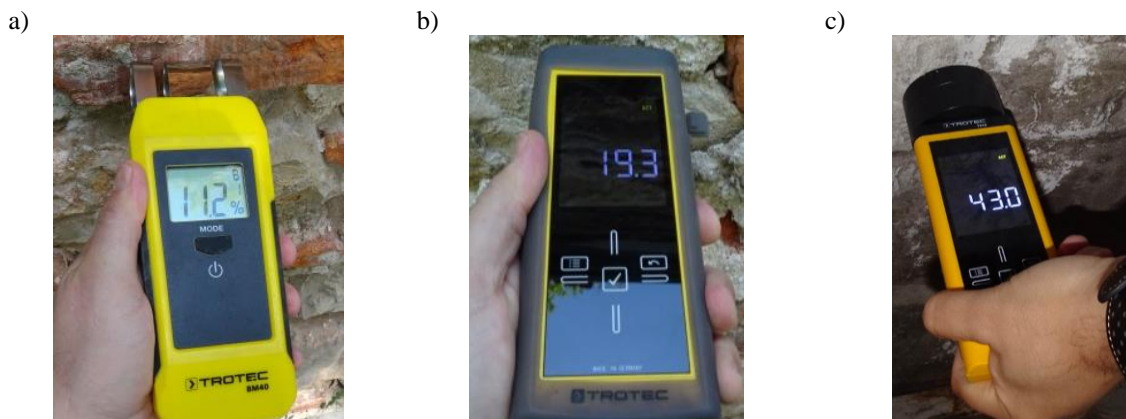
Fig. 22. Moisture tests of masonry elements and joints: a) dielectric method - surface test, b) dielectric method - depth test, c) microwave method

In historic buildings, the use of non-destructive testing is recommended [21, 22, 23]. Moisture content of the fortress walls and the Krzepicka Gate was tested. BM40 and T510 devices operating on the principle of the dielectric measurement method (Fig. 22a and b) and T610 microwave device (Fig. 22c) were used. Wall elements and mortar joints were tested. It is commonly believed that walls with moisture content of up to 3% are dry. Walls with moisture content of up to 5% are slightly damp, while up to 8% are considered damp. Walls with moisture content of up to 12% are considered damp, and above 12% are considered wet. Based on the tests performed, it can be assumed that the fortress wall elements are strongly damp and wet. The mortar should also be classified as strongly damp and wet.

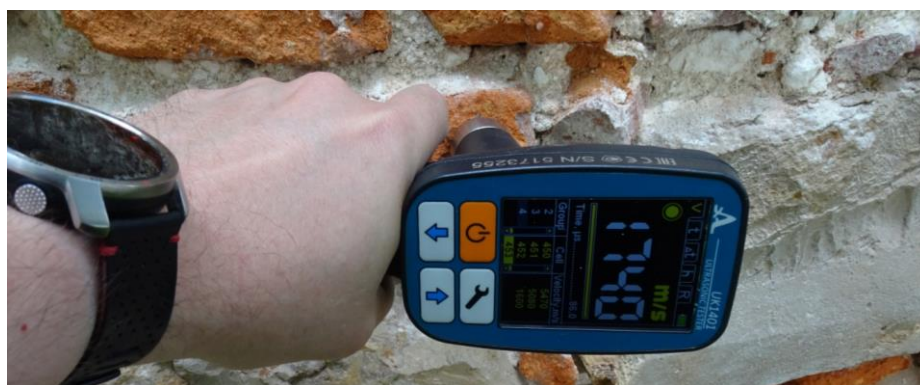
Fig. 23. Test of ultrasonic wave velocity

Non-destructive testing of bricks was performed using the UK1401 ultrasonic device (Fig. 23). The test measures the time of ultrasonic wave transit through the tested element between exponential heads installed at a constant spacing of 150 mm. The device automatically calculates the velocity of the transverse ultrasonic wave. Then on its basis, it is possible to determine the strength of the mortar based on the function defining the relationship between the strength of the mortar and the time of ultrasonic wave transit.

Ultrasonic wave velocities of 1500÷2200 m/s were obtained in the masonry elements. This allows estimating the strength of masonry elements in the range of 10÷20 MPa. A large variability of the test results was obtained (variation coefficient over 20%).
