CEER 2024; 34 (4): 0307-0327 DOI: 10.59440/ceer/195259 Original Research Article

# COMPREHENSIVE MONITORING OF CHANGES IN THE GEOMETRIC STRUCTURE OF A HISTORIC BUILDING THE "SALA BHP" IN GDAŃSK

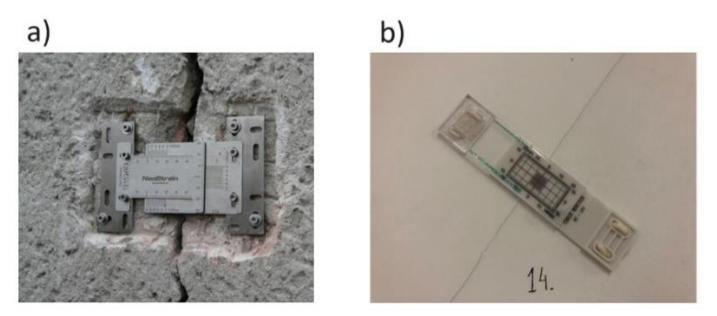
Fig. 12. View of the installed crackmeters: a) inside the facility, b) outside the facility

It was found that changes in the width of monitored cracks located on the walls of the building's facade are caused by changes in atmospheric conditions: ambient temperature, humidity, and sunlight. Significant changes in the readings of the S10 crack gauge means that the crack above the lintel is active, and therefore it is recommended to check the lintel's stress and propose ways to strengthen it.
