**SEISMIC PERFORMANCE EVALUATION
OF HISTORICAL CASE STUDY OF ARMENIAN
ARCHITECTURE TEKOR CHURCH**

Burçin Şenol ŞEKER¹, Merve ÖZKAYNAK^{1*}

¹Amasya University, Architecture Faculty, Architecture Department

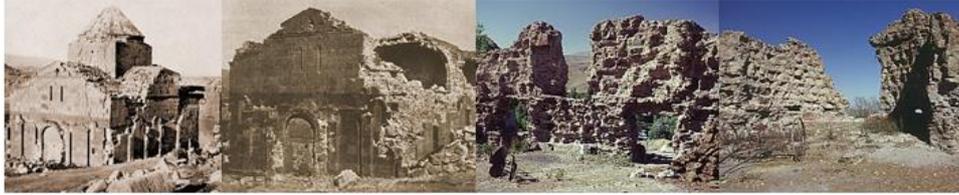
Fig. 2. Damage and deformation: a) Before earthquake in 1912 b) after earthquake in 1912 c) 1980s (URL-2, 2000) d) Remains (URL-2, 2000)

Damaged after the 1912 earthquake (Figure 2a-b), the church was almost completely destroyed in the 20th century (Romanazzi, 2009). As can be seen in the figure 2b, the damage of the earthquake in 1912, the roof and the south facade of the church, whose dome collapsed due to the earthquake, were destroyed.

Another earthquake in 1936 caused an unknown damage to the building. In addition, the fact that the building materials were removed reveals that it was the result of vandalism as well as the earthquake (URL-1). The church in the 1980s is included in the figure 2c. The current state of the church and the remains can be seen in the figure 2d.
