A PRELIMINARY COMPARATIVE STUDY OF SEEPAGE BEHAVIOUR BEHIND RETAINING WALLS WITH CRUMB RUBBER AND GEOCOMPOSITE

Vijayasimhan SIVAPRIYA¹, Chinnusamy SUDHARASAN²,
Ravikumar SURAJ², Kalyansundaram ABINAYA²
Department of Civil Engineering, SSN College of Engineering, India

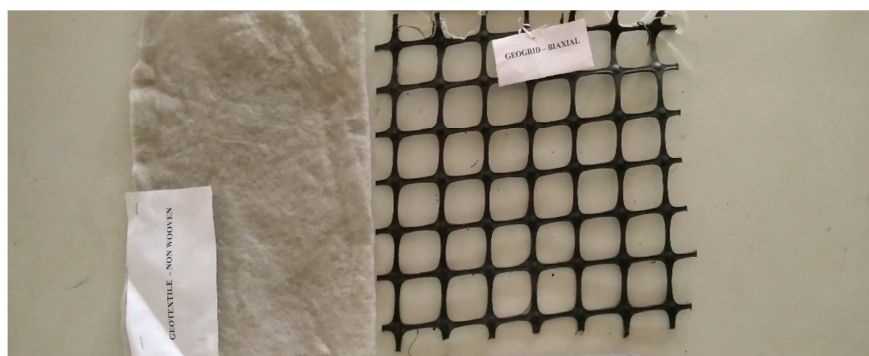
Fig. 5. Geocomposite material

2. Geocomposite (GC): Due to its longevity, currently geocomposite materials are widely used in reinforcing and stabilizing the soil. In the current study, non- woven geotextile sandwiched with geogrid was used as a filter material (laboratory fabricated – Figure 5) with its properties listed in table 3.

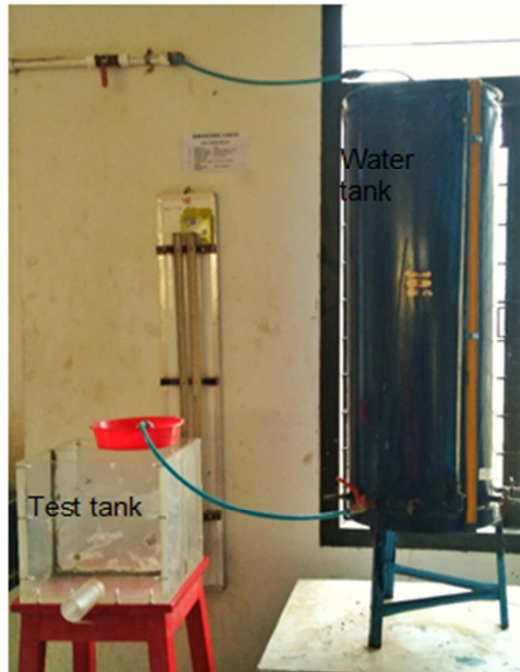
Fig. 8. Setup for the experiment
