FLOOD PROTECTION ON THE ODRA RIVER IN THE SEGMENT BETWEEN NOWA SÓL AND CIGACICE

The paper presents the flood protection on the Odra River in the segment between Nowa Sól and Cigacice, with special emphasis on the possibility of reconstructing the former flood polders in the Middle Odra Region that existed before the year 1945, including the polder in Milsko.

Keywords: flood protection, dry polder, flood polder

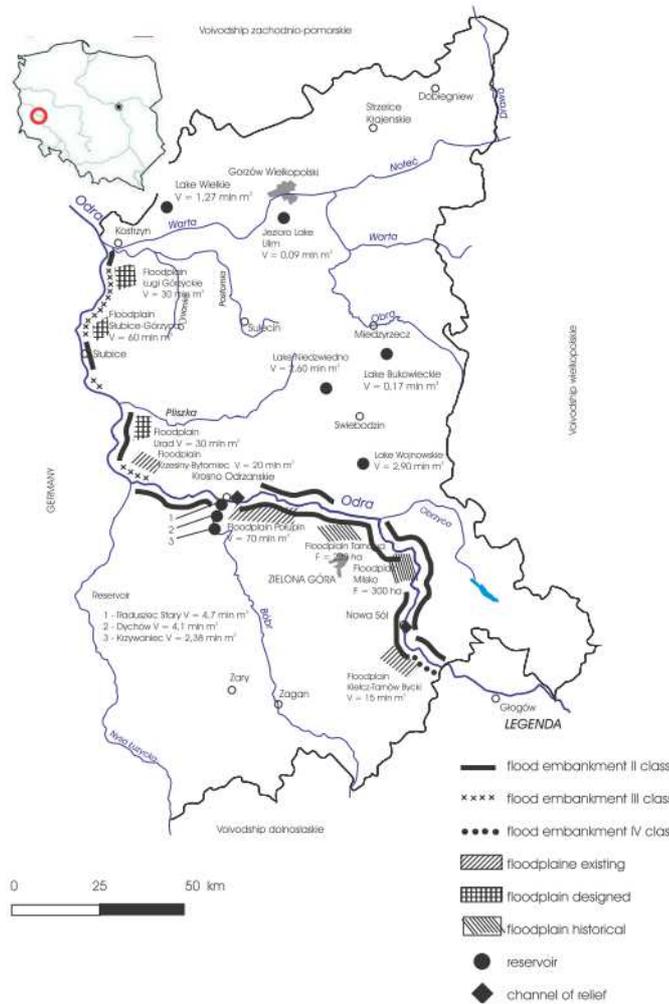
Fig. 1. Flood protection facilities in the Lubuskie Voivodship

Before the First World War, there were 12 polders on both sides of the Odra River with a total area of 12.7 thousand ha and a capacity of 104.6 million m³. At present, there are 10 polders on the Polish side of the Odra River with a total flood area of 6.4 thousand ha and a retention capacity of 75 million m³. During floods, they are flooded by inlet sluices or levee spillways [Rast, Obrdlik, Nieznański 2000]. There are three polders in the Lubuskie Voivodship (Fig. 1):

- Kiełcz-Tarnów Bycki with a capacity of 15.0 million m³,
- Połupin with a capacity of 70.0 million m³,
- Krzesin-Bytomiec with a capacity of 20.0 million m³.

reconstruction of the floodplain polders built by German engineers and existing in the Middle Odra Region in the 1940s and 1950s. These polders are: Milsko (300 ha), Tarnawa (220 ha), Pomorsko (200 ha), Brody-Bródki (180 ha), Nietkowice (310 ha), Będów (180 ha), and Połupin-Szczawno-Laski (2800 ha). Currently, the following polders exist in the Lubusz Odra River Basin: Kiełcz-Tarnów Bycki (815 ha), Połupin (4125 ha) and Krzesin-Bytomiec (1200 ha), and the following polders are planned to be constructed: Urad (30 million m³), Słubice Górzycza (60 million m³) and Ługi Górzycskie (30 million m³) - Fig.1.

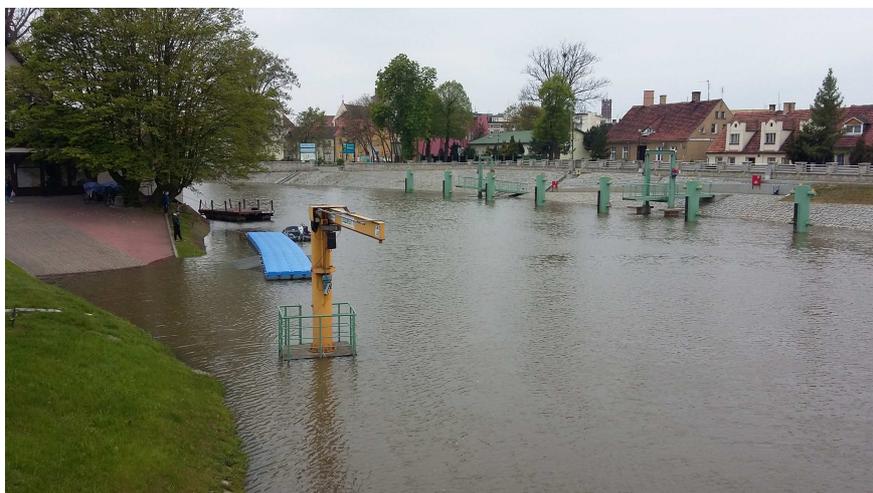
Photo. 1. The flood wall - the river port in Nowa Sól – May 2017 (Photo M. Hudak)

Another objective was to provide flood protection for the town of Nowa Sól. This was achieved by constructing a linear structure, consisting of a body of earth with a reinforced concrete wall on it in the form of a 955 m long ring levee beginning in the area of the intersection between Korzeniowski Street and Żwirko and Wigura Street at the entrance to the port basin, and ending on the high ground in the south-eastern corner of the port basin [Project 2004] - Photo 1. This protective structure contributes significantly to improving the protection of the historical part of the town with an area of about 27 hectares and protects this area against direct flooding by the Odra River, even when flow rates reach a level that can only occur once in a hundred years, i.e. with a probability of $p = 1\%$. Another measure taken to protect the town of Nowa Sól against flooding is reconstruction, extension, and demolition of the existing structures and construction of new structures in the district of Pleszówek (left bank of the valley of the Odra River and the Czarna Struga River) [<http://nowasol.pl>].

- extension of the left bank levee of the Odra River along a length of about 3.00 km, in the river section: km 429.85-432.40 including the related buildings,
- regulation of the Czarna Struga river bed in the section: km 0.000-7.618, including expansion of the levees on both banks and the related objects,
- construction of a flood pumping station (for water from the Czarna Struga basin and water seeping through), including a pumping station canal.

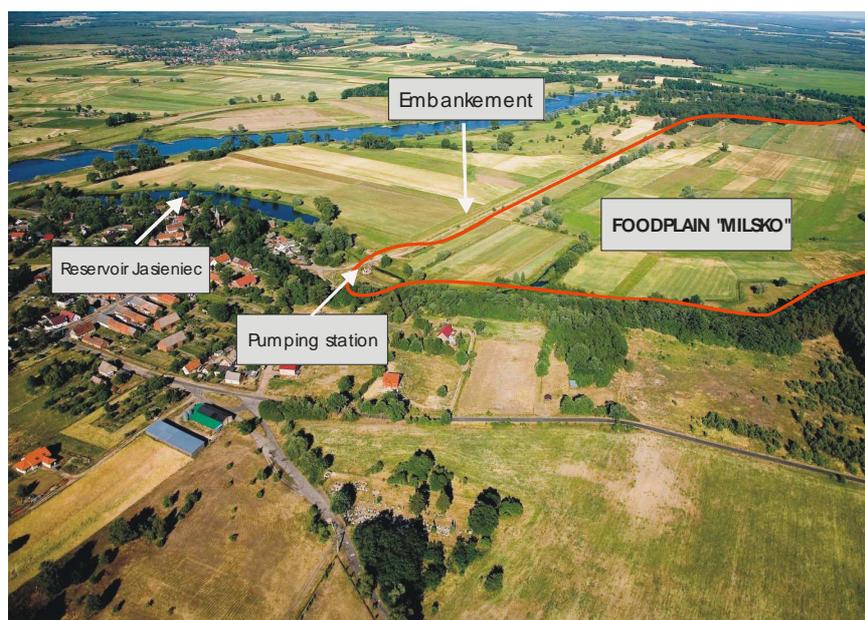
Photo. 2. Floodplain “Milsko” – April 2015 (Photo C. Karczmar)

From among the old polders, the Milsko polder is relatively easy to reactivate. The land, currently used for agriculture (Photo 2), is drained through the Jasieniec stream. At the mouth of the stream, there is a pumping station which directs the water to the canal, the Jasieniec reservoir, and then on to the Odra

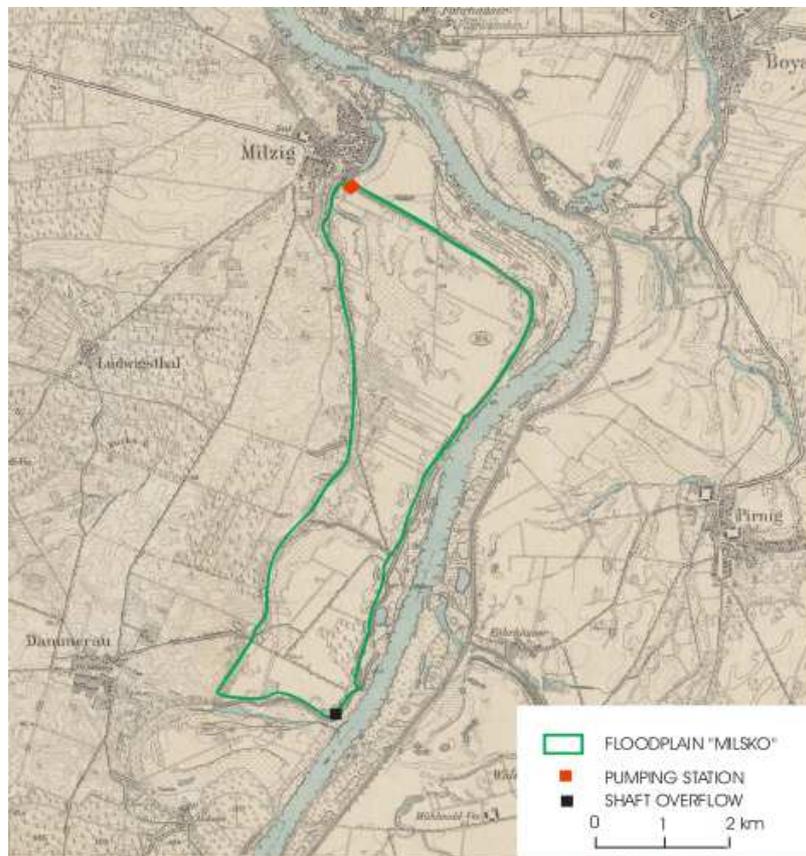
Fig. 2. Historical floodplain near Milsko [<http://amzpbig.com>]

River. The capacity of the existing pumping station is $0.30 \text{ m}^3/\text{s}$ (being 2 pumps with a capacity of $0.15 \text{ m}^3/\text{s}$ each) and the impact area is about 90 hectares. The Milsko polder will be a dry, controlled tank with an area of approximately 300 ha and an estimated capacity of 5 to 10 million m^3 . It will be reactivated according to the design specifications of the historical floodplain (Fig. 2), which was filled through a levee spillway. In order to reactivate the polder, it will be necessary to reconstruct the levee spillway, rebuild the pumping station, and clear the drainage canal.

It will be located between a natural slope (the moraine of the Weichselian glaciation) and the Odra River levee. The elevation of the slope ranges from 85.00 to 90.10 m a.s.l., and the elevation of the polder ranges from 56.50 to 59.50 m a.s.l.

The height of the levee along the river sometimes reaches 4 m but most of it remains at 3 m. The levee is a relatively inexpensive flood protection solution but has a negative impact on the flow of the water in the river. The cross-section of the inter-levee area is narrowed which results in an increase in the floodwater level. The levee cuts off the floodplains, which greatly reduces retention in the river valley leading to an increase in the volume of floodwaters.
