TRUSSES OF TENSEGRITY TYPE IN A CONCEPT OF TRAIN STATION RENOVATION IN ŻARY

Abstract

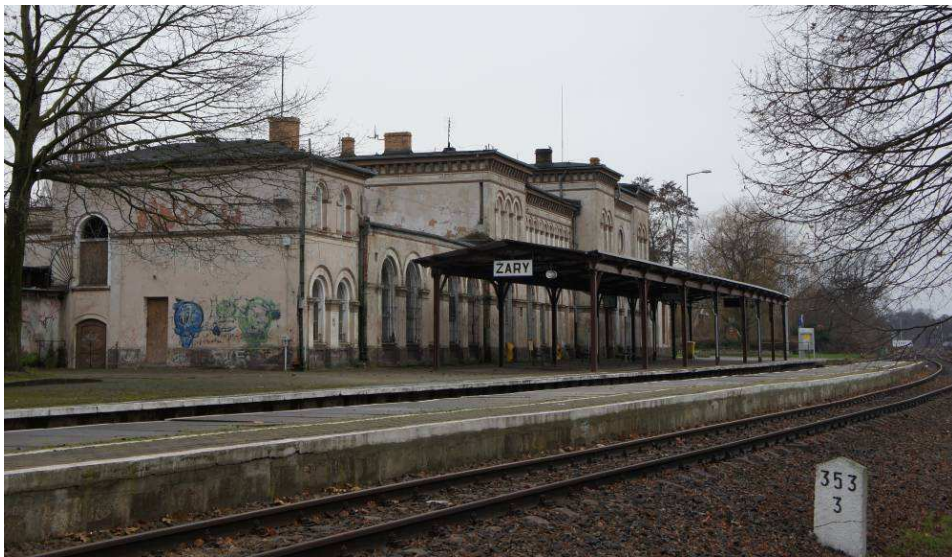
Fig. 3. Train station now - the view from the north

Station was built in the classical style. On the facade of the north and the south dominate windows of full and part arches, over which one placed decorative pediments; and one rosette in the central part of the facade. In the central part and on the facade of the eastern wing, windows are placed between pilasters. The floors are separated by a cordon cornice; the highest floor is also topped with a cornice.

The technical condition of the station and its environment is not satisfactory. The underpass into the station from the Długosz street there are numerous oozing, which gave rise to limestone efflorescence on monolithic binders. The roof is supported by cast-iron pillars; above the further (pre-existing) part is Klein's staple ceiling. Exterior walls loaded with embankment ground, as

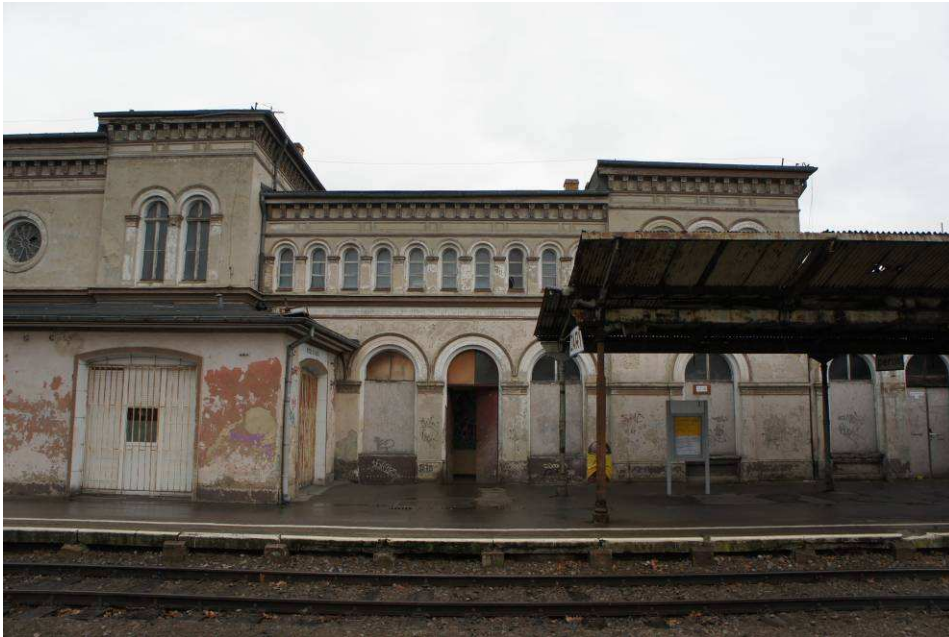
Fig. 4. Train Station now - the view from the south; in the middle of the entrance to the station concourse

The defacing of the technical infrastructure of the building, i. e. an incomplete dehydration, lack of gutters, damaged window sills and window frames, not only affect the disastrous visual state of object, but also lead to its further degradation. The result is a much vaster blistering of plaster, ingrown of vegetation and scouring of the ground around the building. Maintenance works carried out in recent years were superficial and have not been properly chosen. The paint used to repaint the interior pelt. In many places, cracked bitumen revealed the original cobblestones, which is still characterized by high aesthetics. It was a misunderstanding to paint several times the brick wall at the entrance to the underground of the station; raw bricks were much more aesthetically pleasing and required only clearing.
