VALUE OF ANTIQUITY IN THE RESTORATION PROCESS OF THE ART NOUVEAU VILLA DUELFER IN BARLINEK

Halina RUTYNA¹

Abstract

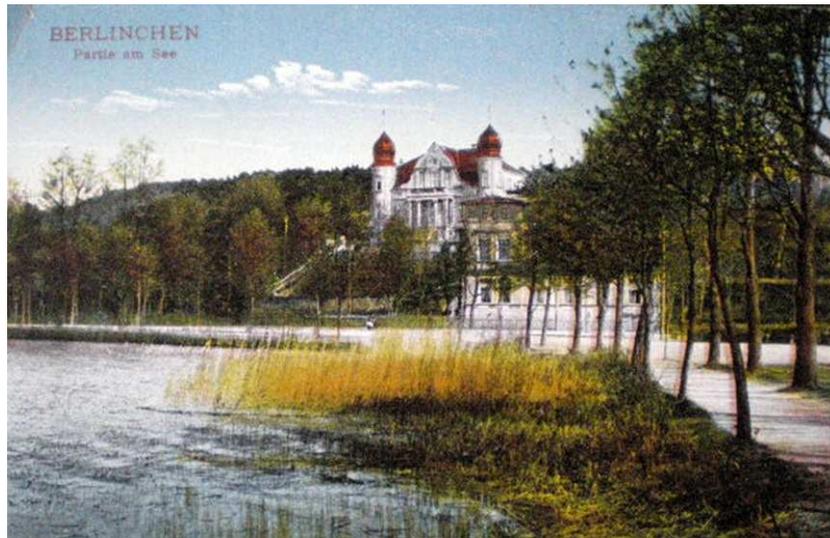
Fig. 1. Pre-war postcard of Berlinchen, showing the excellent location of the Villa Duelfer against the forest and lake. Source: Private collection

three sides is a forest (Fig. 1). Looking at the location and urban composition of the area, the villa's grounds blend into the green, tourist part of the place, which is slightly spatially separated from the centre in such a way that the two zones are axially linked by the clear, simple passage of Strzelecka street. The green areas are also still spatially combined with Barlinek's 'Old Town' area.

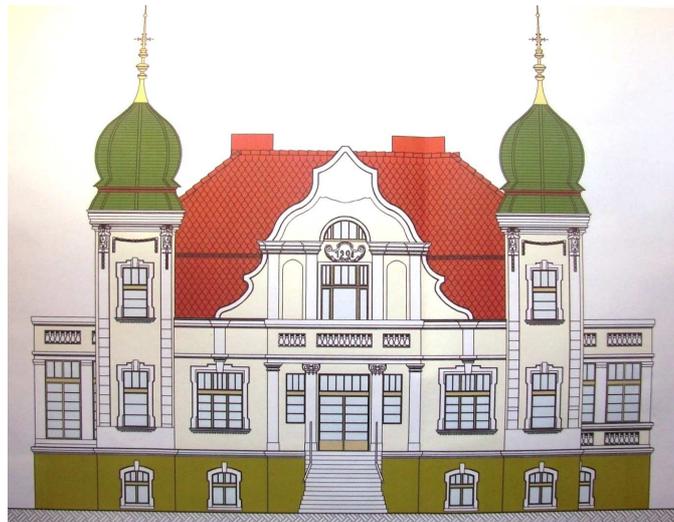
Fig. 2. Front elevation of the villa, by Halina Rutyna, 2008

Whilst maintaining the conservation documentation for the 100-year-old Villa Duelfer, I decided to cultivate the values of antiquity, which I began at the planning stage of the villa's renovation (Fig. 2). The theorist, A. Riegl, maintained that the root of scientific conservation lies in the reasoning that every human action is directed by specific values. From the perspective of the 19th-century knowledge of culture, one could attempt to extract the leading values by analysing different kinds of motivation associated with conservation activities. The diversity of active entities leads, primarily, to the differences in perception of relics of the past and the different value judgements made about these relics.
